Report on
Preliminary Stability Assessment

Proposed Memorial Park
167 – 177 St Andrews Road, Varroville

Prepared for
Catholic Metropolitan Cemeteries Trust

Project 73732.01
March 2017

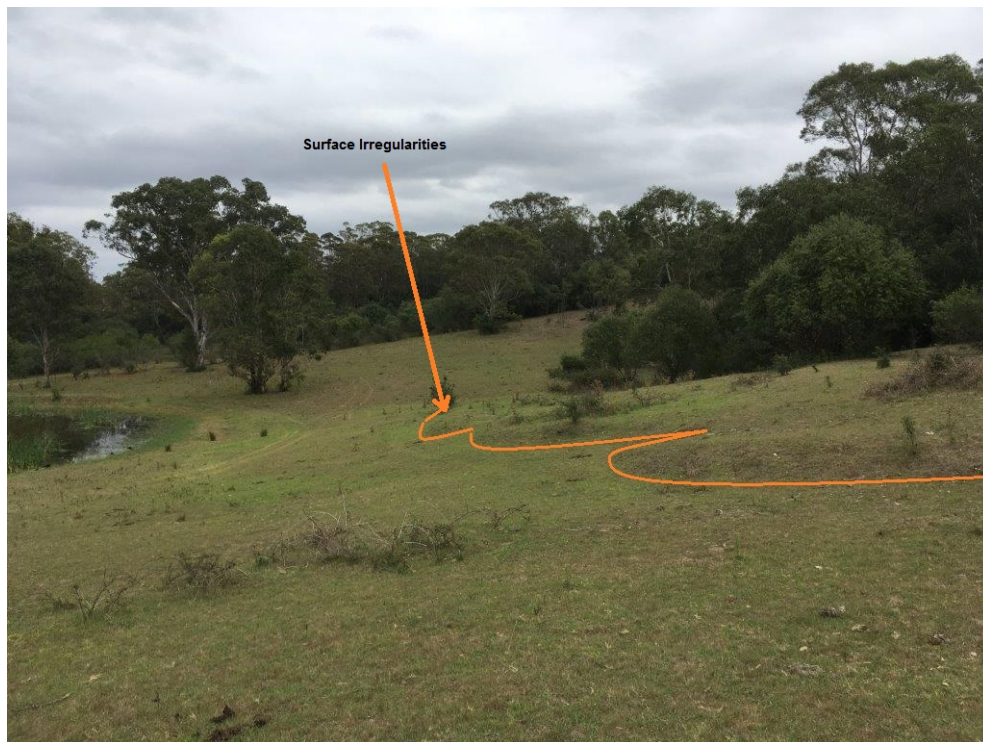
The field observations during walkover inspection confirmed the findings of desktop study. Signs of previous slope movements in the form of local surface irregularities were observed along the gently inclined south-facing slopes of Bunbury Curran Hill. The typical site condition at the surface of the colluvial areas is shown in Figure 2.

Figure 2 – Local surface irregularities in the vicinity of Pit 3 (looking west)

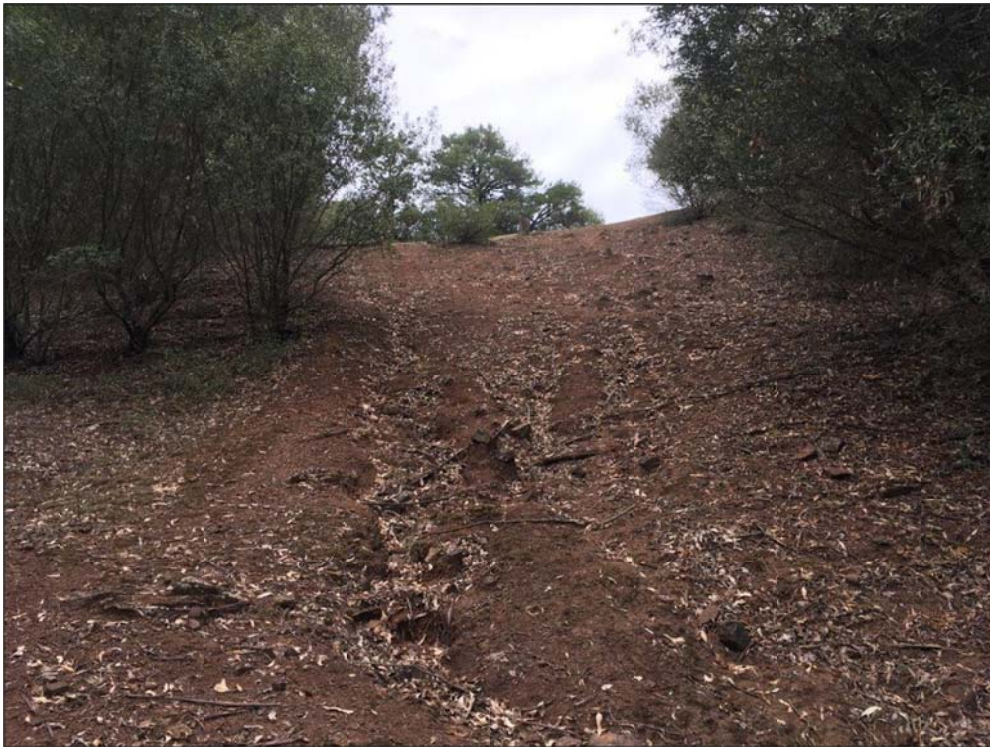
Based on the site observations, stormwater run-off appears to be one of the major issues concerning the site development. There are signs of severe soil erosion resulting from surface run-off particularly across the sloping areas in which the loss of protective cover is evident. Signs of erosion and rilling were observed towards the eastern boundary along an existing track in the vicinity of eastern boundary (Figures 3 & 4). The presence of clayey soils of low permeability at the surface of moderately sloping ground underlain by weathered rock has exacerbated the impact of surface run-off across these areas. The signs of tunnel erosion beneath the access track were observed in two locations (Figure 5). The loss of surface grass could be resulted from both human activities (site preparation for agricultural purposes, road construction, etc) and stormwater run-off.

Figure 3 – The effect of stormwater run-off

Surface drainage should be installed and maintained at the site. All collected stormwater, groundwater and roof runoff should be discharged into the stormwater disposal system. The possible need for subsurface drainage installation as part of individual building and roadway construction (particularly within the moderate risk zone) is noted, the extent of which is best determined once site-specific development details are determined.

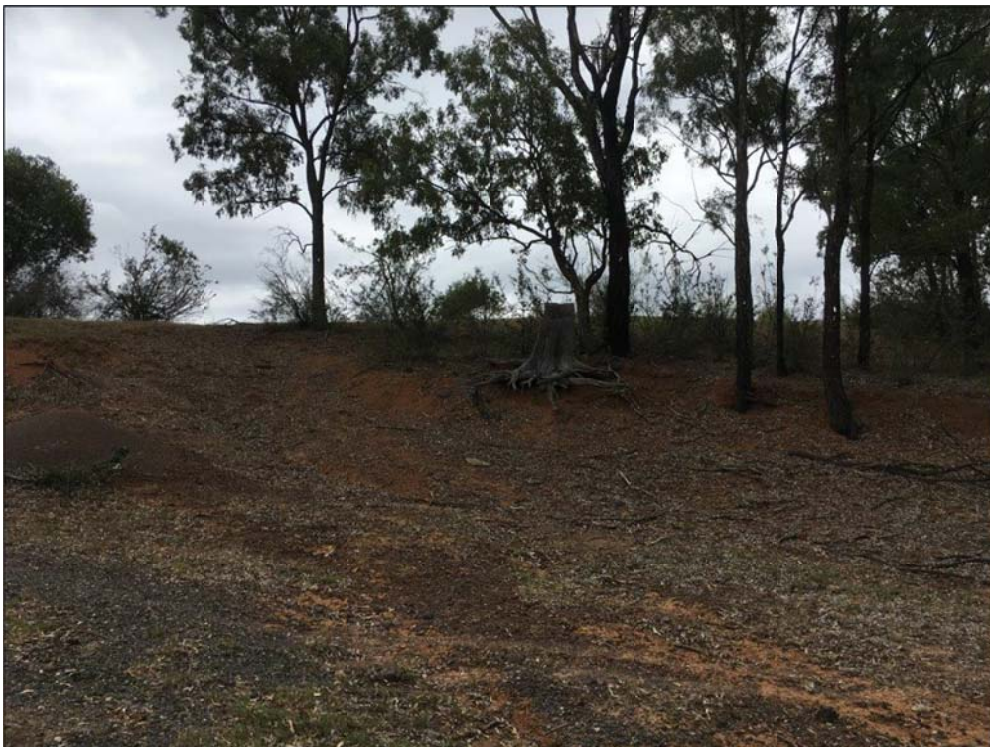
Figure 4 – The effect of stormwater run-off

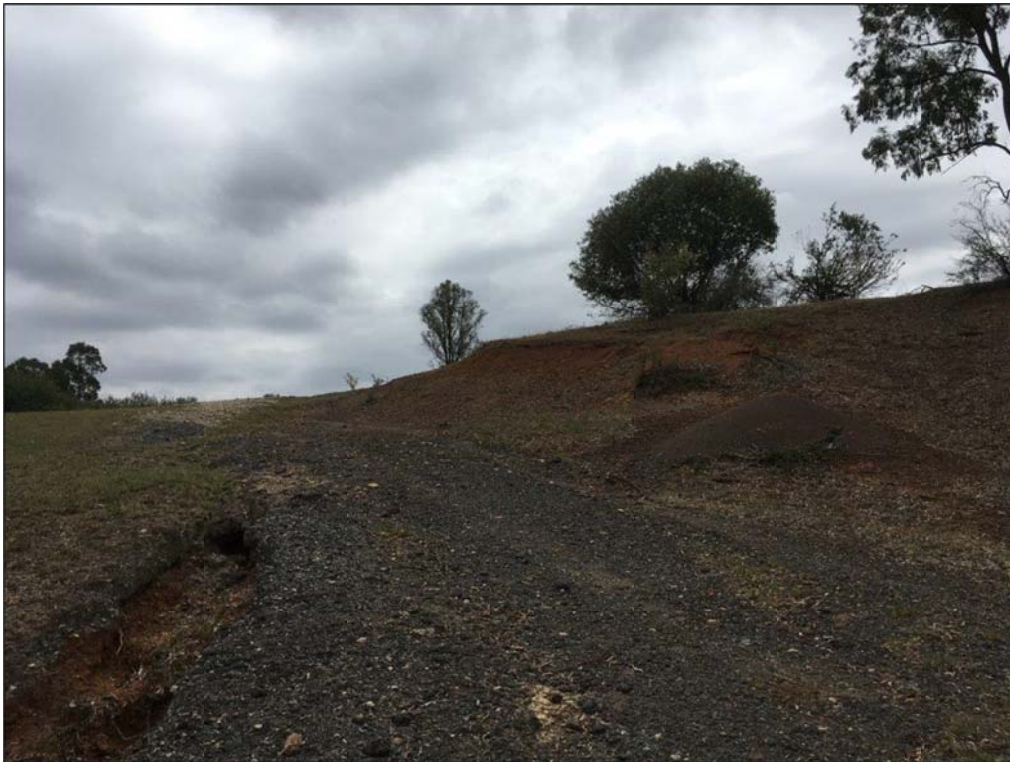
Figure 5 – The effect of stormwater run-off (tunnel erosion)

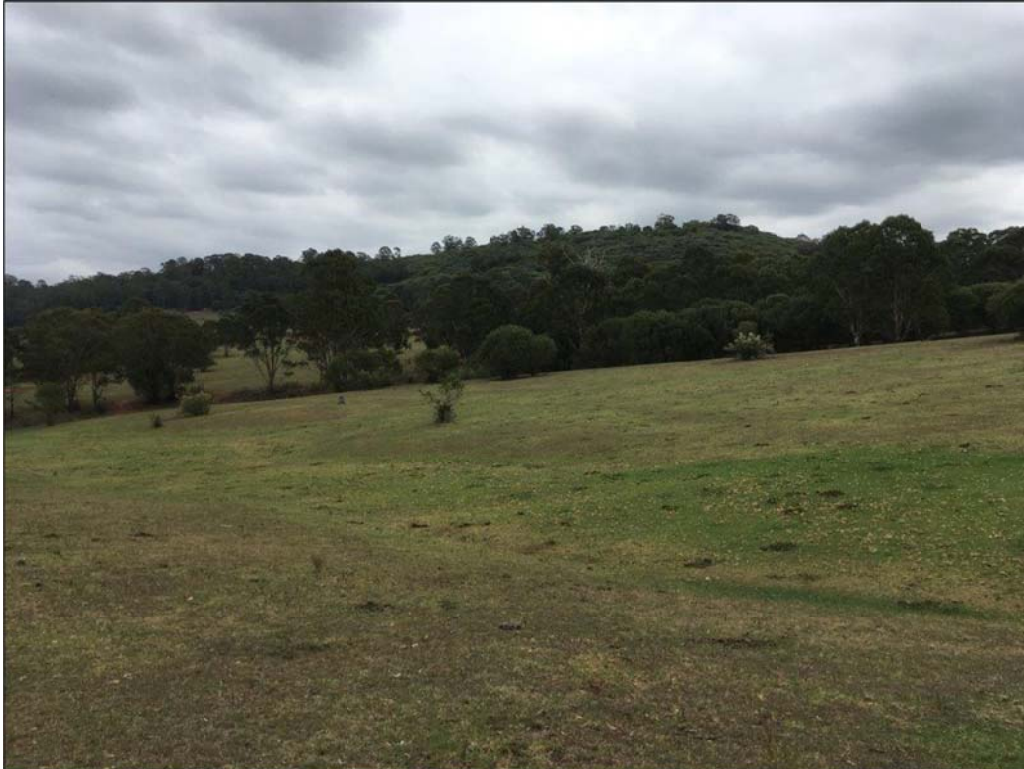
There was a drainage depression immediately to the south of the eroded areas running towards an existing dam at the central portion of the property (Figure 6).

Figure 6 – Drainage Depression (looking north)
