RE: MAXWELL PROJECT (SSD 9526) – MANAGEMENT OF EDDERTON ROAD

Enclosure 1 – Extracts from Maxwell Project Subsidence Assessment (MSEC, 2019)

Enclosure 2 – Subsidence Case Study – Broke and Charlton Roads

Enclosure 3 – Indicative Road Subsidence Monitoring, Management and Remediation Measures

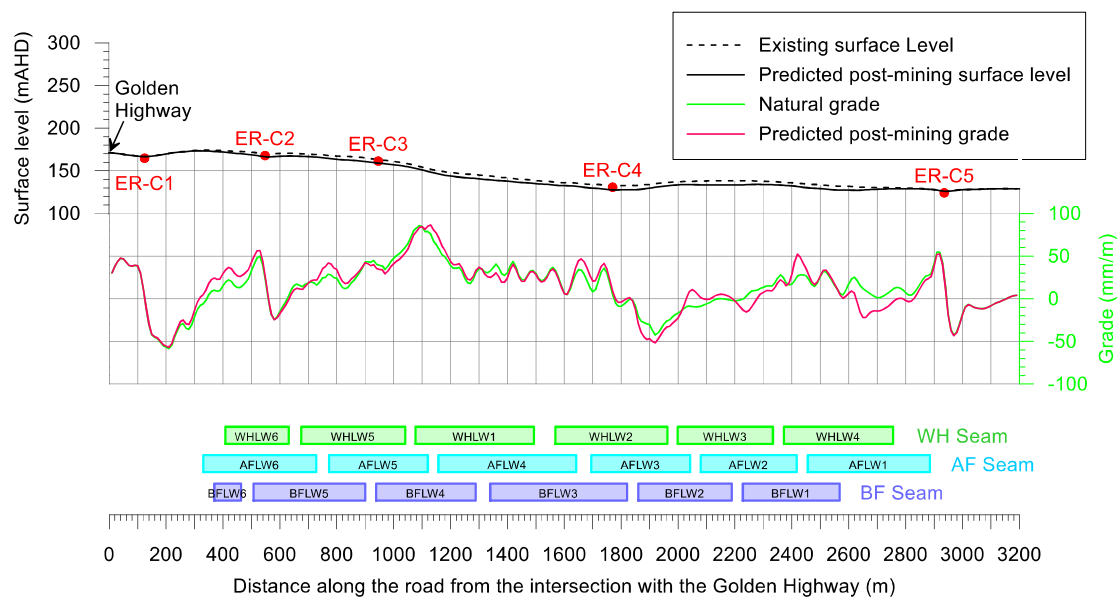
Fig. 6.9 Existing and predicted post-mining surface levels and grades along the current alignment of Edderton Road

The predicted post-mining grades along the current alignment of Edderton Road are reasonably similar to the existing grades. It is unlikely, therefore, that there would be large-scale changes in the surface drainage of the road due to the proposed mining. There is potential for increased ponding near the low-point along the road above the proposed mining area (i.e. near culvert ER-C4) due to the locally increased subsidence in that location.

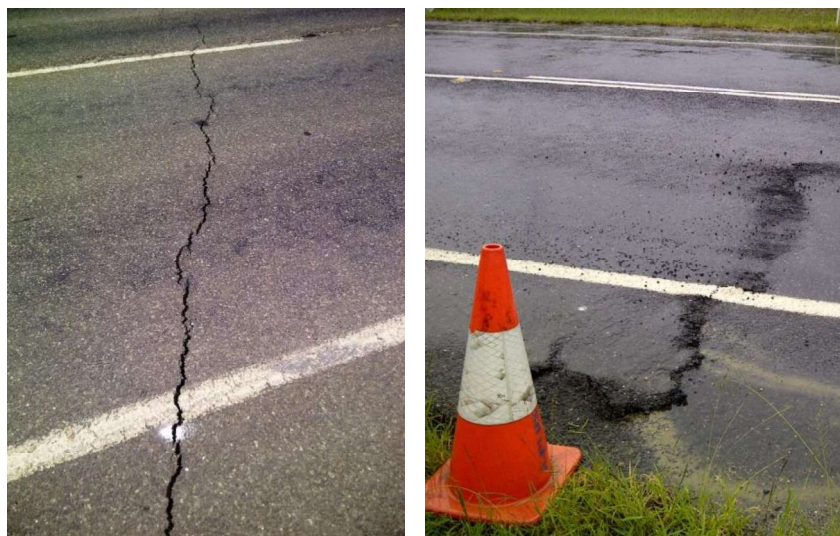
Fig. 6.10 Impacts observed along Broke Road at the Blakefield South Mine

The crack widths observed along Broke and Charlton Roads at the Blakefield South Mine typically varied between 10 mm and 50 mm, with a maximum width of 220 mm. The compression heaving and step heights observed along these roads were typically less than 25 mm, with a maximum height of 50 mm. Examples of the impacts observed at the Blakefield South Mine are provided in Fig. 6.10 for Broke Road and in Fig. 6.11 for Charlton Road.

The impacts on Broke and Charlton Roads were managed using visual monitoring and undertaking temporary repairs of the road pavement during active subsidence. The management strategies required some temporary lane closures and speed restrictions whilst repairs were being undertaken. The final remediation of the road pavement was undertaken after the completion of active subsidence.

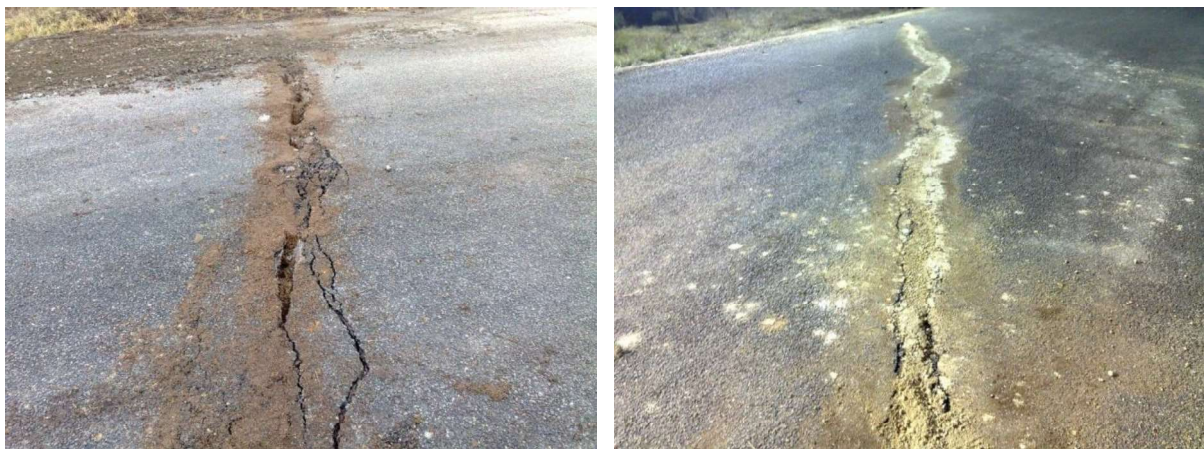
Fig. 6.12 Impacts observed along Charlton Road at the Beltana No. 1 Underground Mine

Beltana Longwalls 1 to 10 had void widths of 275 m and were extracted from the Whybrow Seam at depths of cover ranging between 80 m and 115 m beneath Charlton Road. The crack widths observed along the road typically varied between 50 mm and 100 mm, with a maximum observed crack width around 380 mm. The heave and step heights observed along the road were typically in the order of 25 mm. Examples of the impacts observed along Charlton Road at the Beltana No. 1 Underground Mine are provided in Fig. 6.12.
