## SITE INSPECTION DETAILS

<b>Project</b>	Tahmoor South Coal Project (SSD 8445)
<b>Location</b>	Tahmoor, Thirlmere, Picton, Bargo and surrounds.
<b>Date</b>	10 February 2021
<b>Time</b>	8.45am – 4.30pm

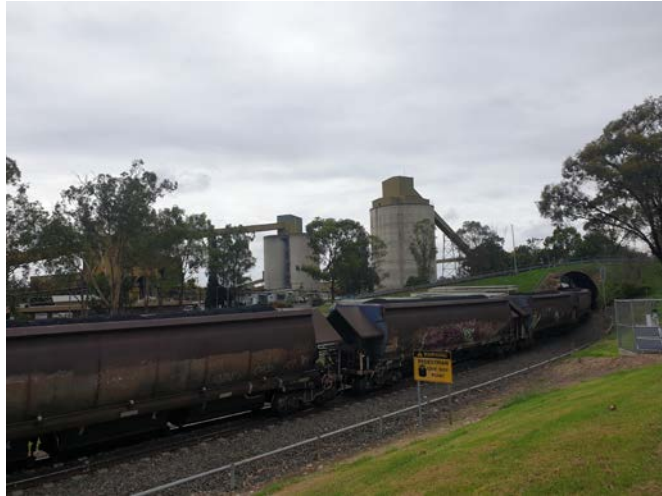
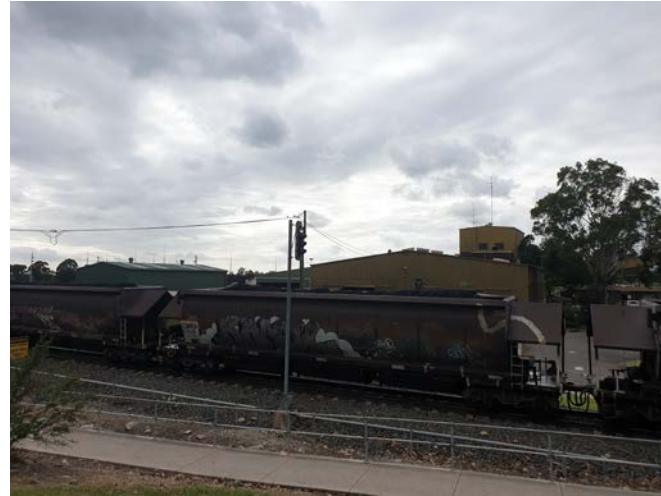
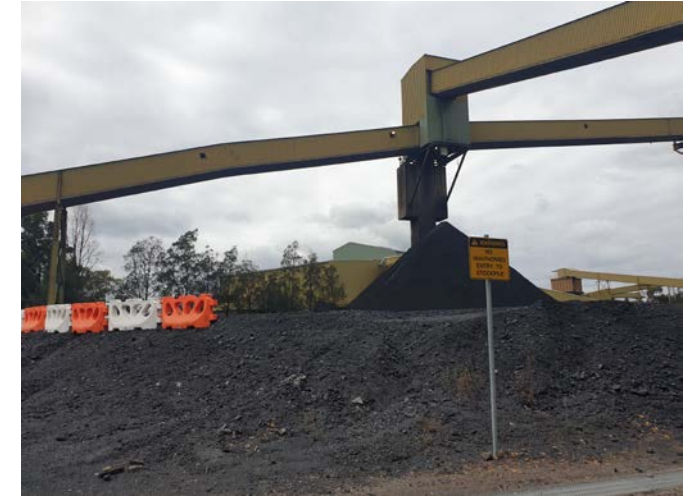
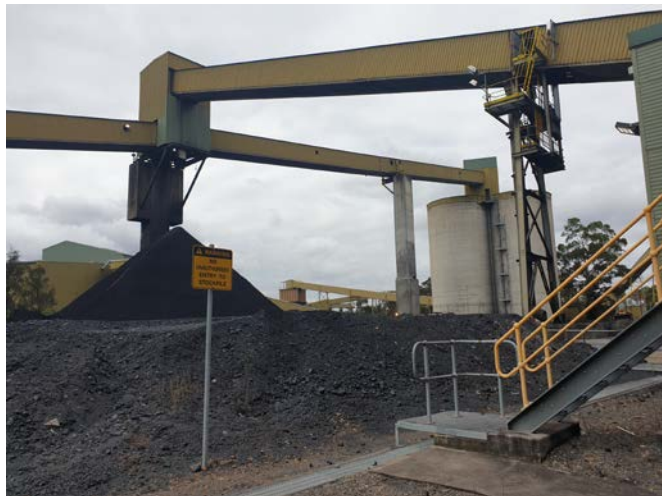
*Tahmoor Coal Pit Top – Image 1(a)*

- Observed key site buildings and features from elevated location adjacent administration building

followed by walk through central section of pit top site

- Discussed movement and storage of coal within the pit-top site, offsite transport of coal, and current operation of flares

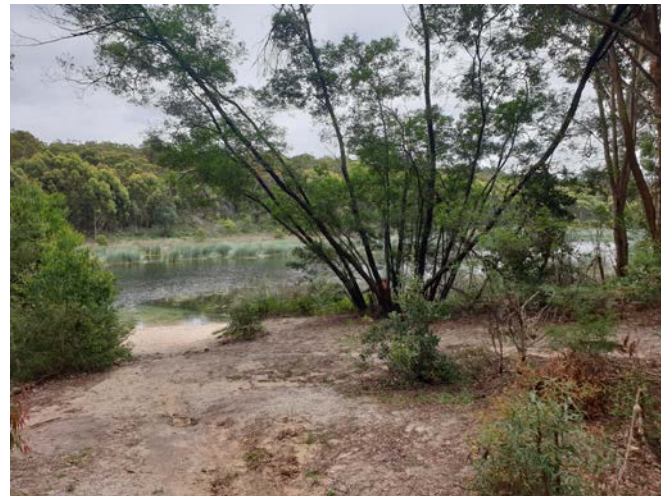
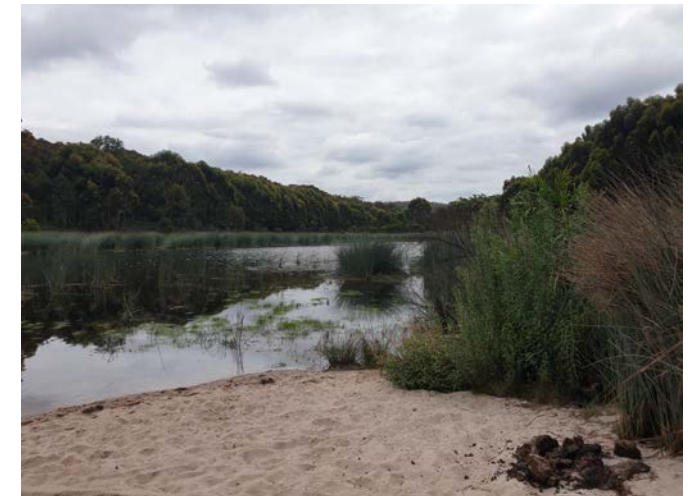
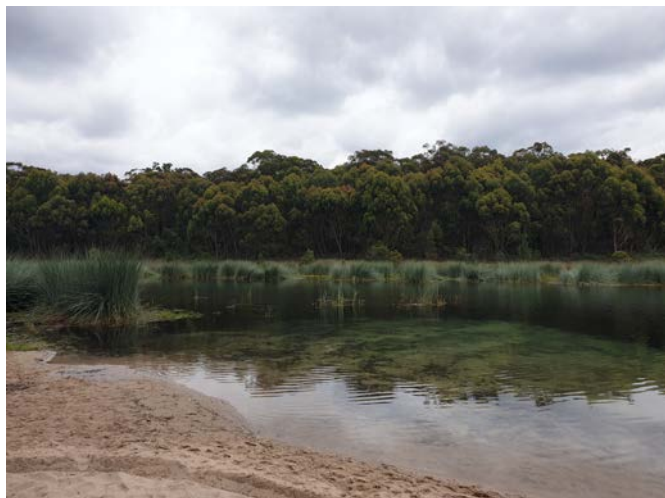
*Thirmele Lakes - Image 2(a)*

- Inspected Lake Couridjah
- Viewed Lake Werri Berri and Lake Gandangarra (from bus)
- Discussed water levels, recreational and environmental significance, proximity of previous longwall mining and ongoing research into lake hydrology

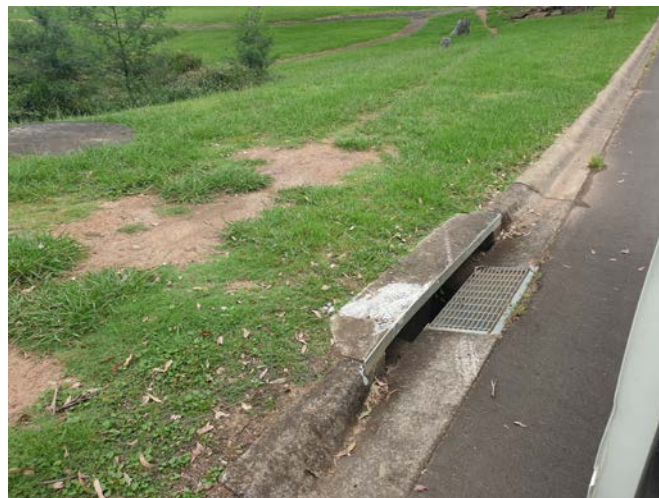
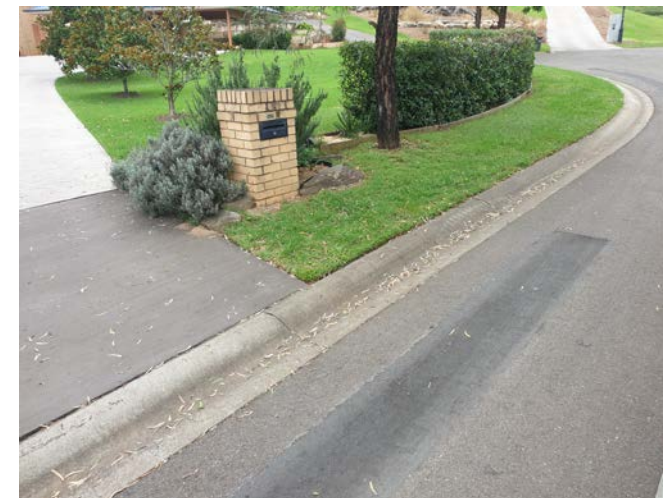
*Stonequarry Creek Road - Image 3(a)*

- Viewed properties in subsidence area and minor repairs to the road surface and kerb (from bus)
- Discussed applicant's existing procedures for managing subsidence and engagement with residents

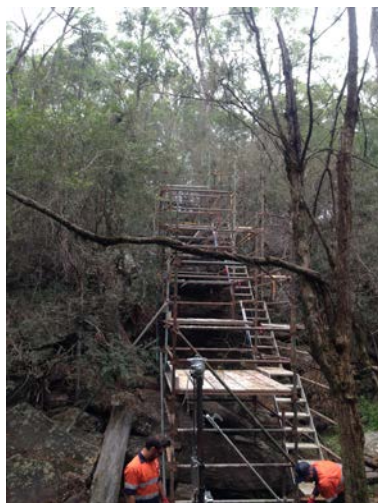
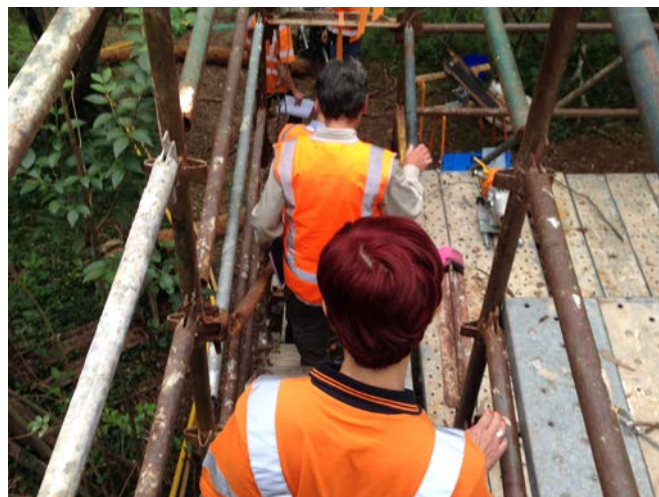
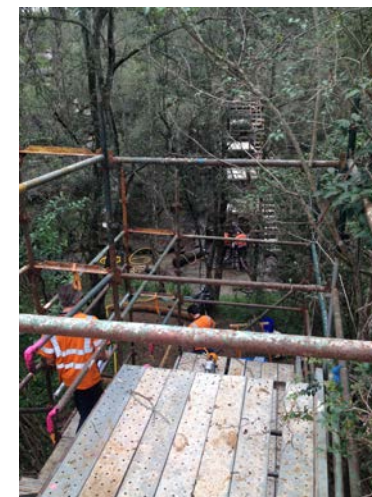
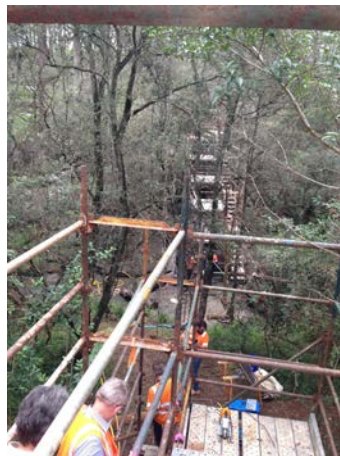
*Redbank Creek - Image 4(a)*

- Met with applicant's subcontractors and inspected one section of creek where remediation work is in progress
- Discussed the past subsidence impacts on geology and hydrology of Redbank creek, remediation methods and results to-date
- Viewed some sections of Picton industrial estate and discussed subsidence, and the applicant's monitoring and management of subsidence impacts

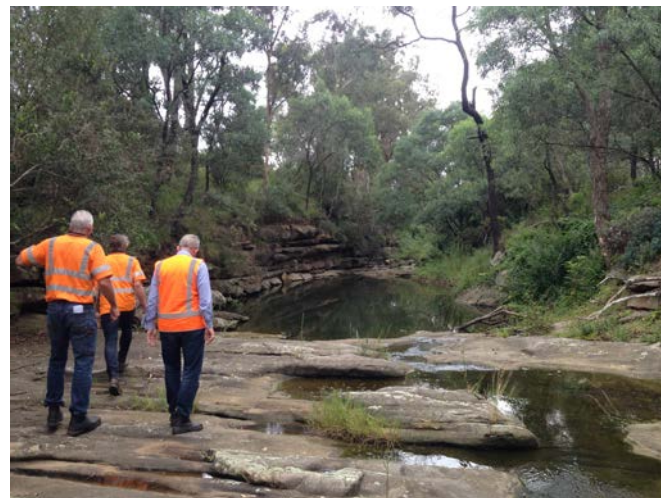
*Myrtle Creek - 5(a)*

- Inspected one pool in creek where remediation has occurred
- Discussed subsidence (and upsidence), and completed remediation works

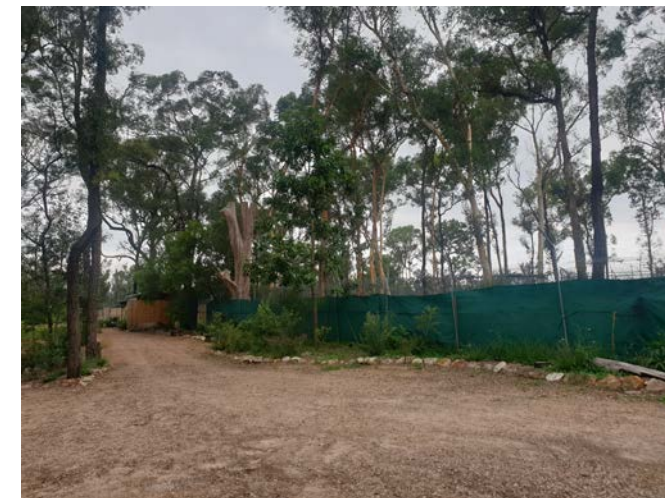
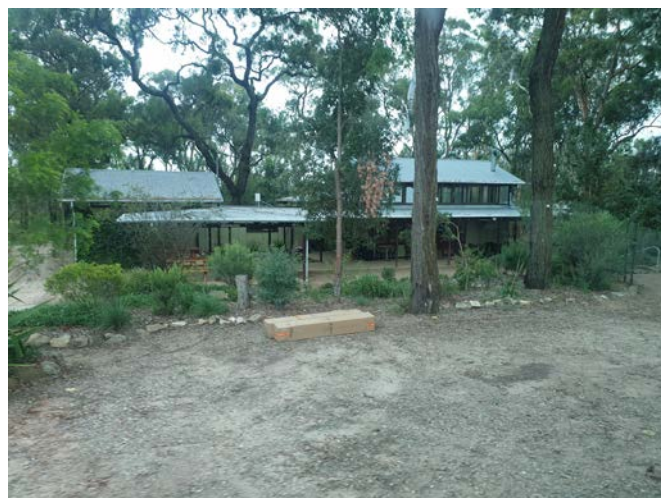
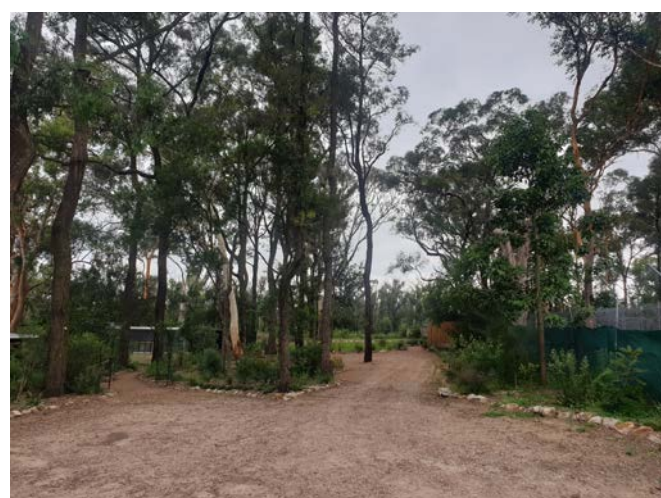
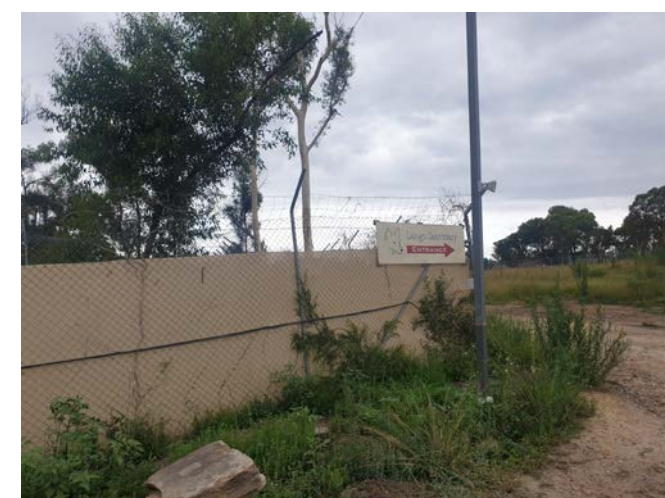
*Wirrimbirra Sanctuary - 6(a)*

- Viewed main built features, including visitor building and animal enclosures (from bus)
- Discussed Applicant's engagement in regard to undermining of Wirrimbirra Sanctuary

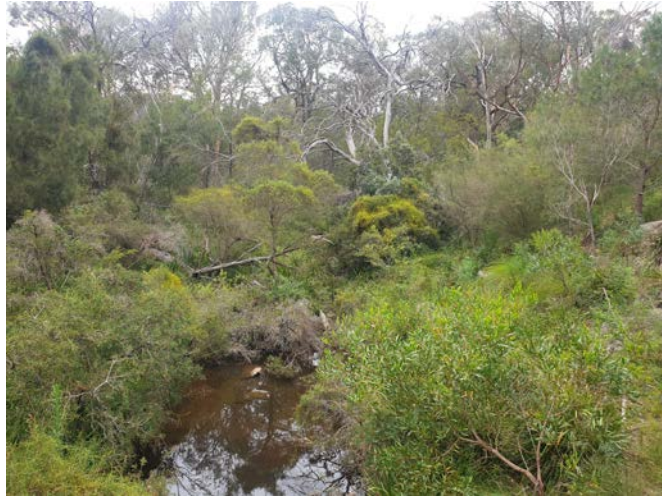
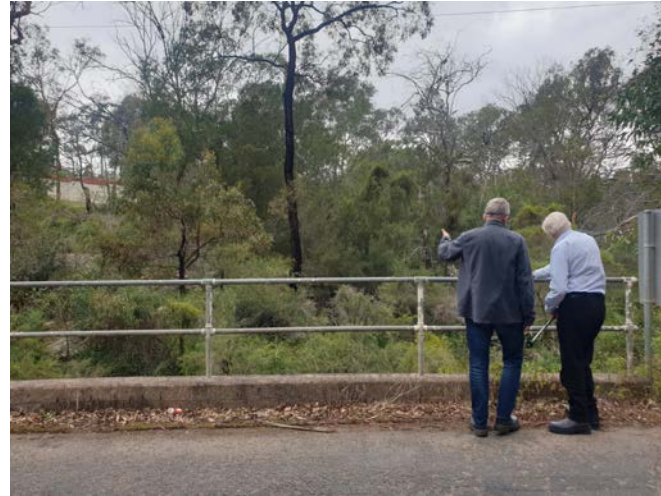
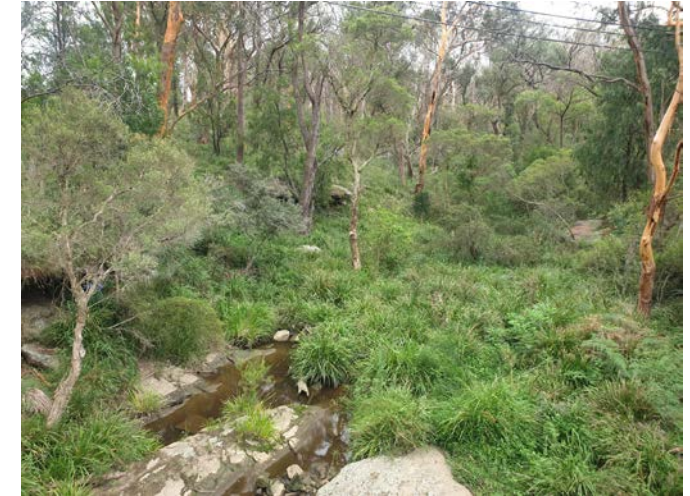
*Dog Trap Creek – Image 7(a)*

- Viewed creek from Arina Road bridge (on foot, traffic controls in place)
- Discussed topography of creek and implications for subsidence risk, and presence of downstream recreation location, Mermaid Pools.

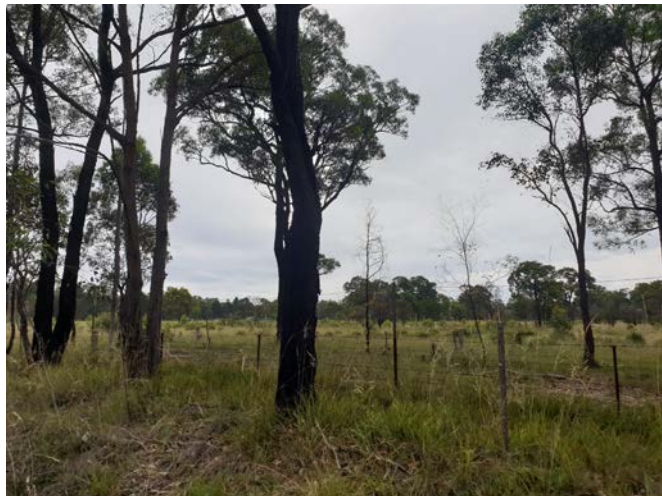
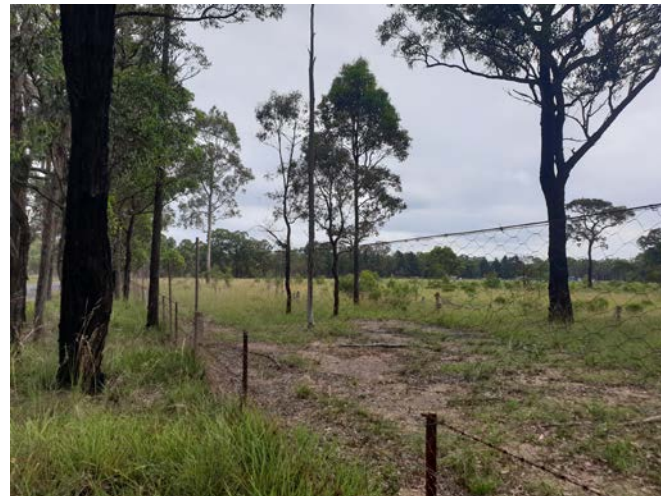
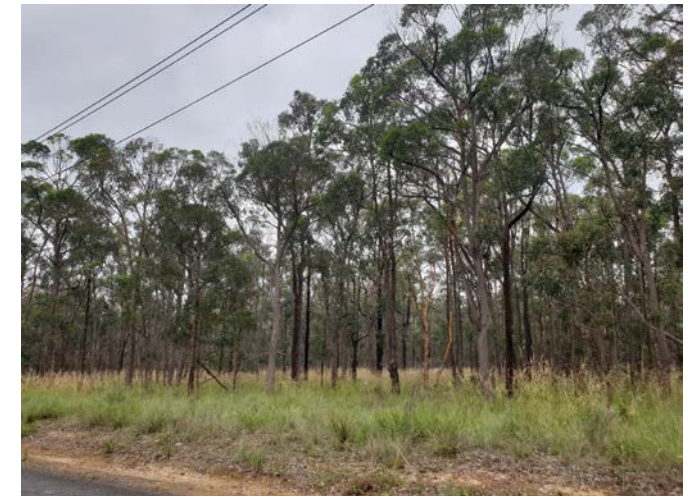
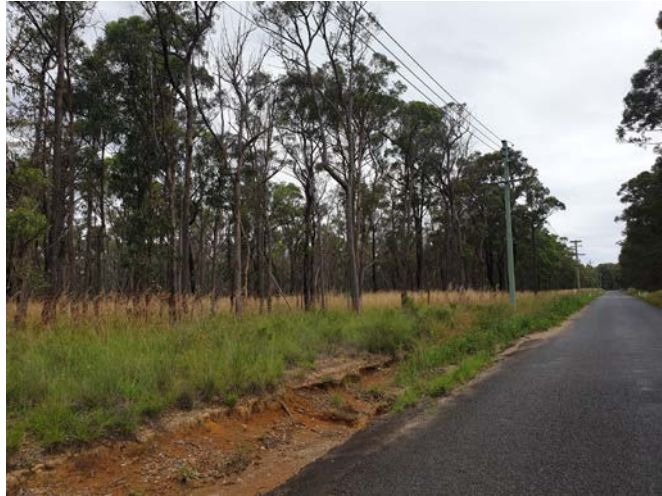
*Proposed Ventilation Shafts – Image 8(a)*

- Viewed areas proposed for clearing and observed Endangered Ecological Community reported in EIS, and examples of affected grevillea sp.
- Discussed footprint of proposed ventilation shafts and extents of clearing proposed

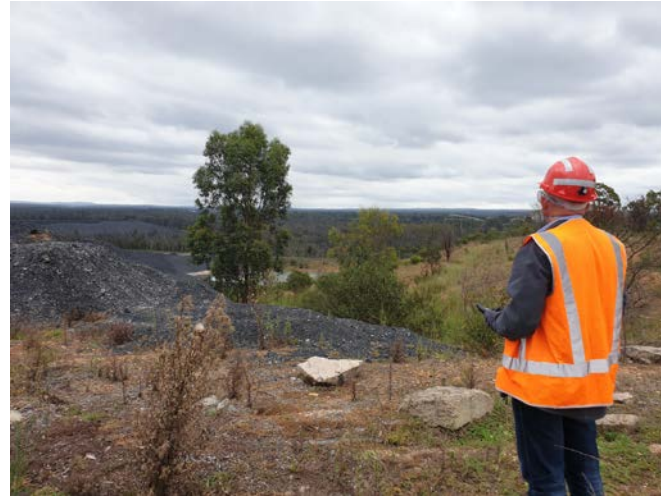
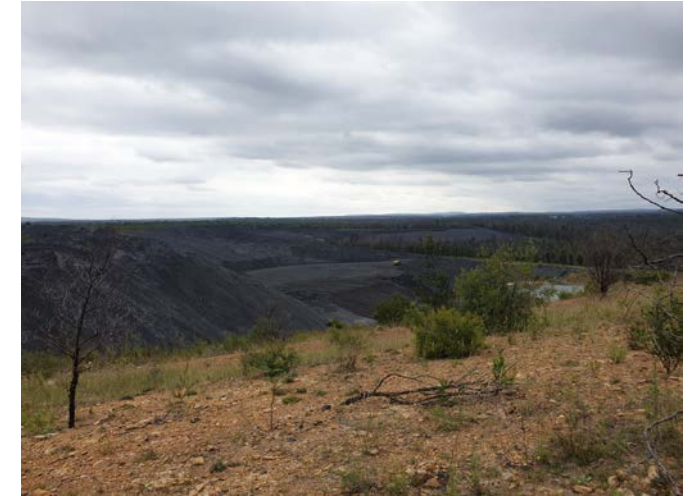
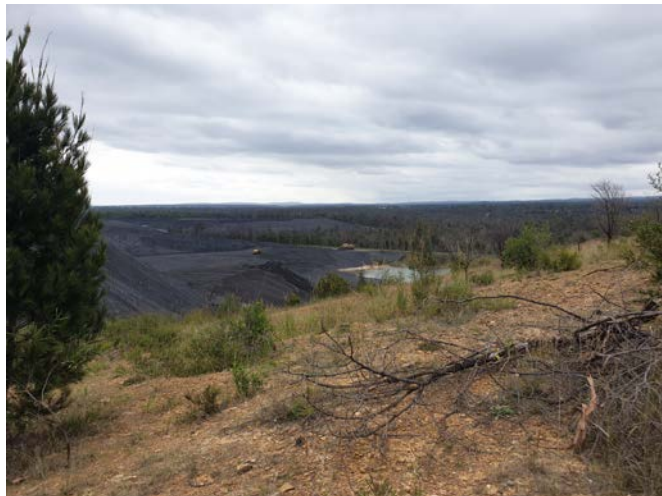
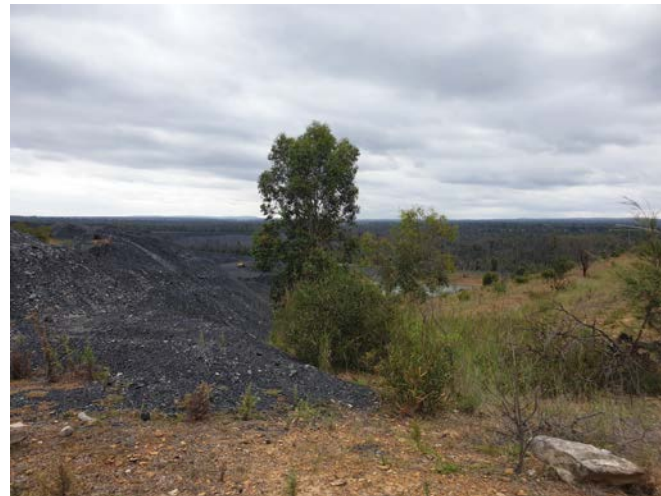
*Refuse Emplacement Area – Image 9(a)*

- Viewed existing refuse emplacement area, observed topography, ongoing refuse emplacement, and areas where revegetation has occurred
- Discussed topography, proposed filling, water management and proposed vegetation removal,

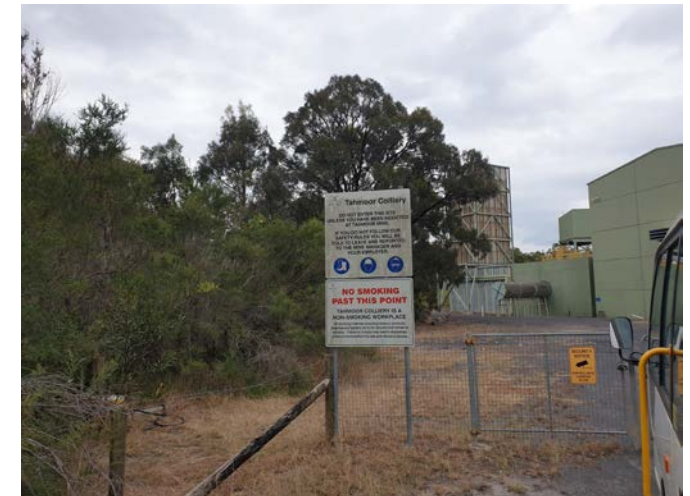
*Existing Ventilation Shaft – Image 10(a)*

- Viewed existing ventilation shaft site from outside of fenced area (from bus)
- Discussed extents of proposed filling area and management of groundwater
