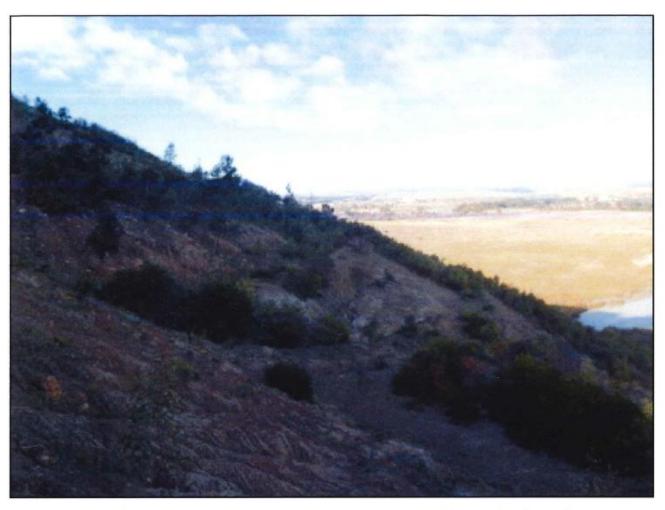
Plate 3: View east along a steep slope showing high levels of erosion.

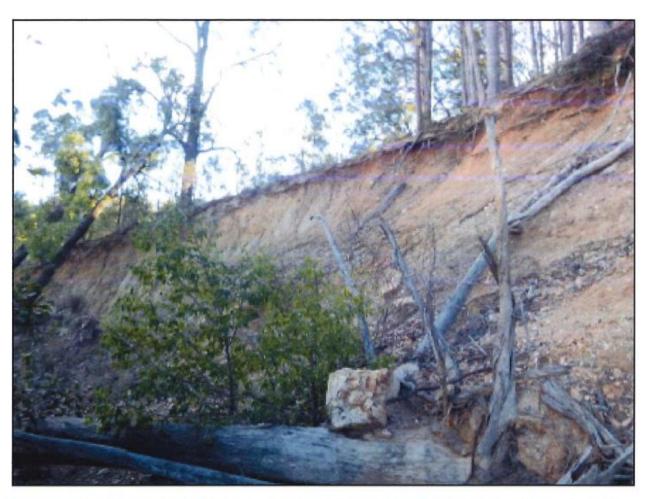
Plate 5: View of an area of previous rehabilitation works that have exacerbated erosion.

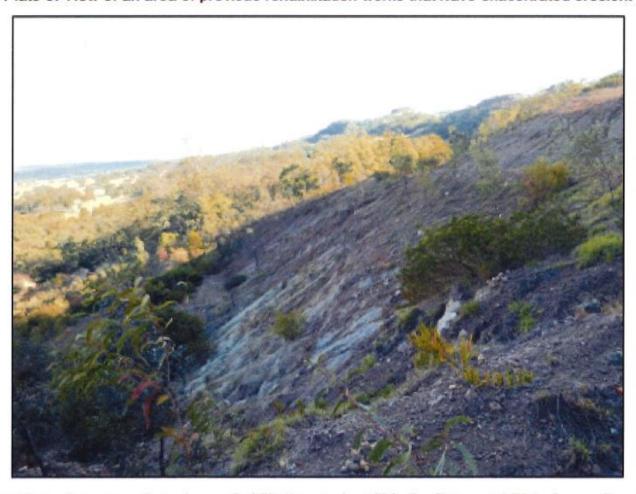
Plate 6: View of an area of previous rehabilitation works within the Proposed Disturbance Boundary.

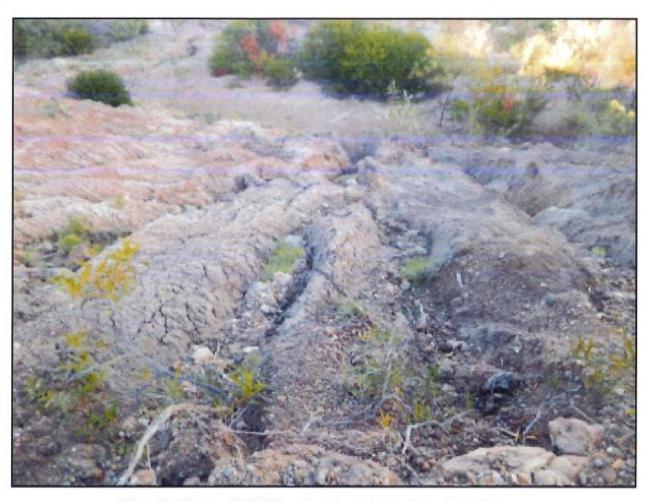
Plate 7: View of high levels of erosion along the slopes.

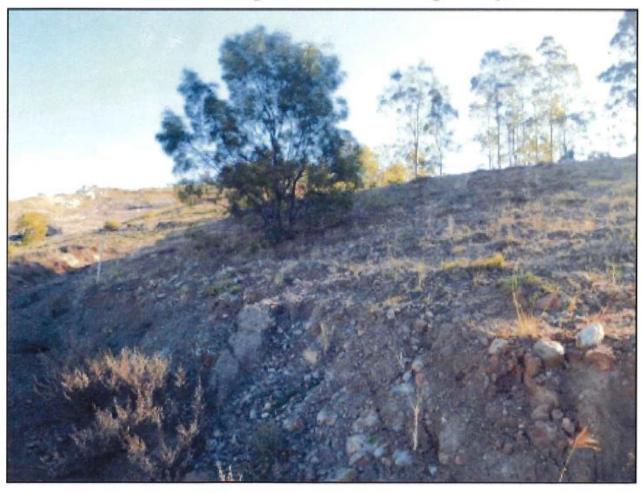
Plate 8: View of disturbance in the southernmost portion of the Proposed Disturbance Area.
