Montage of 4 of the 6 heritage cottages, the RACF and Building 2.

BUILDING 4 - ILU's

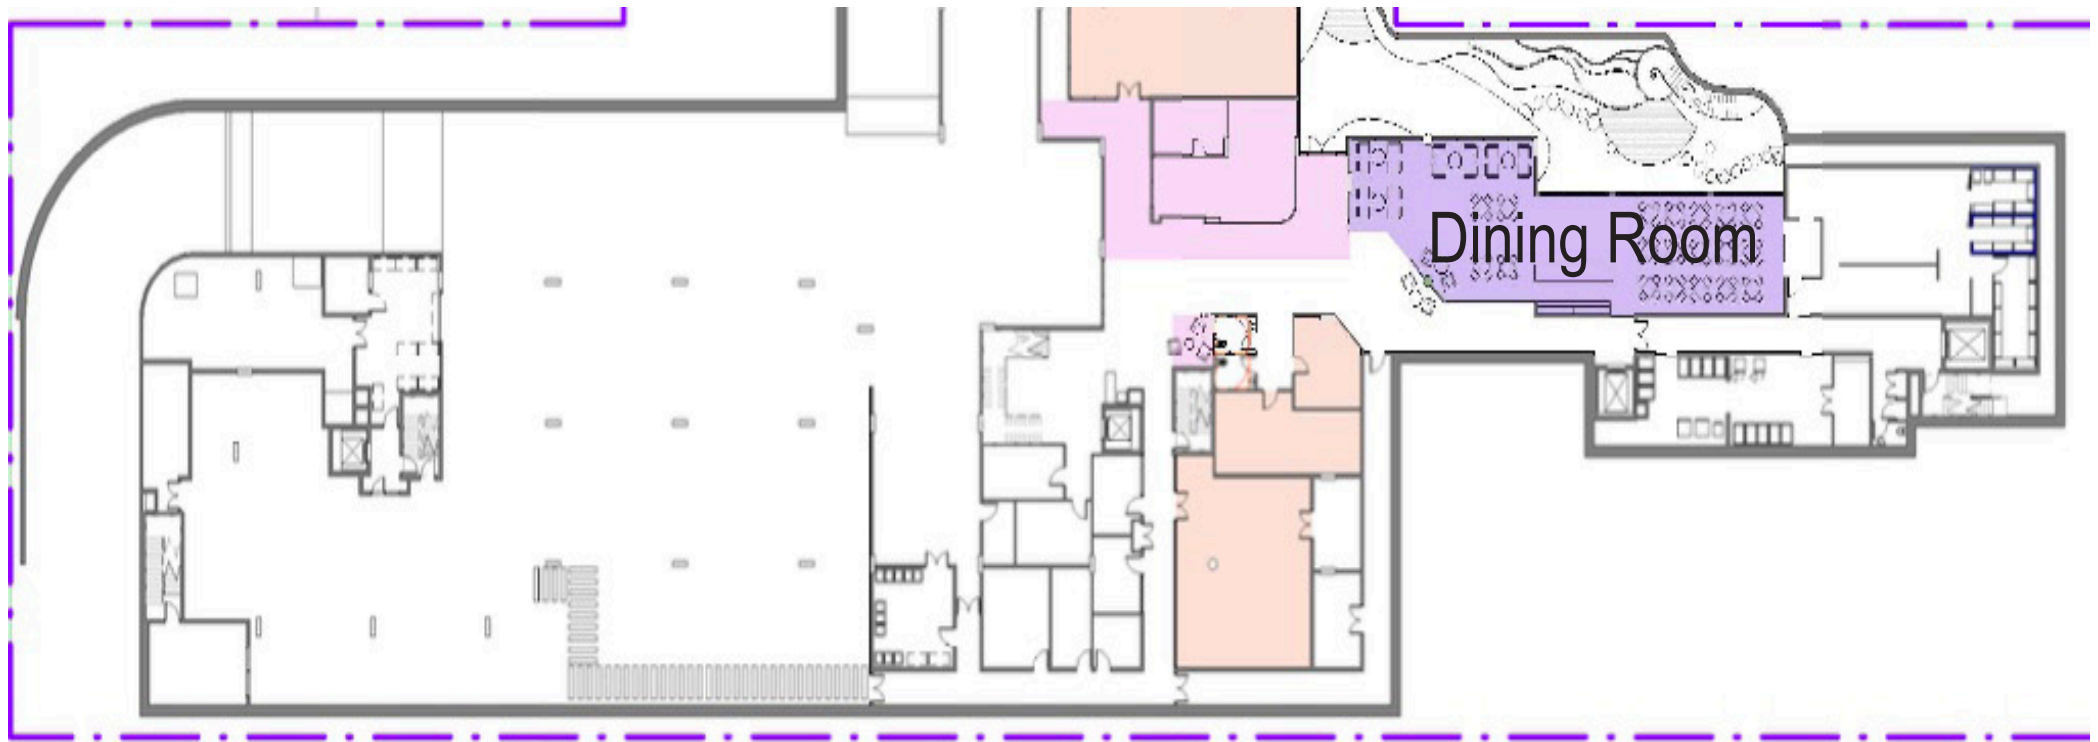
ROOM AREA-BASEMENT 01

- BCA defines a habitable room as a room used for normal domestic activities

Eg. bedroom, living room, lounge room, music room, television room, kitchen, **dining room**, sewing room, study, playroom, family room and sunroom

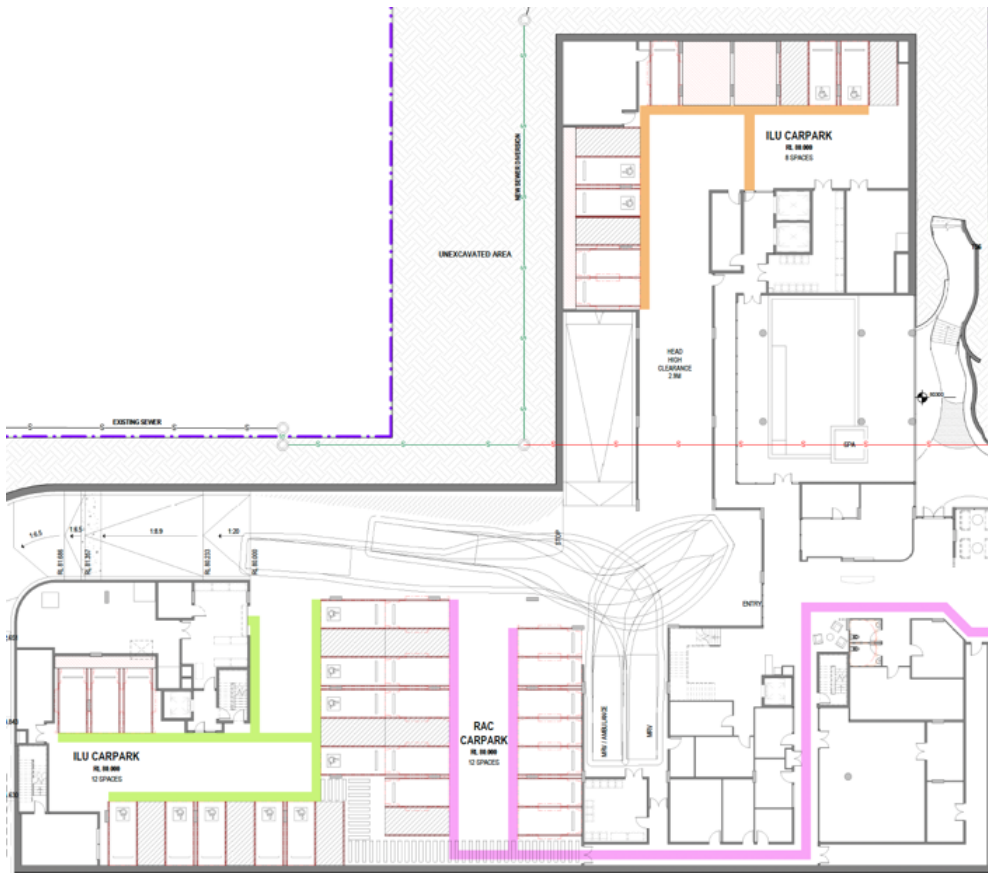
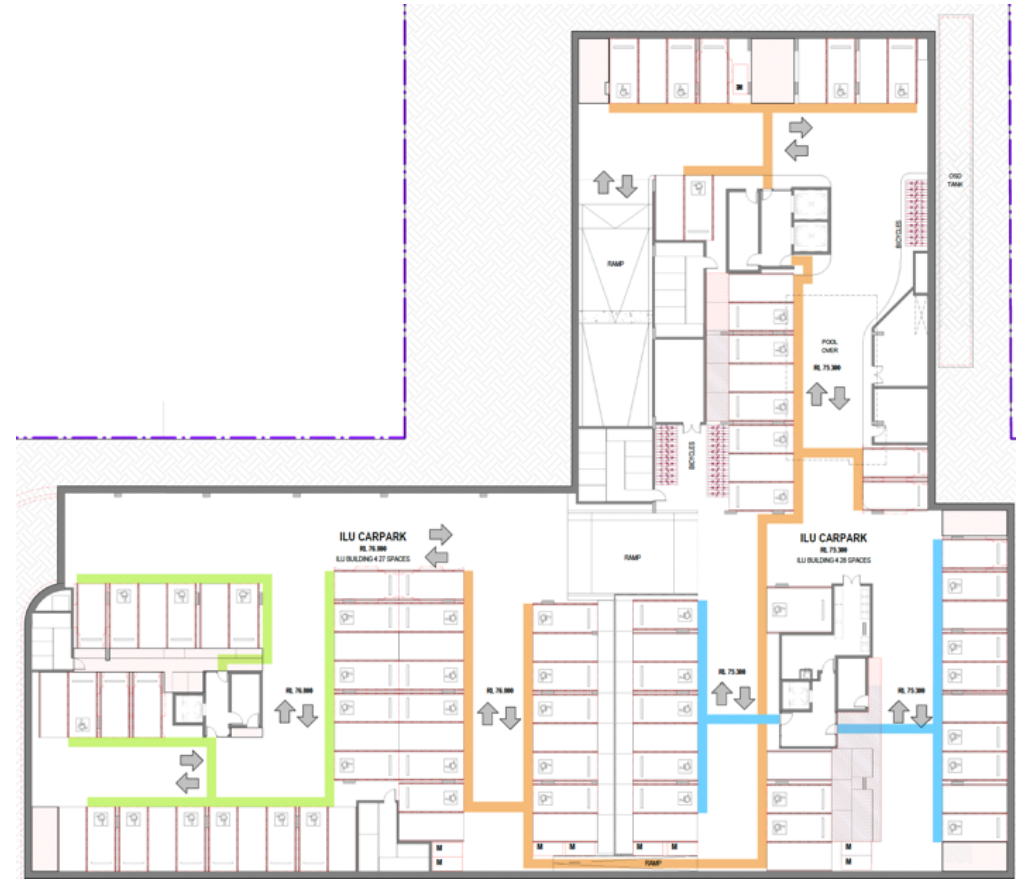
- 60 of the 77 spaces for ILU residents marked for people with disability
- 42 spaces marked as shared
- Shared spaces same width as disabled spaces

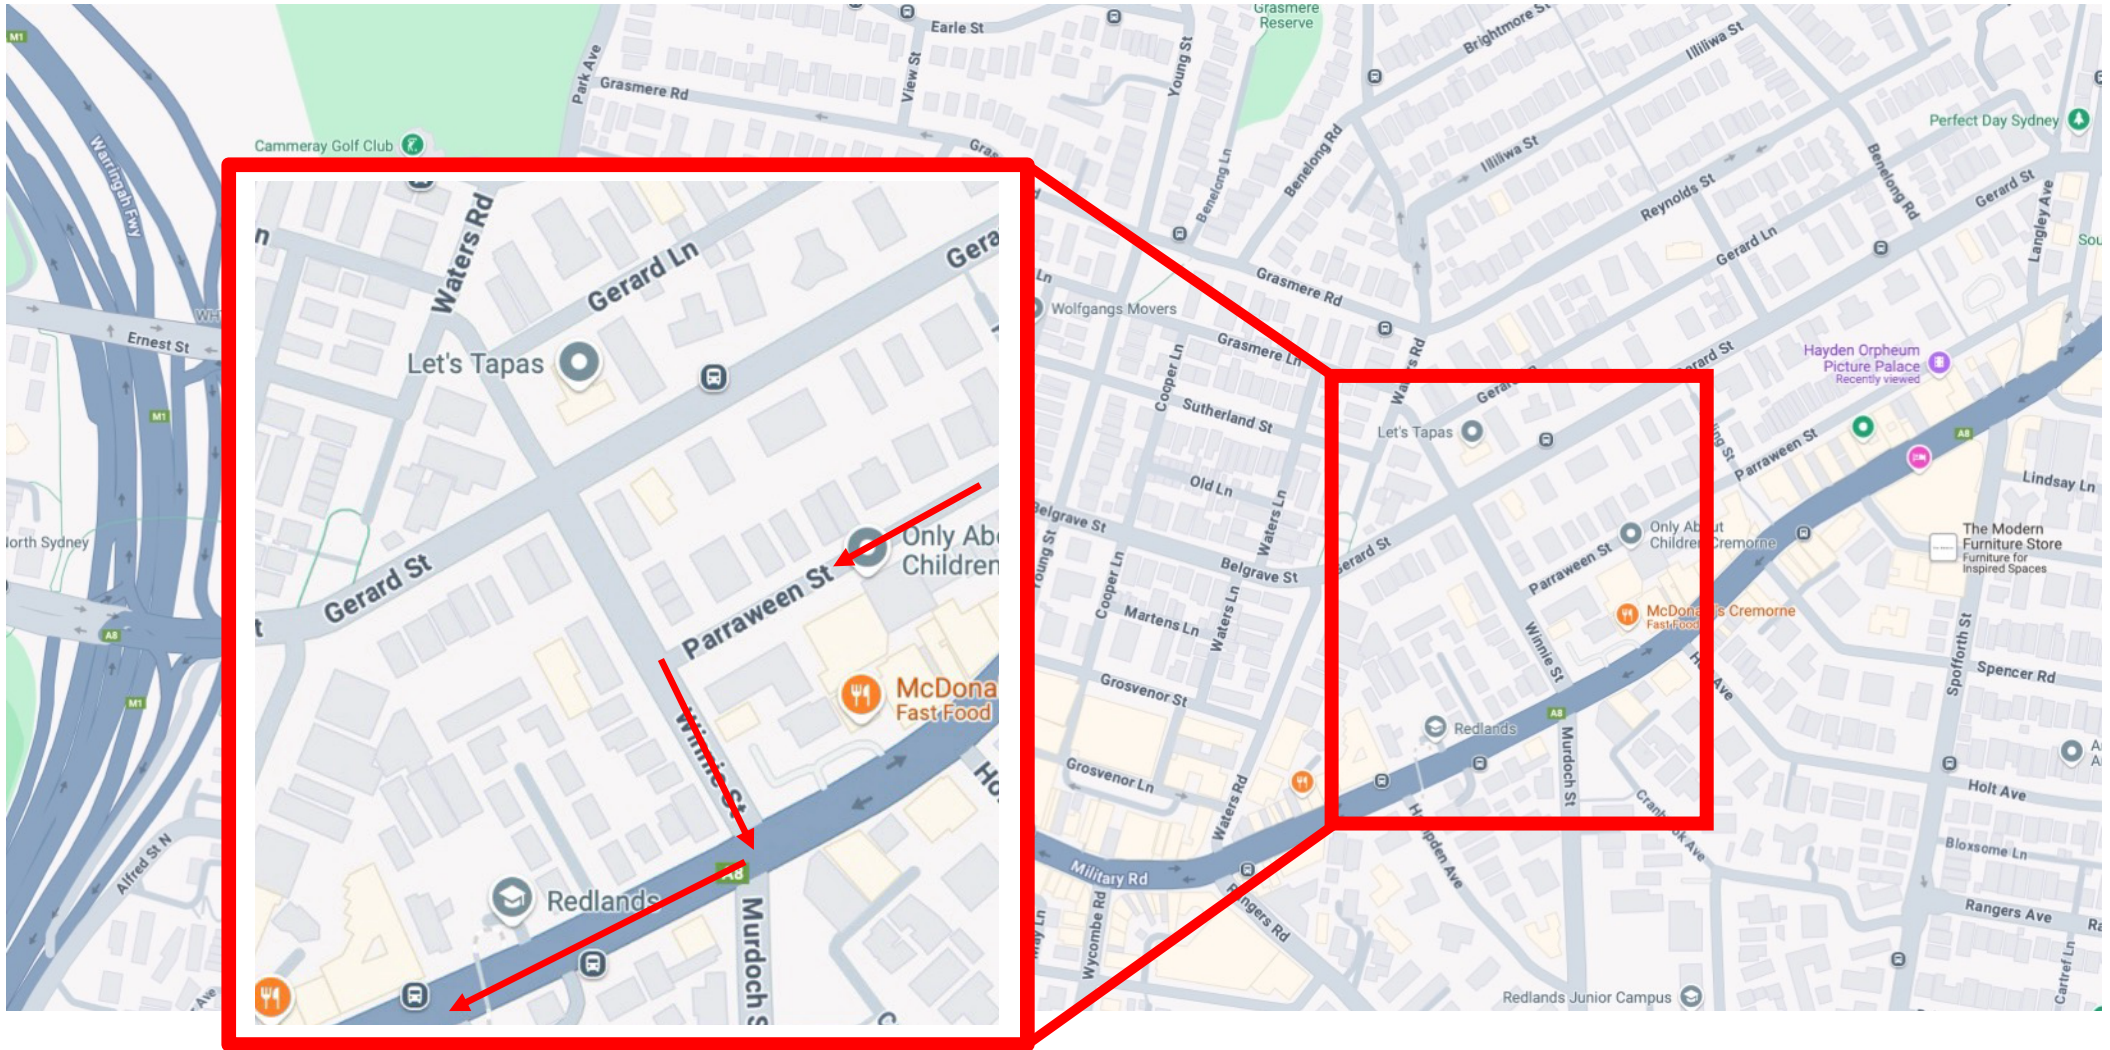
Proposed haulage route for truck and dogs
