## Vegetation Management Plan

Macarthur Memorial Park  
Lot 1 DP 218016, Lot B DP 370979  
& Lot 22 DP 564065  
166 - 176 St Andrews Road,  
Varroville

October 2017  
(REF: A17003V)

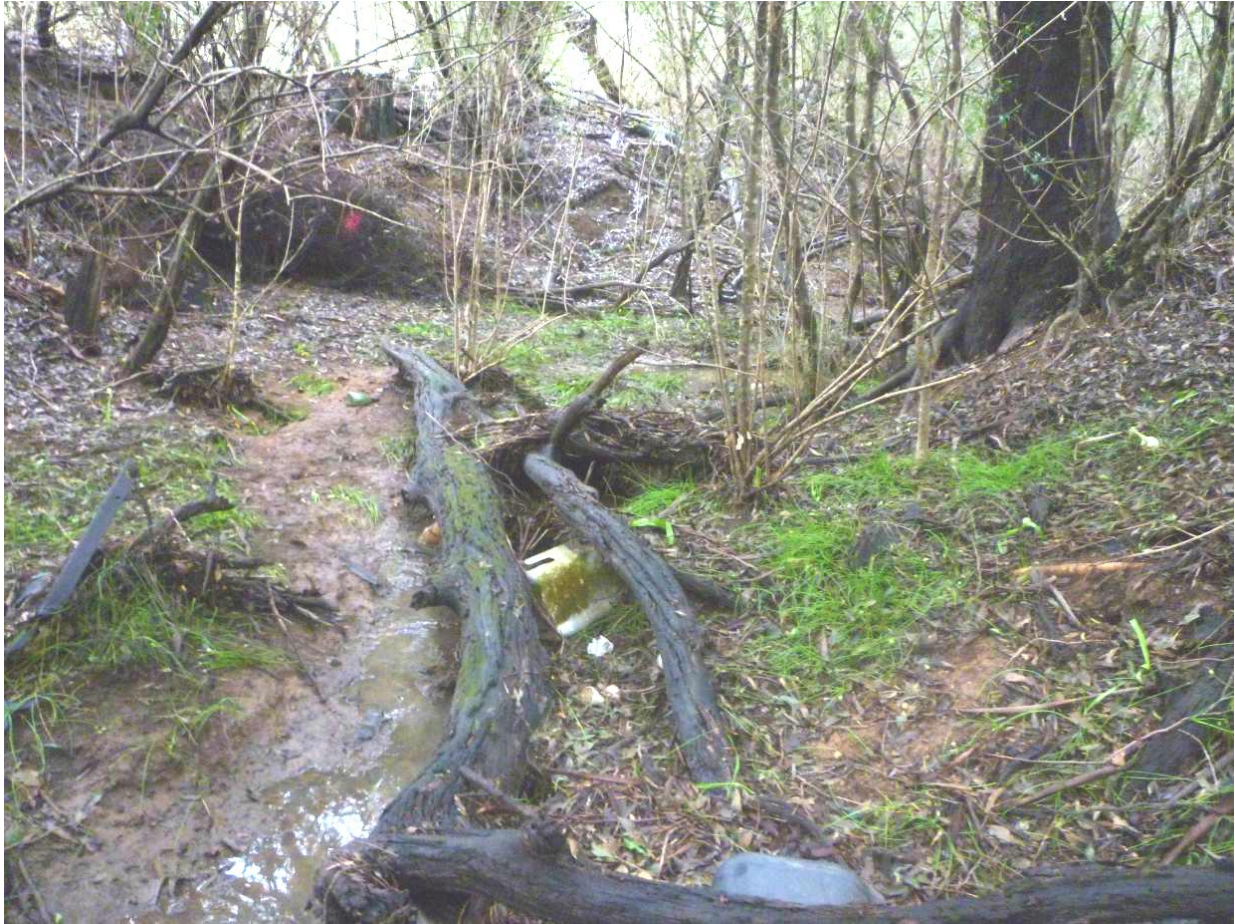
**Photo 1** – Deep incised gully SE Portion of the site, held in check by remnant native canopy and weeds (Watercourse 10),

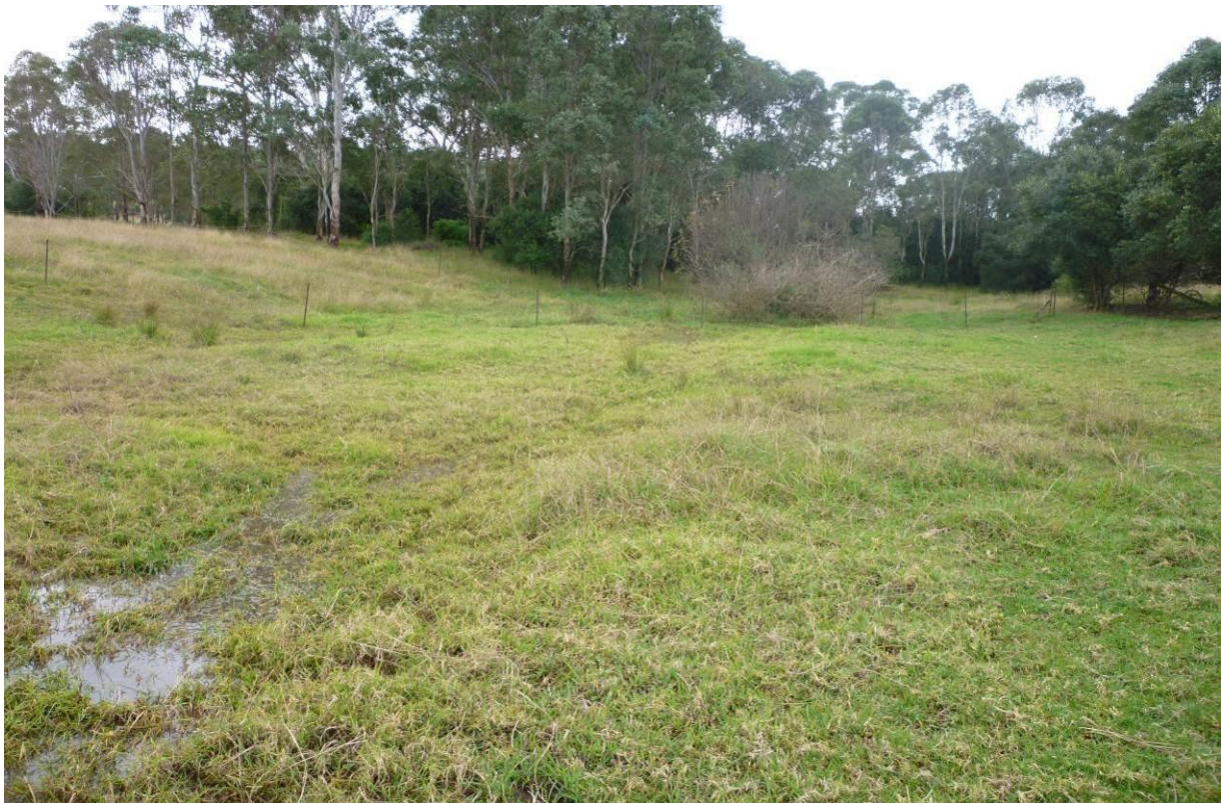
**Photo 2** – Intermittent channel with a wide grassed channel (Watercourse 7),

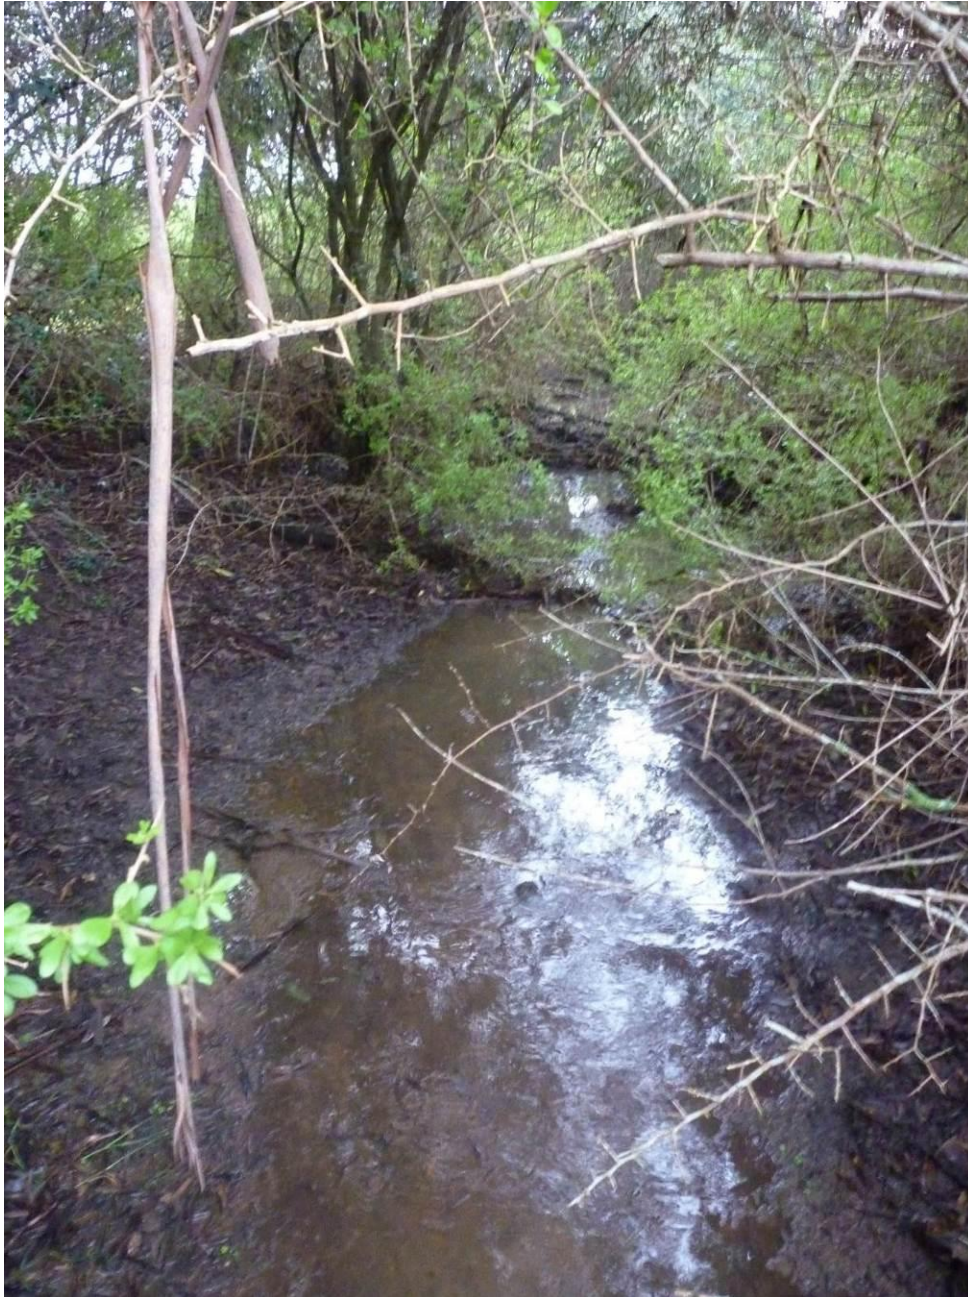
**Photo 3** – *Typical Lower reach (Water Course 9)*

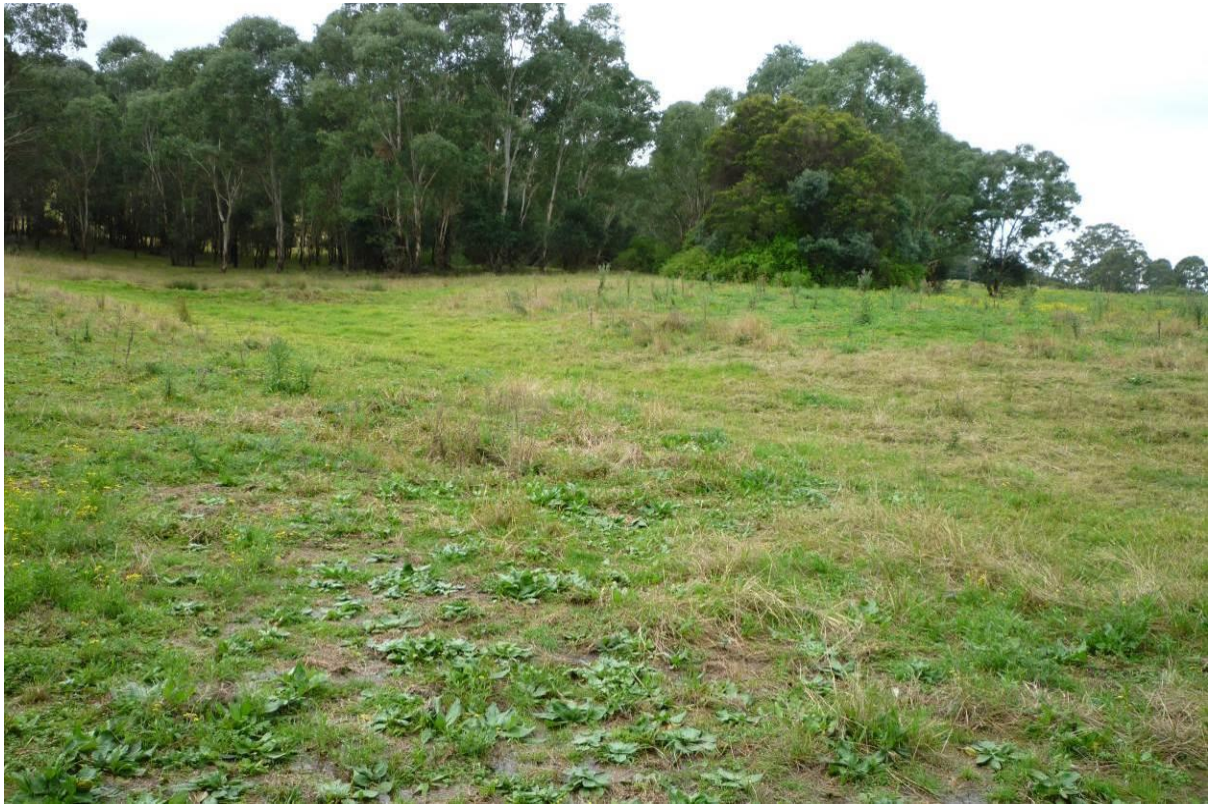
**Photo 4** – Typical drainage line - grassed swale with small dam at head no evidence of drainage < 12 hours after heavy rains (Drainage line 13)

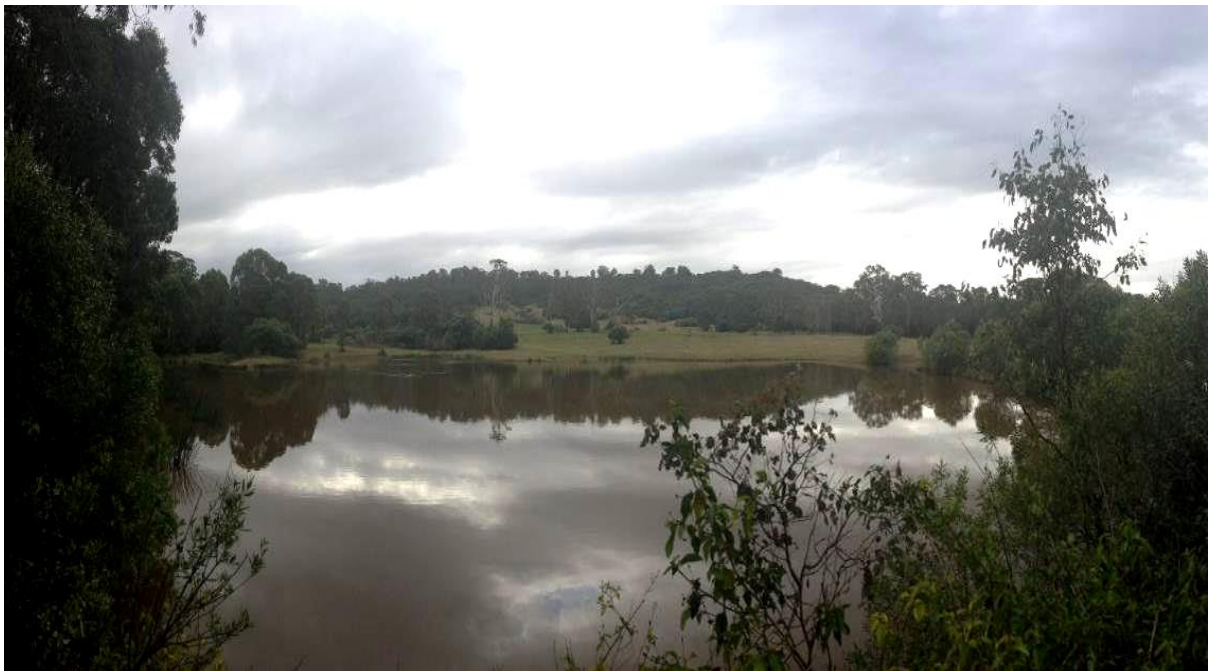
**Photo 5** – Dam 4 (approx. 9,950m<sup>2</sup>)
