Report on
Detailed Site Investigation for Contamination

Proposed Memorial Park
167 - 177 St Andrews Road, Varroville, NSW

Prepared for
Catholic Metropolitan Cemeteries Trust

Project 92237.00
September 2017

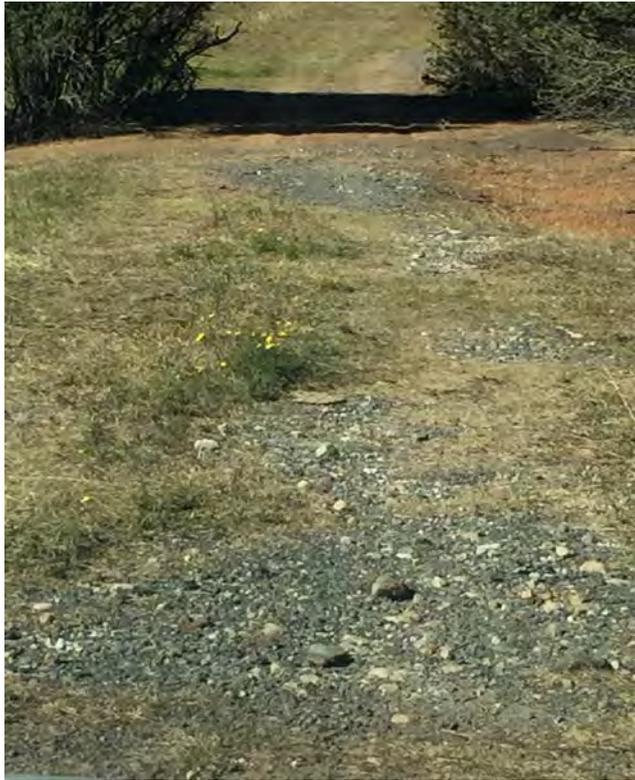
- The former vineyard located in the eastern central portion of the site comprises terraced, contoured slopes and was generally cleared of vegetation; and
- Scattered cattle bones were observed throughout the area. Road base material including blue metal gravel and possible coal wash material was observed on the hill top and on access roads around the vineyard (Photograph 1).

Photograph 1 - Access road to and around former vineyard.

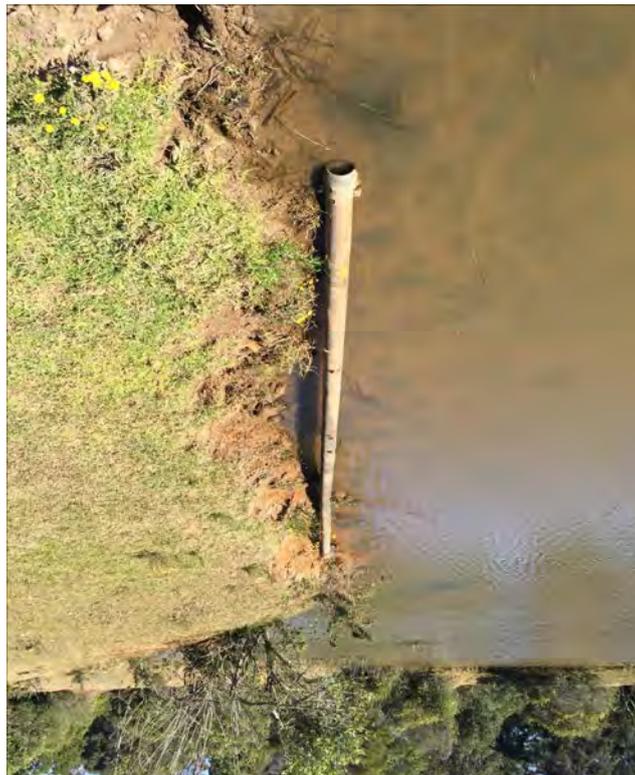
- A total of 10 dams were observed across the site during the walkover. The largest dams were located within the western centre of the site. The dams appeared to be well maintained with no evidence of fly tipping, and all pump systems appeared to be well maintained and free from odour or soil staining (Photograph 2). Many of the dams appeared to be connected by ephemeral channels likely active during high rainfall events;
- Across the low lying paddock regions located across the south western portion of the site, agricultural equipment, construction and fencing material and soil stockpiles appeared to be stored in several locations. Localised fuel/oil leakage onto the soil surface was observed next to drums/achinery; and
- Access tracks and paths across the site were generally covered with road base containing red brick and/or blue gravel material;

Photograph 2 - Dam bank and loose pipe from pump system

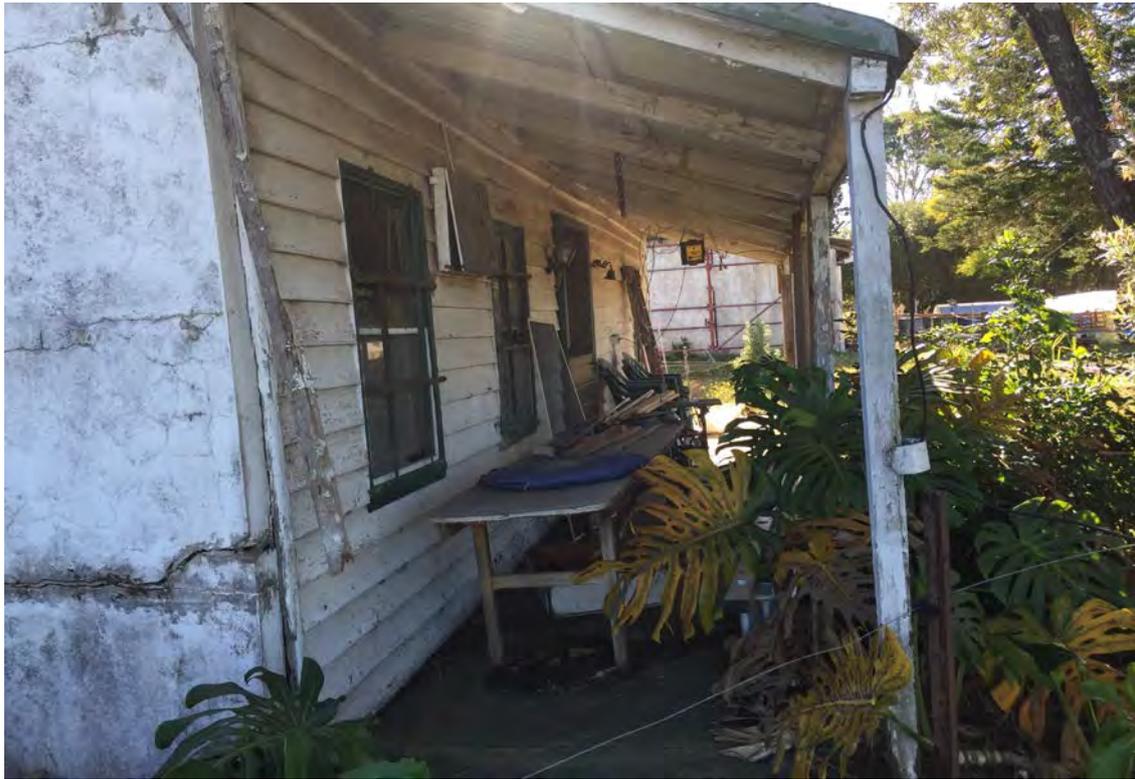
- In the south eastern part of the site was located a house (former homestead) constructed with brick and timber (Photograph 3). The former homestead was not occupied and was in a dilapidated state, with paint flakes visible on the surface of the surrounding soil. The surrounding ground surface was partially covered with concrete paving stones. Suspected asbestos containing material (ACM) was observed in part of the structure including eaves and corrugated roofing panels (Photograph 4). For safety reasons, the interior of the house was not inspected at the time of the walkover;

Photo 3 - Former homestead

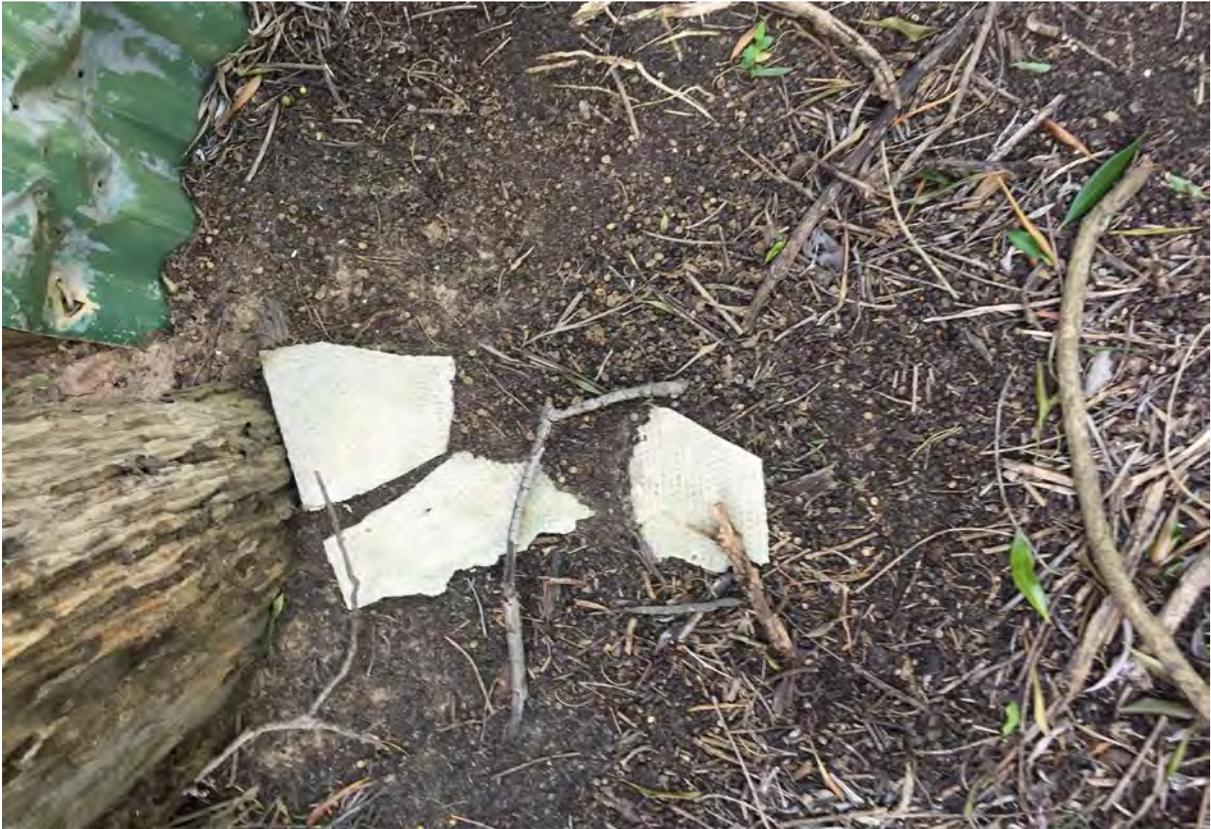
- TPH C16-C34 (F3) and C34-C40 (F4) in surface soils from TP14 (where localised spillage near drums were noted during the walkover) exceeded the corresponding ESL, Management Limit and Direct Contact HSLs;
- Benzo(a)pyrene and total PAH in surface soils from TP21 (located next to timber power pole) exceeded the corresponding HIL and ESL. Several other PAHs were detected significantly above the laboratory LOR; and
- Localised impact surrounding the former homestead and sheds comprising:
 - o Lead, zinc and aldrin and dieldrin in surface soils from TP17;
 - o Zinc in surface soils from TP39;
 - o Zinc in surface soils from TP41; and
 - o Fragments of ACM on the site surface observed at TP39.

Photo 5 - Fragments of bonded ACM visible at TP39

| Source | Exposure Pathway | Receptor | Recommended Risk Management Action |
|--|--|---|--|
| 3 – Surface ACM near former homestead and sheds | P5 – Surface water run-off P6 – Lateral migration of perched groundwater providing baseflow to watercourses P7 – Direct contact with terrestrial ecology | R5 – Local groundwater R6 – Surface water bodies R7 – Terrestrial ecology | Conduct Hazmat Survey for structures prior to demolition. Hazardous materials to be removed and disposed of by suitably licensed asbestos removal contractor. Include scope of remediation in RAP. Ground surface to be inspected after demolition and residual ACM fragments to be hand-removed. |

DP concludes that the potential for contamination constraints outside of the identified impact areas (refer to Table 3) is considered to be low. To mitigate identified impact areas, DP recommends a Remediation Action Plan (RAP) is prepared to inform how the identified impact areas will be remediated and validated. The RAP shall include a rationale for localised more detailed and/or delineation sampling, where required (e.g. power poles). A hazardous material survey should be conducted prior to demolition of the existing buildings, particularly the former homestead area and nearby sheds. Demolition of structures containing hazardous materials should be carried out by a licenced asbestos removal contractor.
