**Geoscientific Investigation  
(with special emphasis on  
groundwater attributes) -  
Proposed Macarthur Memorial  
Park at Varroville, NSW**

**THE TRUSTEE FOR  
THE CATHOLIC METROPOLITAN CEMETERIES TRUST  
(ABN 85 744 325 709)**

**November 15, 2014  
Project Number 1403**

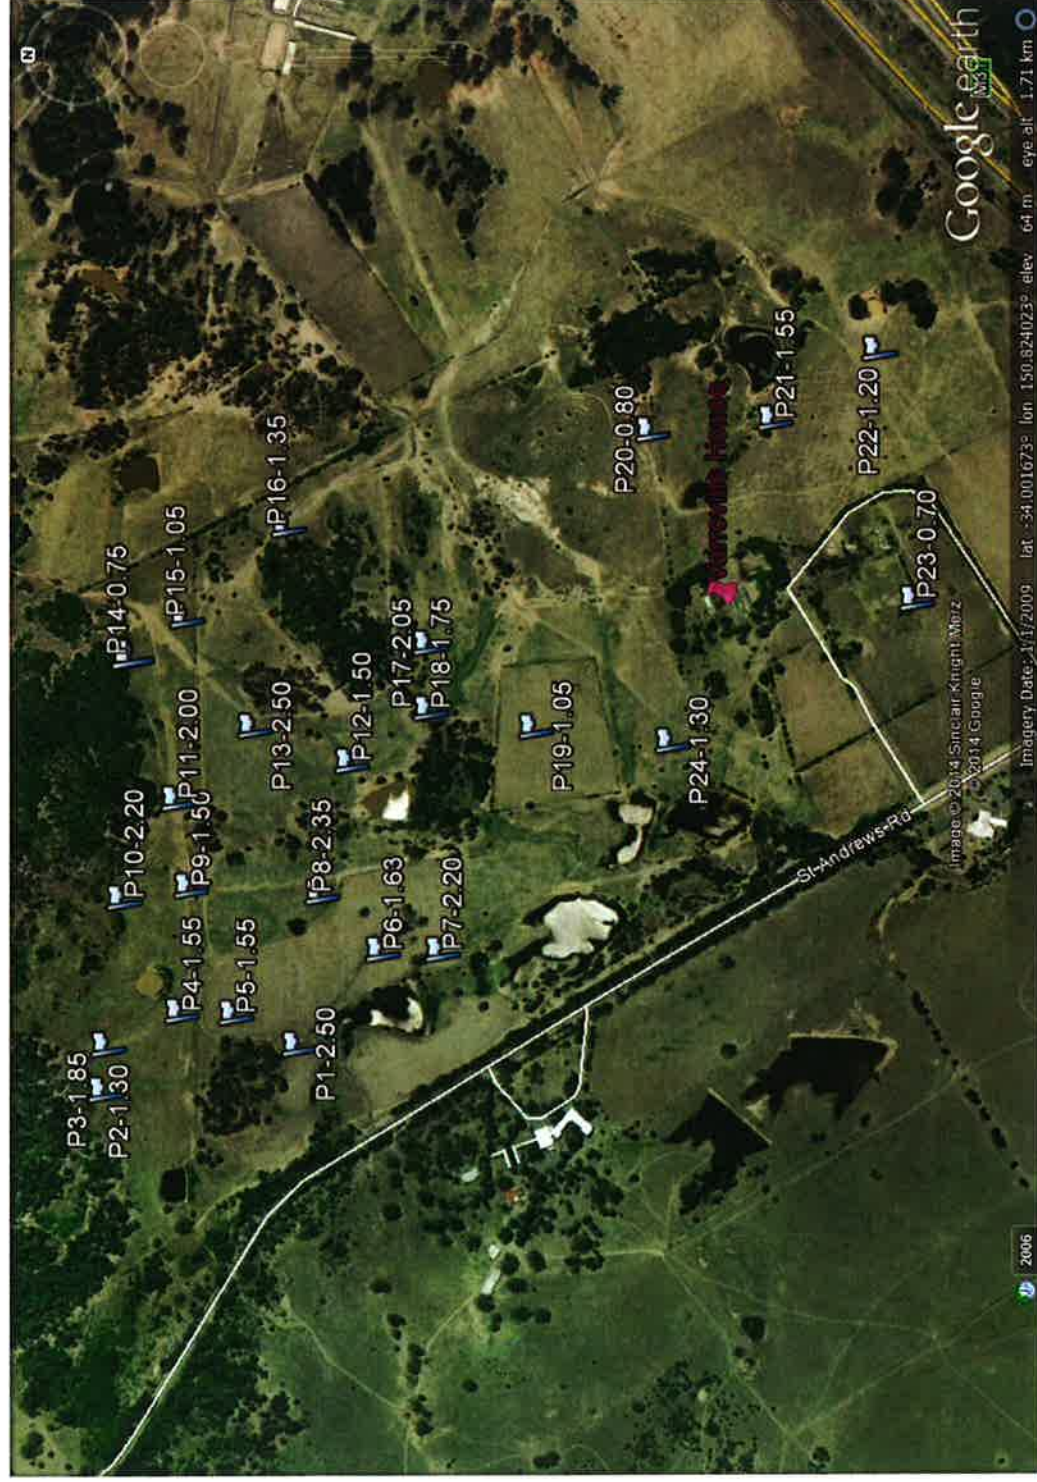
Figure 3. Site Investigation - PIT locations and Soil Depths – 1<sup>st</sup> & 2<sup>nd</sup> October 2014.

Blue flag – approximate pit location from field GPS; Px – PIT number; -x.xx soil depth (m). (base image - Google Earth, 2014)

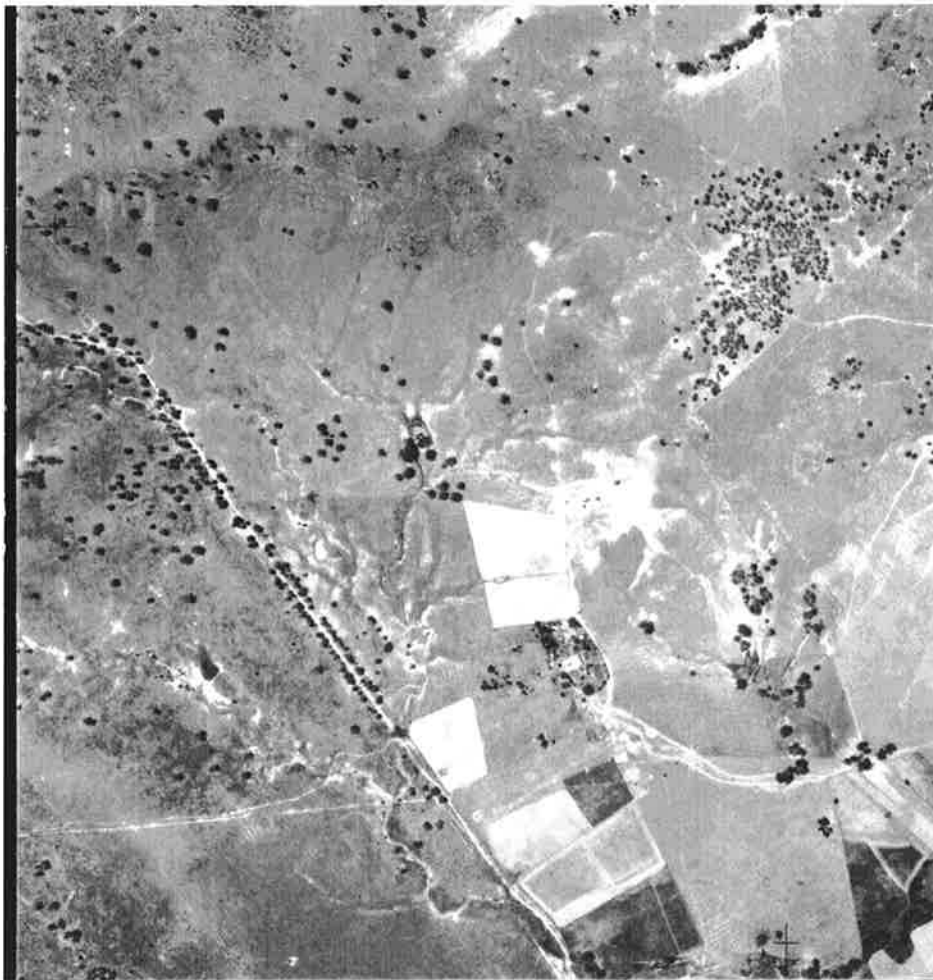
Figure 4. Extract of 1947 aerial photograph of the site  
- original scale approx. 1:12000 (NSW Dept. for Lands image 2014)

An examination of early site aerial photographs e.g. Figure 4 from 1947 shows that for at least 87 years the site has been substantially cleared of native vegetation; in fact there is much more residual forest on the site today than there was in that year - or even 1955 – 1978. Large parts of the site appear bare while that amount under direct paddock cultivation was very small. Waterways were largely devoid of trees but appear to have been wetter areas at the time (based on photographic contrast; earliest known rainfall data exists from 1959).

What is clear in the 1947 photograph is, that hillside seepage associated with the upper remnant sandstone ridge forming the north and north-western and elevated boundary area of the site, has only a very modest diffuse seepage zone at the approximate basal geological boundary of the sandstone. In the northwestern most corner of the site, the extent of this seepage is the most pronounced. Instability, as earthflows and/or slumps, is already present on these hillsides.

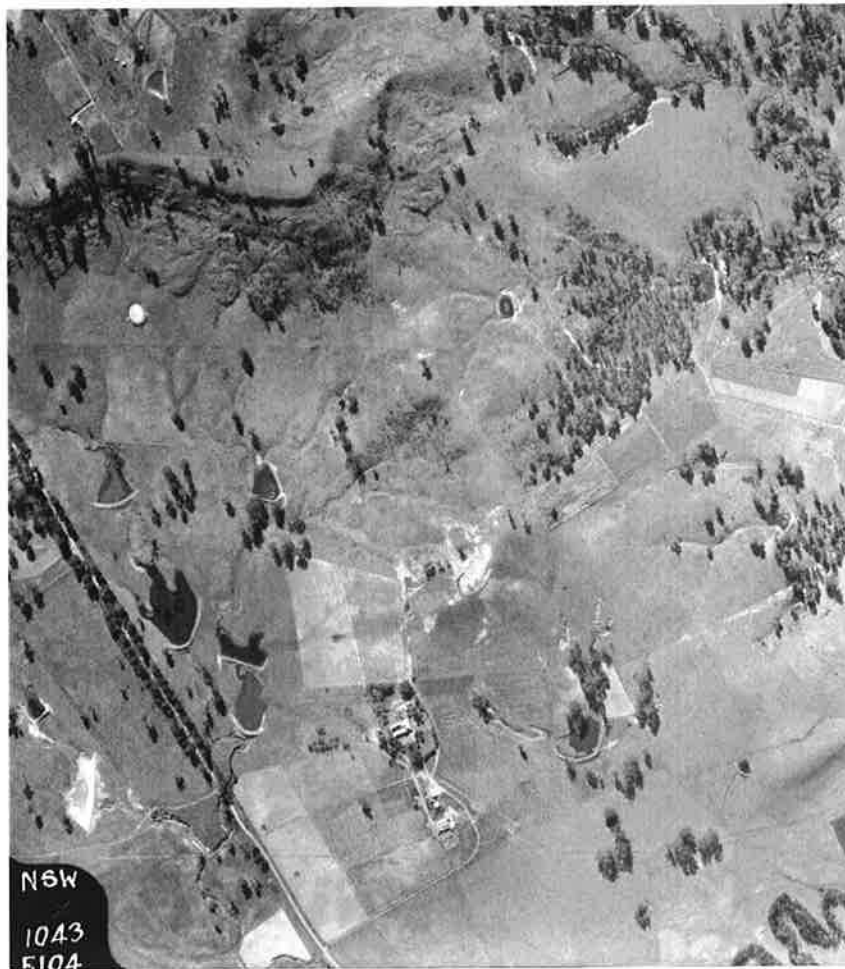
Figure 5. Extract of 1961 aerial photograph of the site  
- original scale approx.1:13000. (NSW Dept. for Lands image, 2014)

By 1961 (Figure 5) further dams had been built and Dams 2, 3, 4, 5, expanded to a size commensurate with what is seen today. The site appears less degraded at that time with more isolated tree plantings and clear definition of the instability in the elevated areas.

- \* 1961 (Figure 5) taken during a period of 'wetting-up' and the landscape looks well-vegetated and drainage lines show vegetation reflecting more moisture present; 1960 and 1961 had been years with average or better annual rainfall;

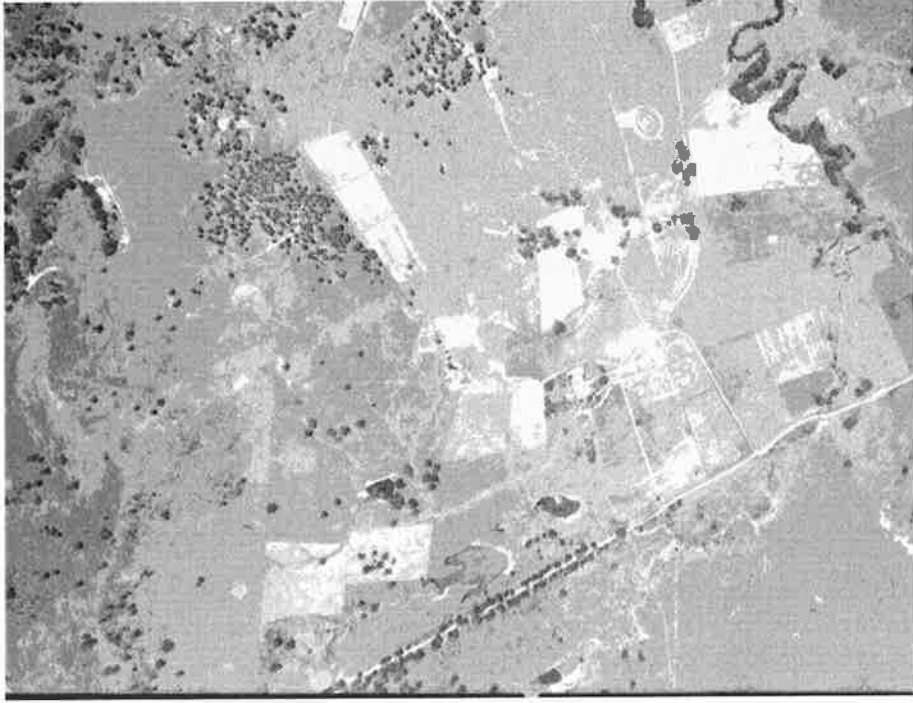
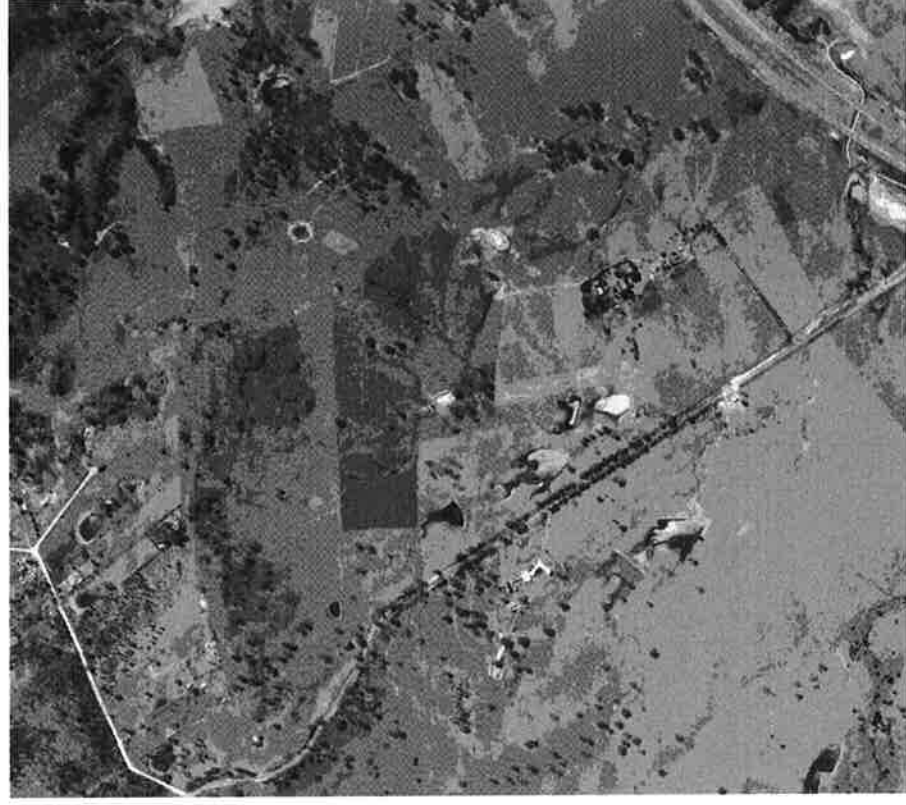
Figure 8. Extracts from District aerial photographs for dates of 1955 (a) - original scale 1:15360, and 30/11/1975 (b) - original scale 1:40000. (NSW Dept. of Lands image 2014)

- \* 1975 (Figure 8(b)) similar to the above; wetting-up times, land well nourished with certain areas looking considerably moister and drainage lines well-delineated; 1975 and 1974 had been years with average or better annual rainfall.

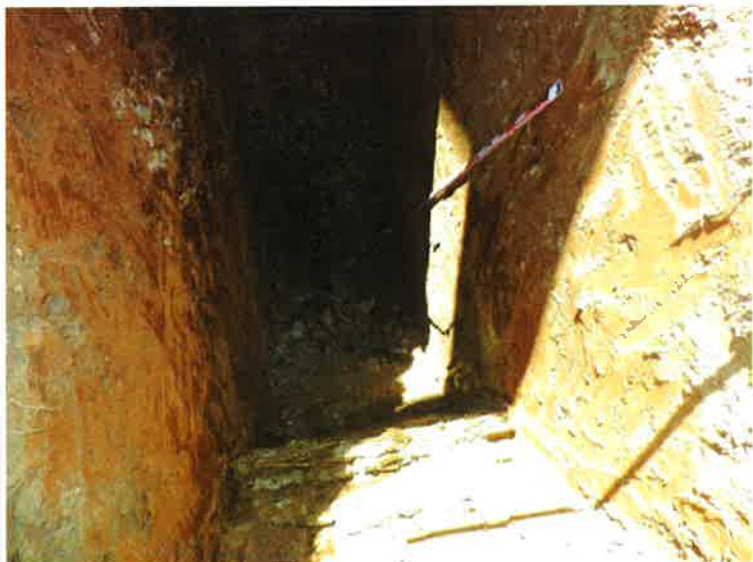
GROUNDWATER CONDITIONS			
None seen

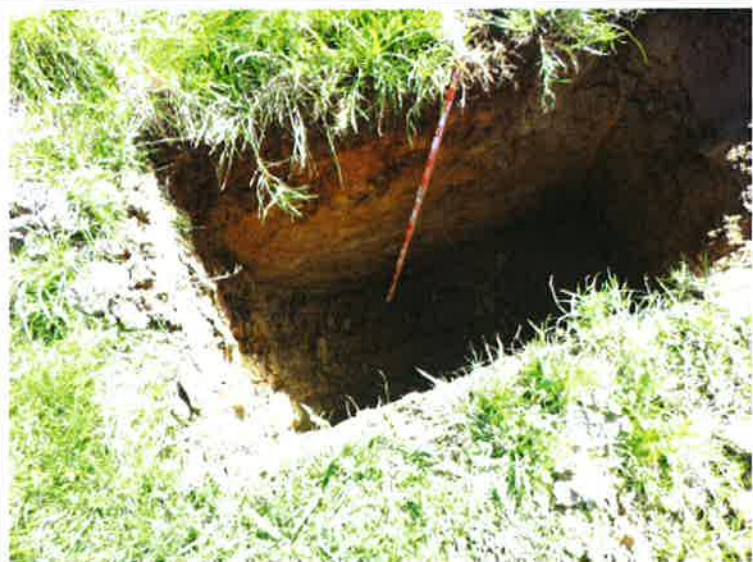
RED EARTH GEOSCIENCES - PIT LOG			
Dated excavated: 1 Oct 2014		PROJECT No 1403	
PIT No 2		Record if logged date different to excavated date:	
All Coordinates Approximate - unless stated (may be derived from geodetic software):			
Position method: GPS handheld		Latitude (WGS-84) (hD.d): S33.99873	
Longitude (WGS-84) (hD.d): E150.81862			
Method and orientation: Backhoe with 750 mm wide bucket; parallel to contour		Easting (MGA): 298532.905	
Logged: BBD		Strike of PIT (deg): 059M	
Northing (MGA): 6235839.696			
Approx surface dimensions (m): 2.0x0.9		Maximum depth (m): 1.55	
elevation (m) (AHD): 90			
Approx site slope (deg): 6		Weather - and/or Adverse conditions: Fine, sunny ~ 21deg, strong breeze	
DESCRIPTION		SAMPLES (all)	
0 - 0.25 dry, brown, sandy clay topsoil 0.2 - 0.4 red-br, occ. Fe gravel, silty clay 0.4 - 1.05 moist, mod stiff, red-br & yell-br mottled clay 1.05 - 1.3 dry, yell-grey, sandy clay 1.3 - 1.55 complete in MW iron-rich, grey, siltstone; possibly minor sandy lenses; plant fossils  Very hard digging, surprisingly dry, locate on spur		nil

GROUNDWATER CONDITIONS			
None seen

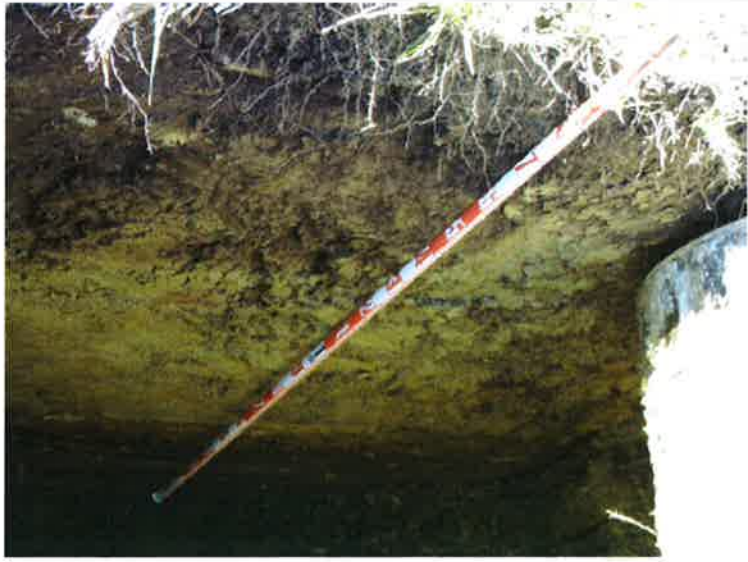
RED EARTH GEOSCIENCES - PIT LOG			
Dated excavated: 1 Oct 2014		PROJECT No 1403	
PIT No 3			
Record if logged date different to excavated date:		All Coordinates Approximate - unless stated (may be derived from geodetic software):	
Position method: GPS handheld		Latitude (WGS-84) (hD.d): S33.99870	Longitude (WGS-84) (hD.d): E150.81800
Method and orientation: Backhoe with 750 mm wide bucket; perpendicular to contour		Easting (MGA): 298475.562	
Logged: BBD		Strike of PIT (deg): 157M	Northing (MGA): 6235841.803
Approx surface dimensions (m): 1.7x0.75		Maximum depth (m): 1.95	elevation (m) (AHD): 87
Approx site slope (deg): 13-14		Weather - and/or Adverse conditions: Fine, warm, strong breeze	
DESCRIPTION		SAMPLES (all)	
0 - 0.75 dk br, sandy clay and clayey sand topsoil; minor gravel; A horizon - mixed; likely incorporates about 0.3 m thick zone of slide debris 0.75 - 1.25 very moist, yell-br sandy clay with minor Fe/shale sand; minor charcoal roots 1.25 - 1.57 moist, mod stiff, beige & yell-br, sandy clay 1.57 - 1.85 moist, br br-black & red-br mottled, sandy clay 1.85 - 1.95 complete in hard, dk br, sandy siltstone  Surficial instability present		nil

GROUNDWATER CONDITIONS			
Excavated into slump area looking for groundwater; none seen, but noticeably moister

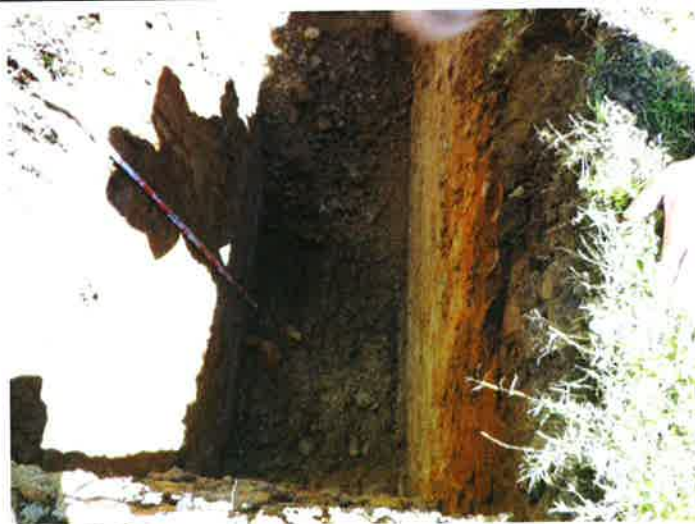
RED EARTH GEOSCIENCES - PIT LOG			
Dated excavated: 1 Oct 2014		PROJECT No 1403	PIT No 4
Record if logged date different to excavated date:		All Coordinates Approximate - unless stated (may be derived from geodetic software):	
Position method: GPS handheld	Latitude (WGS-84) (hD.d): S33.99954		Longitude (WGS-84) (hD.d): 150.81906
Method and orientation:	Backhoe with 750 mm wide bucket; parallel to contour		Easting (MGA): 298575
Logged: BBD	Strike of PIT (deg):	069	Northing (MGA): 6235750
Approx surface dimensions (m):	2.2x0.98	Maximum depth (m): 1.6	elevation (m) (AHD): 79
Approx site slope (deg):	Weather - and/or Adverse conditions: Fine, warm, strong breeze		
DESCRIPTION			SAMPLES (all)
0 - 0.55 dry, dk br silty topsoil, with variable transition to: 0.55 -0.8 mod stiff, red-br clay; rootlets to 0.7 0.8 - 1.0 moist, red-br and yell-br mottled sandy clay 1.0 -1.12 stiff, red-br and grey clay 1.12 - 1.32 dry, br gravelly sandy clay; pieces of broken bedrock 1.32 - 1.55 dry, stiff, mottled red-br and grey clay 1.55 -1.6 complete in very hard grey sandy siltstone (difficult excavation) Minor gravel in lenses throughout profile; horizon transitions variable			nil

GROUNDWATER CONDITIONS			
No free groundwater

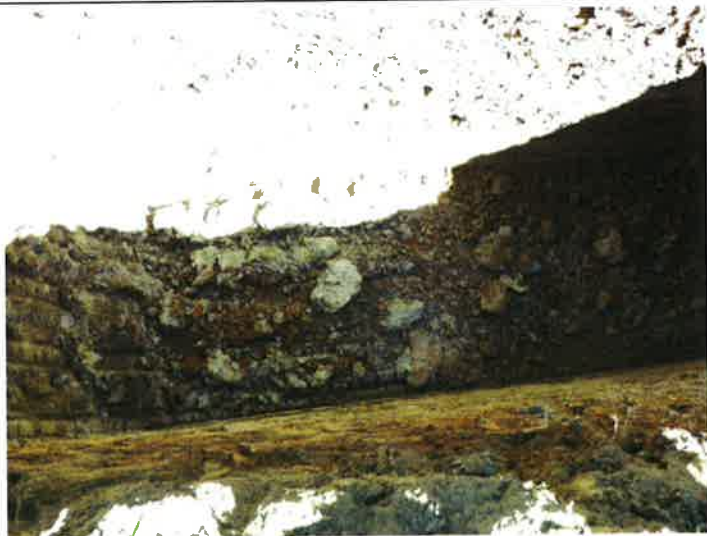
<b>RED EARTH GEOSCIENCES - PIT LOG</b>			
<b>Dated excavated:</b> 1 Oct 2014		<b>PROJECT No</b> 1403	<b>PIT No</b> 5
<b>Record if logged date different to excavated date:</b>		<b>All Coordinates Approximate - unless stated (may be derived from geodetic software):</b>	
<b>Position method:</b> GPS handheld	<b>Latitude (WGS-84) (hD.d):</b> 34.00016		<b>Longitude (WGS-84) (hD.d):</b> 150.81902
<b>Method and orientation:</b>	Backhoe with 750 mm wide bucket; parallel to contour		<b>Easting (MGA):</b> 298573
<b>Logged:</b> BBD	<b>Strike of PIT (deg):</b>		<b>Northing (MGA):</b> 6235681
<b>Approx surface dimensions (m):</b> 2.3x0.95	<b>Maximum depth (m):</b> 2.1	<b>elevation (m) (AHD):</b> 79	
<b>Approx site slope (deg):</b> 6 (2 long)	<b>Weather - and/or Adverse conditions:</b> Fine, warm, strong breeze		
<b>DESCRIPTION</b>			<b>SAMPLES (all)</b>
0 - 0.4 dk br clayey sand and sandy clay topsoil, irregular horizon boundary 0.4 - 0.65 variable, red-br, br, yell-br clay and sandy clay 0.65 - 1.05 moist, mot dk red-br clay 1.05 - 1.55 moist, grey and lt grey with yell-br and red-br mot sandy clay with broken weathered bedrock (MW-HW sandy siltstone with minor free water on bedding) 1.55 - 1.8 dry, hard, dk grey MW siltstone with carbonaceous pieces. (Dry layer of weathered bedrock) Continued excavation: 1.8 - 2.1 complete in damp, soft grey claystone with iron staining and accumulations			nil

<b>GROUNDWATER CONDITIONS</b>			
Minor free moisture on weathered bedrock pieces

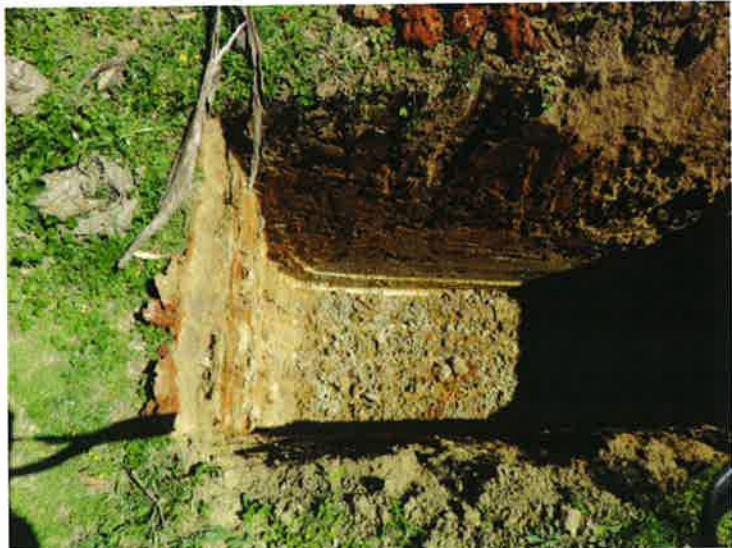
RED EARTH GEOSCIENCES - PIT LOG			
Dated excavated: 1 Oct 2014		PROJECT No 1403	
		PIT No 6	
Record if logged date different to excavated date:		All Coordinates Approximate - unless stated (may be derived from geodetic software):	
Position method:	GPS handheld	Latitude (WGS-84) (hD.d): 34.00183	Longitude (WGS-84) (hD.d): 150.81989
Method and orientation:	Backhoe with 750 mm wide bucket; parallel to contour		Easting (MGA): 298657
Logged:	BBD	Strike of PIT (deg): 153	Northing (MGA): 6235498
Approx surface dimensions (m):	2..3x0.8	Maximum depth (m): 2.13	elevation (m) (AHD): 74
Approx site slope (deg):	4	Weather - and/or Adverse conditions: Fine, warm	
DESCRIPTION			SAMPLES (all)
0 - 0.38 lt br, red-br and lt grey mixed sandy topsoil and sandy clay 0.38 - 0.91 mixed horizon of red-br sandy clay, blocky, isolated gravel pieces; rootlets to 0.52 0.91 - 1.13 dry, mot red-br and grey-br gravelly sandy clay 1.13 - 1.63 stiff, lt grey and yell-grey sandy clay 1.63 - 1.93 mot dk red-br, yell-br and grey-br HW siltstone with gravel pieces 1.93 - 2.13 complete in soft, grey SW siltstone			nil

GROUNDWATER CONDITIONS			
None seen

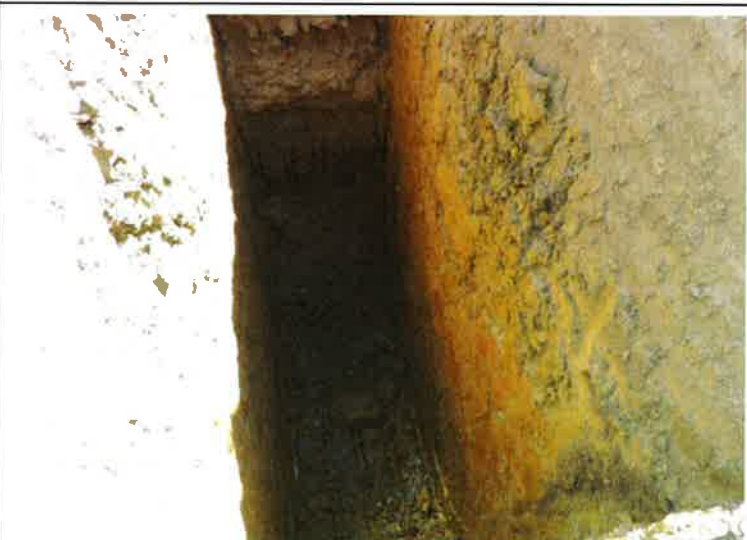
RED EARTH GEOSCIENCES - PIT LOG			
Dated excavated: 1 Oct 2014		PROJECT No 1403	
PIT No 7			
Record if logged date different to excavated date:		All Coordinates Approximate - unless stated (may be derived from geodetic software):	
Position method: GPS handheld		Latitude (WGS-84) (hD.d): 34.00251	Longitude (WGS-84) (hD.d): 150.81989
Method and orientation: Backhoe with 750 mm wide bucket; parallel to contour		Easting (MGA): 298659	
Logged: BBD		Strike of PIT (deg): 066	Northing (MGA): 6235422
Approx surface dimensions (m): 2.35x0.85		Maximum depth (m): 2.6	elevation (m) (AHD): 69
Approx site slope (deg):		Weather - and/or Adverse conditions: Fine, warm	
DESCRIPTION		SAMPLES (all)	
0 - 0.62 mixed, yell-br to lt br, sandy clay and clayey sand topsoil 0.62 - 1.34 moist, stiff yell-grey clay with minor Fe gravel 1.34 - 1.95 moist, mod stiff, red-br sandy clay with minor gravel 1.95 - 2.2 moist, mod stiff, dk yell to mid grey mot, sandy clay 2.2 - 2.6 complete in moist, lt grey with yell-br mot, HW siltstone/laminite with pieces of angular sandstone to 70 mm diam (below change of slope leading to watercourse with dam)		nil

GROUNDWATER CONDITIONS			
None seen

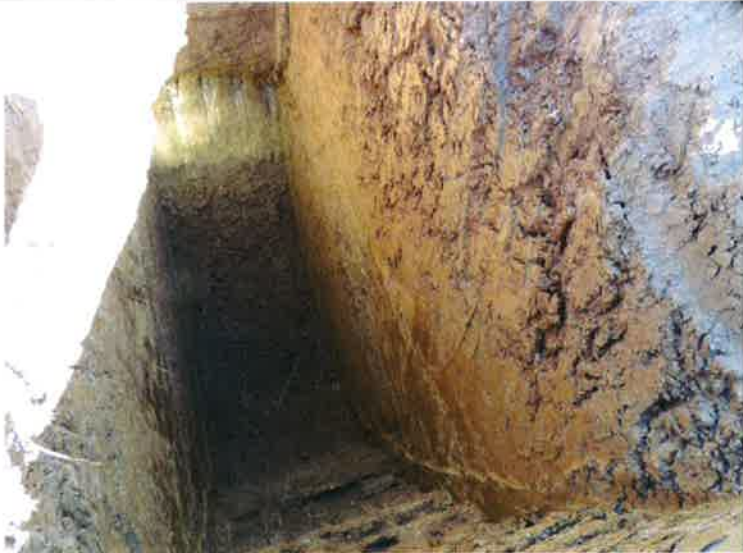
RED EARTH GEOSCIENCES - PIT LOG			
Dated excavated:	1 Oct 2014	PROJECT No 1403	PIT No 8
Record if logged date different to excavated date:		All Coordinates Approximate - unless stated (may be derived from geodetic software):	
Position method:	GPS handheld	Latitude (WGS-84) (hD.d): 34.00115	Longitude (WGS-84) (hD.d): 150.82069
Method and orientation:	Backhoe with 750 mm wide bucket; parallel to contour		Easting (MGA): 298729
Logged:	BBD (logged from surface)	Strike of PIT (deg): 142	Northing (MGA): 6235575
Approx surface dimensions (m):	2.35x0.8	Maximum depth (m): 2.65	elevation (m) (AHD): 72
Approx site slope (deg):	3	Weather - and/or Adverse conditions: Fine, warm	
DESCRIPTION			SAMPLES (all)
0 - 0.25 br sandy topsoil 0.25 - 2.35 moist, red-br sandy clay; highly consistent; minor Fe pisoliths to 3mm Ø 2.35 - 2.65 complete in damp, soft, crumbly red-br and black (Mn veinlets) and calcite blebs silty sandstone  Remarkably different soil not seen elsewhere on site; extremely consistent horizon - reminiscent of weathered dyke material; possible sill or intrusive structure. Pit not entered for logging.			nil

GROUNDWATER CONDITIONS			
No free water seen

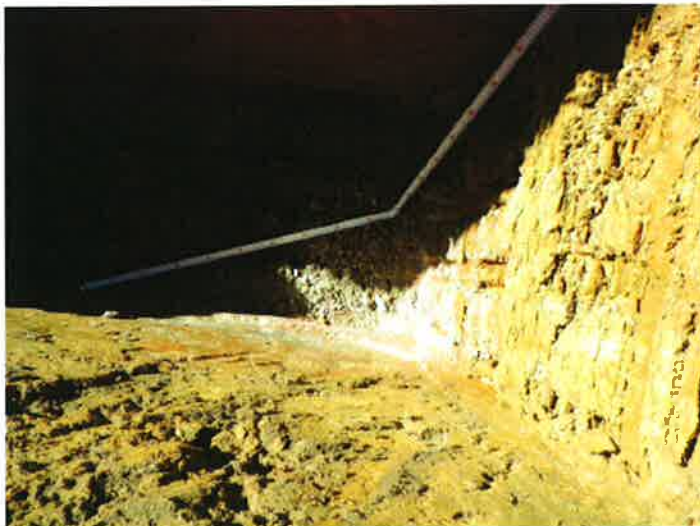
RED EARTH GEOSCIENCES - PIT LOG			
Dated excavated: 1 Oct 2014		PROJECT No 1403	
		PIT No 9	
Record if logged date different to excavated date:		All Coordinates Approximate - unless stated (may be derived from geodetic software):	
Position method: GPS handheld	Latitude (WGS-84) (hD.d): 33.99965		Longitude (WGS-84) (hD.d): 150.82080
Method and orientation:	Backhoe with 750 mm wide bucket; perpendicular to contour		Easting (MGA): 298736
Logged: BBD	Strike of PIT (deg): 098	Northing (MGA): 6235741	
Approx surface dimensions (m): 2.4x0.8	Maximum depth (m): 1.55	elevation (m) (AHD): 81	
Approx site slope (deg): 4	Weather - and/or Adverse conditions: Fine, warm		
DESCRIPTION		SAMPLES (all)	
0 - 0.25 dk br silty clay topsoil 0.25 - 0.8 moist, mod stiff, yell-br occ red-br mot, sandy clay 0.8 - 0.95 stiff, red-br clay; rootlets to 0.9 0.95 - 1.5 red-br and grey mot, sandy clay with slts gravel 1.5 - 1.55 complete in dry, grey occ red-br mot, HW siltstone		nil

GROUNDWATER CONDITIONS			
None seen

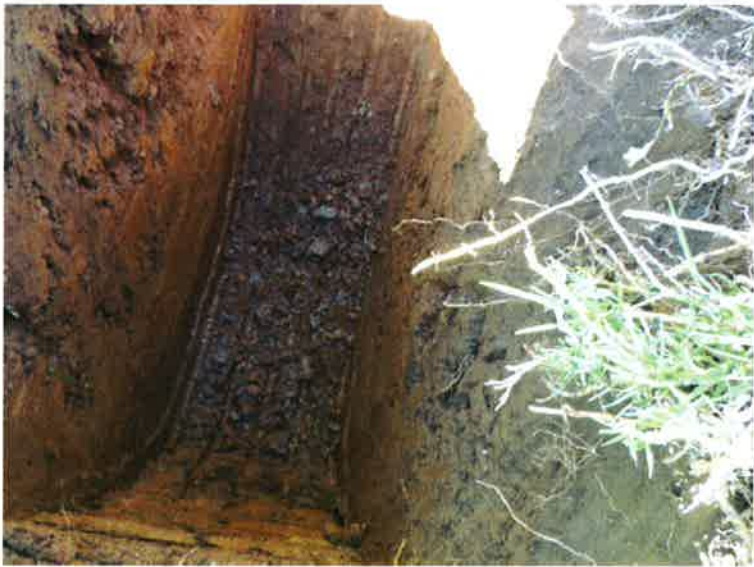
RED EARTH GEOSCIENCES - PIT LOG			
Dated excavated:	1 Oct 2014	PROJECT No 1403	PIT No 10
Record if logged date different to excavated date:		All Coordinates Approximate - unless stated (may be derived from geodetic software):	
Position method:	GPS handheld	Latitude (WGS-84) (hD.d): 33.99890	Longitude (WGS-84) (hD.d): 150.82064
Method and orientation:	Backhoe with 750 mm wide bucket; parallel to contour		Easting (MGA): 298719
Logged:	BBD logged from surface	Strike of PIT (deg): 102	Northing (MGA): 6235824
Approx surface dimensions (m):	2.2x0.8	Maximum depth (m): 2.25	elevation (m) (AHD): 83
Approx site slope (deg):	13.5	Weather – and/or Adverse conditions: Fine, warm	
DESCRIPTION			SAMPLES (all)
0 - 0.6 moist, br and dk br sandy clay and silty clay topsoil (very moist in top 0.3m) 0.6 -1.4 damp, red-br and br sandy clay 1.4 – 2.2 moist, stiff, red-br clay and sandy clay 2.2 - 2.25 complete in moist, HW lt grey, occ red-br mot, siltstone; rootlets to 2.25m  (logged from surface; at toe of landslip)			nil

GROUNDWATER CONDITIONS			
None seen

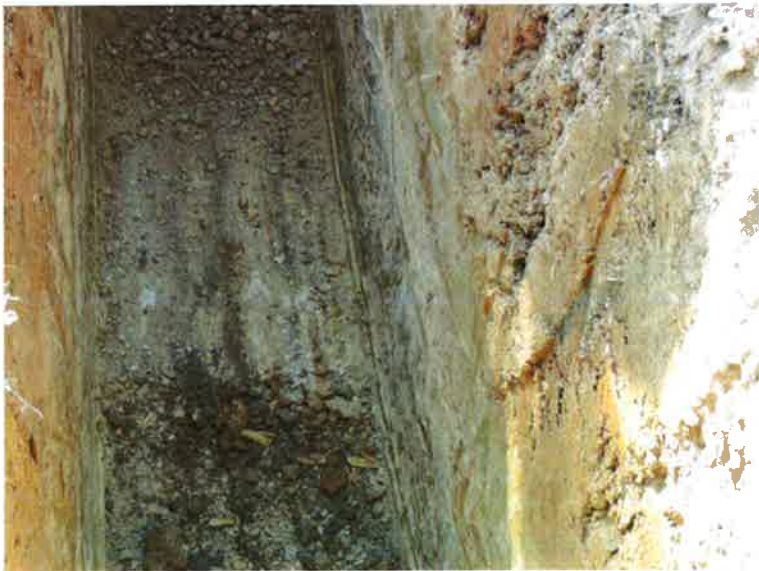
RED EARTH GEOSCIENCES - PIT LOG				
Dated excavated: 2 Oct 2014		PROJECT No 1403		PIT No 11
Record if logged date different to excavated date:			All Coordinates Approximate - unless stated (may be derived from geodetic software):	
Position method: GPS handheld		Latitude (WGS-84) (hD.d): 33.99952		Longitude (WGS-84) (hD.d): 150.82201
Method and orientation: Backhoe with 750 mm wide bucket; parallel to contour		Easting (MGA): 298847		
Logged: BBD		Strike of PIT (deg): 086		Northing (MGA): 6235758
Approx surface dimensions (m): 3.3x0.8		Maximum depth (m): 2.15		elevation (m) (AHD): 84
Approx site slope (deg):		Weather - and/or Adverse conditions: Fine, clear sky, warm, slight breeze		
DESCRIPTION				SAMPLES (all)
0 - 0.45 dry, sandy and silty topsoil, uneven horizon thickness 0.45 - 1.1 variable horizon, blocky in parts, mot red-br sandy clay and br clayey sand 1.1 - 1.5 moist, stiff, red-br clay 1.5 - 2.0 grey with red-br mot, sandy clay 2.0 - 2.15 complete in dry, hard grey shale with sandy facies (laminite)				nil

GROUNDWATER CONDITIONS				
None seen

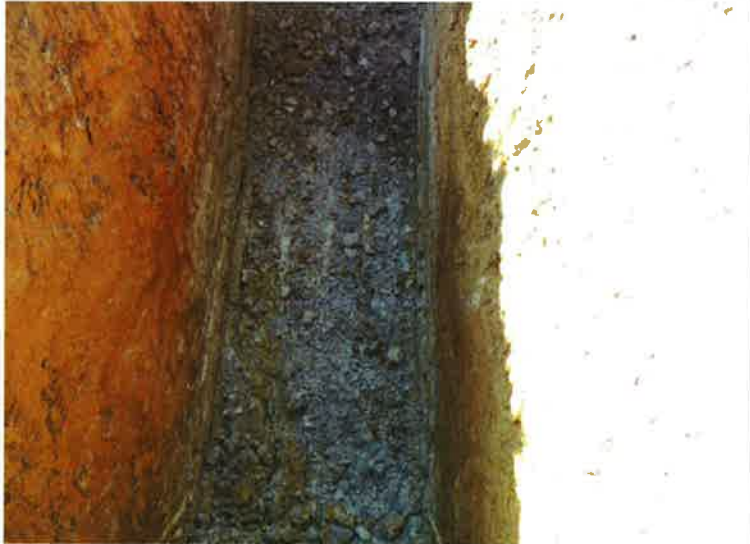
RED EARTH GEOSCIENCES - PIT LOG			
Dated excavated:	2 Oct 2014	PROJECT No 1403	PIT No 12
Record if logged date different to excavated date:		All Coordinates Approximate - unless stated (may be derived from geodetic software):	
Position method:	GPS handheld	Latitude (WGS-84) (hD.d): 34.00149	Longitude (WGS-84) (hD.d): 150.82252
Method and orientation:	Backhoe with 750 mm wide bucket; parallel to contour		Easting (MGA): 298899
Logged:	BBD	Strike of PIT (deg): 124	Northing (MGA): 6235541
Approx surface dimensions (m):	2.3x0.8	Maximum depth (m): 1.6	elevation (m) (AHD): 75
Approx site slope (deg):	3	Weather - and/or Adverse conditions: Fine, clear sky, warm, slight breeze	
DESCRIPTION			SAMPLES (all)
0 - 0.3 variable, br sandy and clayey topsoil, irregular horizon boundary 0.3 - 0.8 moist, mod stiff, red-br and br sandy clay 0.8 - 1.05 moist, stiff red-br clay and sandy clay; rootlets to 1.0 1.05 - 1.3 red-br, yell-br and grey mot sandy clay 1.3 - 1.5 moist, yell-br with grey mot gravelly sandy clay 1.5 - 1.6 complete in HW grey siltstone with sandy lenses and some yell-br mot; moister and softer in parts (laminite)			nil

GROUNDWATER CONDITIONS			
None seen

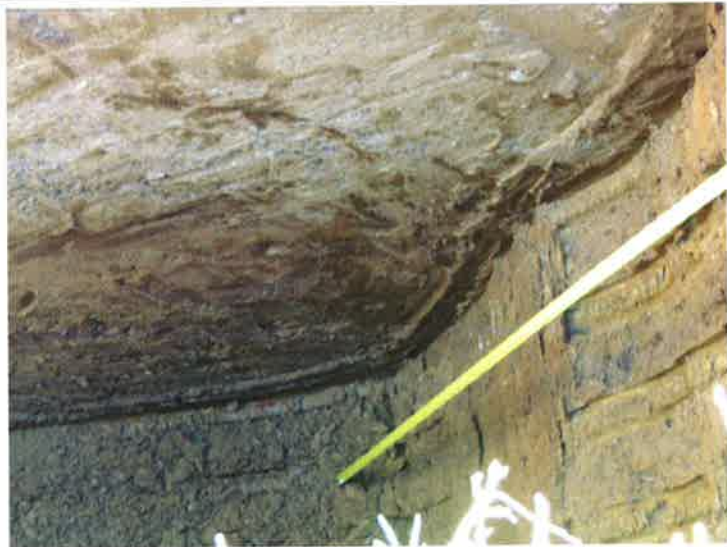
RED EARTH GEOSCIENCES - PIT LOG			
Dated excavated: 2 Oct 2014		PROJECT No 1403	PIT No 13
Record if logged date different to excavated date:		All Coordinates Approximate - unless stated (may be derived from geodetic software):	
Position method: GPS handheld	Latitude (WGS-84) (hD.d): 34.00038		Longitude (WGS-84) (hD.d): 150.82301
Method and orientation:	Backhoe with 750 mm wide bucket; perpendicular to contour		Easting (MGA): 298942
Logged: BBD partially logged from surface	Strike of PIT (deg): 043	Northing (MGA): 6235665	
Approx surface dimensions (m): 2.4x0.76	Maximum depth (m): 3.1	elevation (m) (AHD): 81	
Approx site slope (deg): 3.25	Weather - and/or Adverse conditions: Fine, clear sky, warm, slight breeze		
DESCRIPTION		SAMPLES (all)	
0 - 0.2 approx - br topsoil 0.2 - 2.5 very uniform, moist, generally stiff, red-br and dk br sandy clay and clayey sand with minor gravel lenses; Mn veinlets 1.3 - 2.7; rootlets to 2.3 2.5 - 2.7 moist, very soft, EW grey shale with Mn veinlets (bedrock); Excavation continued - logged from surface 2.7 - 3.1 complete in HW lithic sandstone		nil

GROUNDWATER CONDITIONS			
None seen

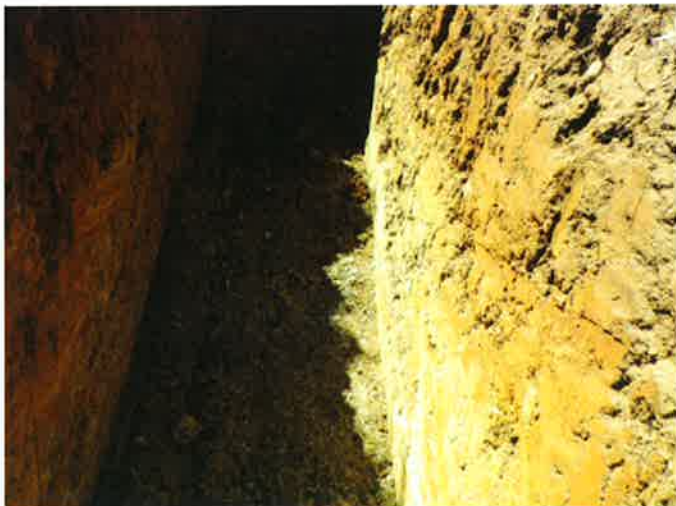
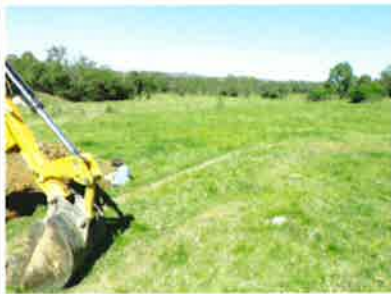
RED EARTH GEOSCIENCES - PIT LOG			
Dated excavated: 2 Oct 2014		PROJECT No 1403	PIT No 14
Record if logged date different to excavated date:		All Coordinates Approximate - unless stated (may be derived from geodetic software):	
Position method: GPS handheld	Latitude (WGS-84) (hD.d): 33.99904		Longitude (WGS-84) (hD.d): 150.82400
Method and orientation: Backhoe with 750 mm wide bucket; parallel to contour	Easting (MGA): 299030		
Logged: BBD	Strike of PIT (deg): 072	Northing (MGA): 6235815	
Approx surface dimensions (m): 2.8x0.8	Maximum depth (m): 2.1	elevation (m) (AHD): 94	
Approx site slope (deg): 11.5	Weather - and/or Adverse conditions: Fine, clear sky, warm, slight breeze		
DESCRIPTION		SAMPLES (all)	
0 – 0.3 modified, dry, sandy and silty topsoil; included colluvium with cobbles to 100mm diam 0.3 – 0.57 damp, crumbly mot red-br and yell-br sandy clay; rootlets to 0.5 0.57 – 0.75 stiff, grey with yell mot, clay 0.75 – 1.15 dry, hard, HW-MW grey siltstone Excavation continued in hard digging conditions 1.15 – 2.1 complete in MW grey laminite  (location below bank/terrace in old grapevine cultivation area; foot of steeper slopes generally and on a spur)		nil

GROUNDWATER CONDITIONS			
None seen

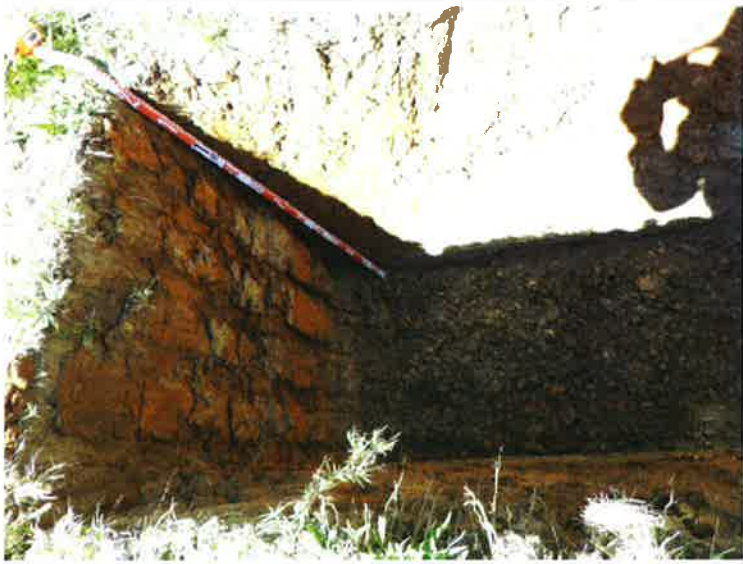
RED EARTH GEOSCIENCES - PIT LOG			
Dated excavated: 2 Oct 2014		PROJECT No 1403	
PIT No 15			
Record if logged date different to excavated date:		All Coordinates Approximate - unless stated (may be derived from geodetic software):	
Position method: GPS handheld		Latitude (WGS-84) (hD.d): 33.99962	Longitude (WGS-84) (hD.d): 150.82453
Method and orientation: Backhoe with 750 mm wide bucket; perpendicular to contour		Easting (MGA): 299080	
Logged: BBD		Strike of PIT (deg): 105	Northing (MGA): 6235752
Approx surface dimensions (m): 2.1x0.83		Maximum depth (m): 1.25	elevation (m) (AHD): 94
Approx site slope (deg): 9.5		Weather - and/or Adverse conditions: Fine, clear sky, warm, slight breeze	
DESCRIPTION			SAMPLES (all)
0 - 0.2 variable, dry, br sandy topsoil 0.2 - 0.65 variable, moist, mod stiff, sandy clays and clayey sands 0.65 - 0.95 moist, stiff, mot red-br and grey clay 0.95 - 1.05 dry, stiff, yell-br and red-br mot grey clay 1.05 - 1.25 complete in EW-HW grey siltstone; rootlets present  (excavation on steeper slope)			nil

GROUNDWATER CONDITIONS			
None seen

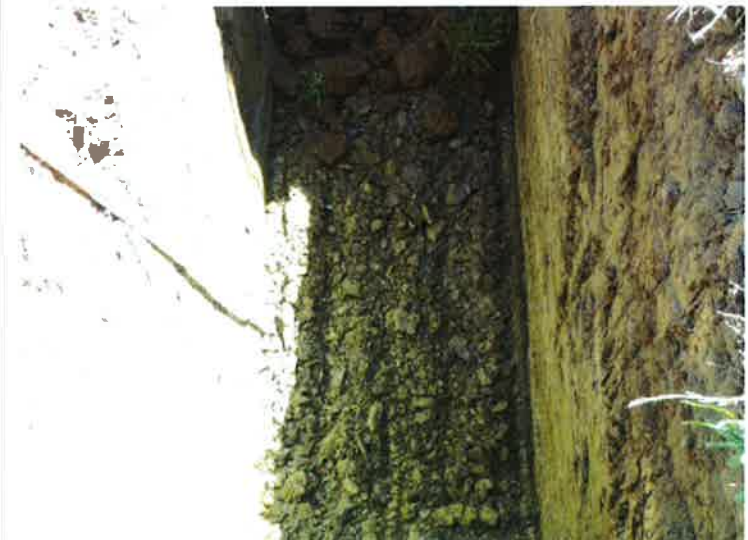
RED EARTH GEOSCIENCES - PIT LOG			
Dated excavated:	2 Oct 2014	PROJECT No 1403	PIT No 16
Record if logged date different to excavated date:		All Coordinates Approximate - unless stated (may be derived from geodetic software):	
Position method:	GPS handheld	Latitude (WGS-84) (hD.d): 34.00078	Longitude (WGS-84) (hD.d): 150.82578
Method and orientation:	Backhoe with 750 mm wide bucket; parallel to contour		Easting (MGA): 299199
Logged:	BBD	Strike of PIT (deg): 163	Northing (MGA): 6235626
Approx surface dimensions (m):	2.5x0.8	Maximum depth (m): 1.45	elevation (m) (AHD): 101
Approx site slope (deg):	7	Weather - and/or Adverse conditions: Fine, clear sky, warm, slight breeze	
DESCRIPTION			SAMPLES (all)
0 - 0.15 dry, blocky, poorly developed br silty/sandy/clayey topsoil 0.15 - 0.70 moist, mod stiff, red-br and br mot sandy clay and clayey sand 0.70 - 1.35 mixed, yell-br clay and gravelly sandy clay; rootlets to 0.75 1.35 - 1.45 complete in hard, MW grey carbonaceous siltstone  (near top of hill, unlikely to be deep soil)			nil

GROUNDWATER CONDITIONS			
None seen

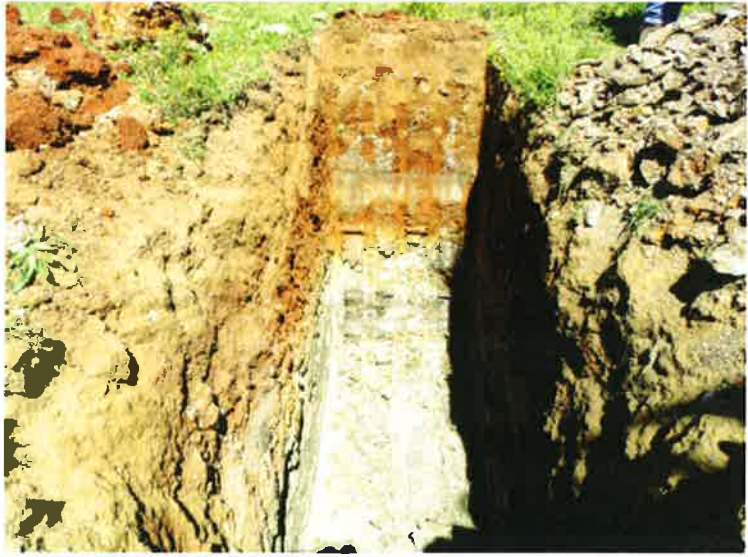
<b>GROUNDWATER CONDITIONS</b>					
Minor free moisture on bedding planes in uppermost weathered bedrock

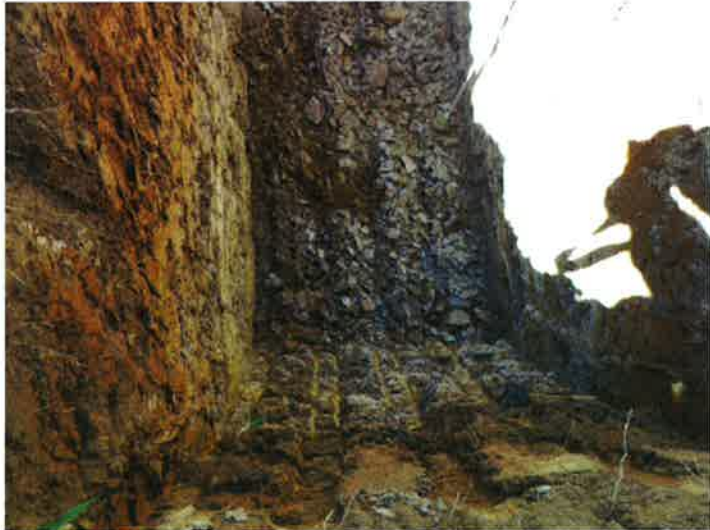
1.2	72
<b>Approx site slope (deg):</b>	<b>Weather - and/or Adverse conditions:</b> Fine, clear sky, warm, slight breeze		
<b>DESCRIPTION</b>		<b>SAMPLES (all)</b>	
0 - 0.2 br silty sand topsoil 0.2 -0.6 dry, stiff, red-br, yell-br and grey mot sandy clay 0.6 - 0.8 dry, stiff, grey and dk grey, lt grey and yell-br mot gravelly sandy clay; roots to 0.65 0.8 - 1.2 complete in dry, hard, lt grey, MW-SW sandy siltstone (laminite)		nil	
<b>GROUNDWATER CONDITIONS</b>			
None seen

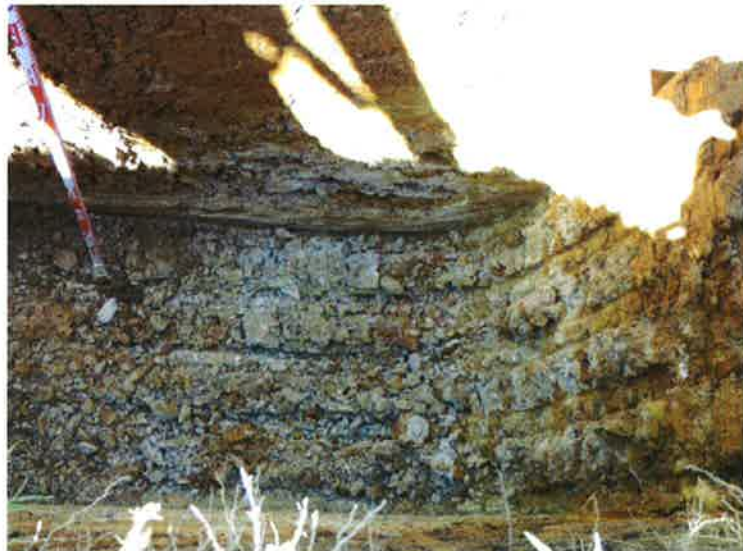
RED EARTH GEOSCIENCES - PIT LOG			
Dated excavated: 2 Oct 2014		PROJECT No 1403	
PIT No 21			
Record if logged date different to excavated date:		All Coordinates Approximate - unless stated (may be derived from geodetic software):	
Position method: GPS handheld	Latitude (WGS-84) (hD.d): 34.00634		Longitude (WGS-84) (hD.d): 150.82726
Method and orientation: Backhoe with 750 mm wide bucket; perpendicular to contour	Easting (MGA): 299348		
Logged: BBD	Strike of PIT (deg): 165	Northing (MGA): 6235012	
Approx surface dimensions (m): 2.5x0.8	Maximum depth (m): 1.6	elevation (m) (AHD): 65	
Approx site slope (deg): 5	Weather - and/or Adverse conditions: Fine, clear sky, warm, slight breeze		
DESCRIPTION		SAMPLES (all)	
0 - 0.4 variable, br silty and sandy topsoil, horizon boundary irregular 0.4 - 1.1 red-br sandy clay occ sandy and gravelly lenses; charcoaled roots 1.1 - 1.55 moist, firm, red-br and grey mot sandy clay 1.55 - 1.6 Complete in lt grey an yell mot, MW-SW sandy siltstone with Fe staining and concretions (laminite)  (surface has been moderately terraced)		nil

GROUNDWATER CONDITIONS			
None seen

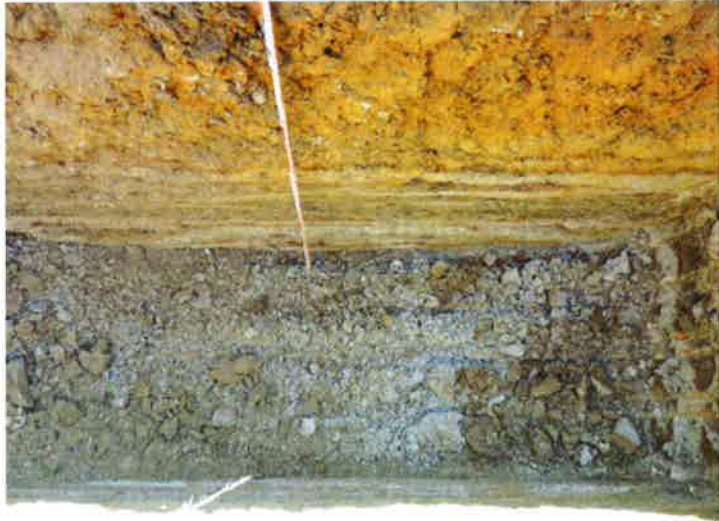
34.00754	150.82824
Method and orientation:	Backhoe with 750 mm wide bucket; parallel to contour		Easting (MGA): 299442
Logged:	BBD	Strike of PIT (deg): 175	Northing (MGA): 6234881
Approx surface dimensions (m):	2.6x0.8	Maximum depth (m): 1.35	elevation (m) (AHD): 58
Approx site slope (deg):	3	Weather – and/or Adverse conditions: Fine, clear sky, warm, slight breeze	
DESCRIPTION			SAMPLES (all)
0 – 0.35 variable, br sandy clay and clayey sand topsoil 0.35 – 0.75 moist, stiff, yell-br sandy clay 0.75 – 1.2 dry, dk br and grey mot occ yell-br broken and weathered siltstone pieces in clay (C horizon) 1.2 – 1.35 complete in dry, lt grey HW siltstone			nil
GROUNDWATER CONDITIONS			
None seen

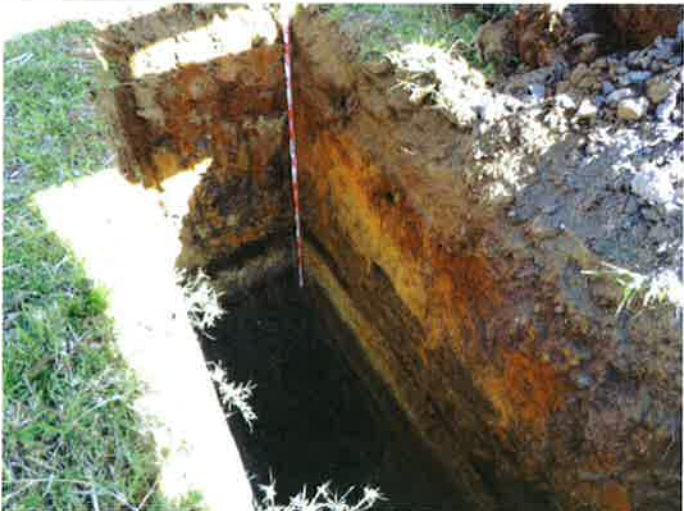
RED EARTH GEOSCIENCES - PIT LOG			
Dated excavated: 2 Oct 2014		PROJECT No 1403	
PIT No 23			
Record if logged date different to excavated date:		All Coordinates Approximate - unless stated (may be derived from geodetic software):	
Position method: GPS handheld		Latitude (WGS-84) (hD.d): 34.00793	Longitude (WGS-84) (hD.d): 150.82474
Method and orientation: Backhoe with 750 mm wide bucket; parallel to contour		Easting (MGA): 299119	
Logged: BBD		Strike of PIT (deg): 158	Northing (MGA): 6234831
Approx surface dimensions (m): 2.3x0.8		Maximum depth (m): 1.76	elevation (m) (AHD): 72
Approx site slope (deg): 4.5		Weather - and/or Adverse conditions: Fine, clear sky, warm, slight breeze	
DESCRIPTION			SAMPLES (all)
0 - 0.25 dry, br silty sandy topsoil 0.25 - 0.6 moist, stiff, red-br sandy clay with minor gravel 0.6 - 0.7 dry, stiff, red-br and yell-br mot gravelly sandy clay 0.7 - 1.05 moist, red-br mot, HW-MW, grey siltstone bedrock with moisture on bedding; rootlets to 0.75 Excavation continued to 1.76 50 - 150 mm thick bed of moist, carbonaceous shale with free moisture on bedding planes; quickly transitions to very hard, MW, dk grey shale			nil

GROUNDWATER CONDITIONS			
Free moisture in limited bed of deeper weathered bedrock

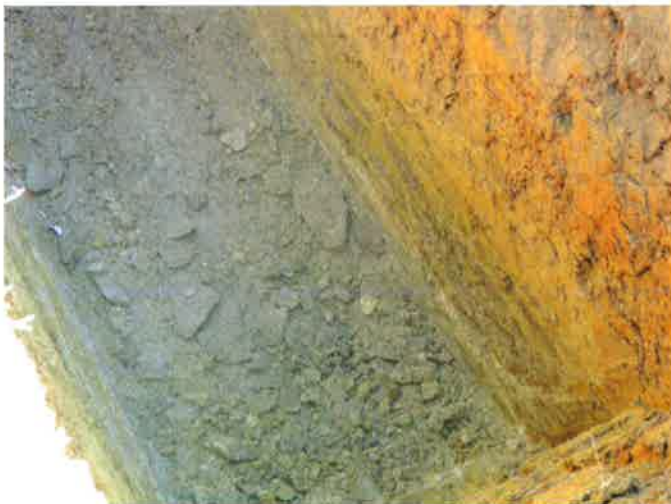
34.00516	150.82278
Method and orientation:	Backhoe with 750 mm wide bucket; parallel to contour		Easting (MGA): 298932
Logged:	BBD	Strike of PIT (deg): 165	Northing (MGA): 6235134
Approx surface dimensions (m):	2.35x0.76	Maximum depth (m): 1.45	elevation (m) (AHD): 66
Approx site slope (deg):	5	Weather - and/or Adverse conditions: Fine, clear sky, warm, slight breeze	
DESCRIPTION			SAMPLES (all)
0 - 0.25 variable, br silty and sandy topsoil, variable horizon boundary 0.25 - 0.7 stiff, red-br and occ yell-br mot, sandy clay 0.7 - 1.3 yell-br and dk br and grey mot sandy clay and clayey sand with minor gravel; rootlets to 0.95 1.3 -1.45 complete in very hard, MW, grey sandy siltstone and sandy lenses (laminite)			nil
GROUNDWATER CONDITIONS			
None seen
