Catholic Metropolitan Cemeteries Trust

Preliminary Geotechnical,
Groundwater and Salinity Assessment:
Proposed Wallacia Cemetery,
Wallacia, NSW

P1706171JR01V01
October 2017

PROJECT: PROPOSED CEMETERY
 PLANSET: GEOTECHNICAL GROUNDWATER AND SALINITY MAPPING
 CLIENT: CATHOLIC METROPOLITAN CEMETERIES TRUST

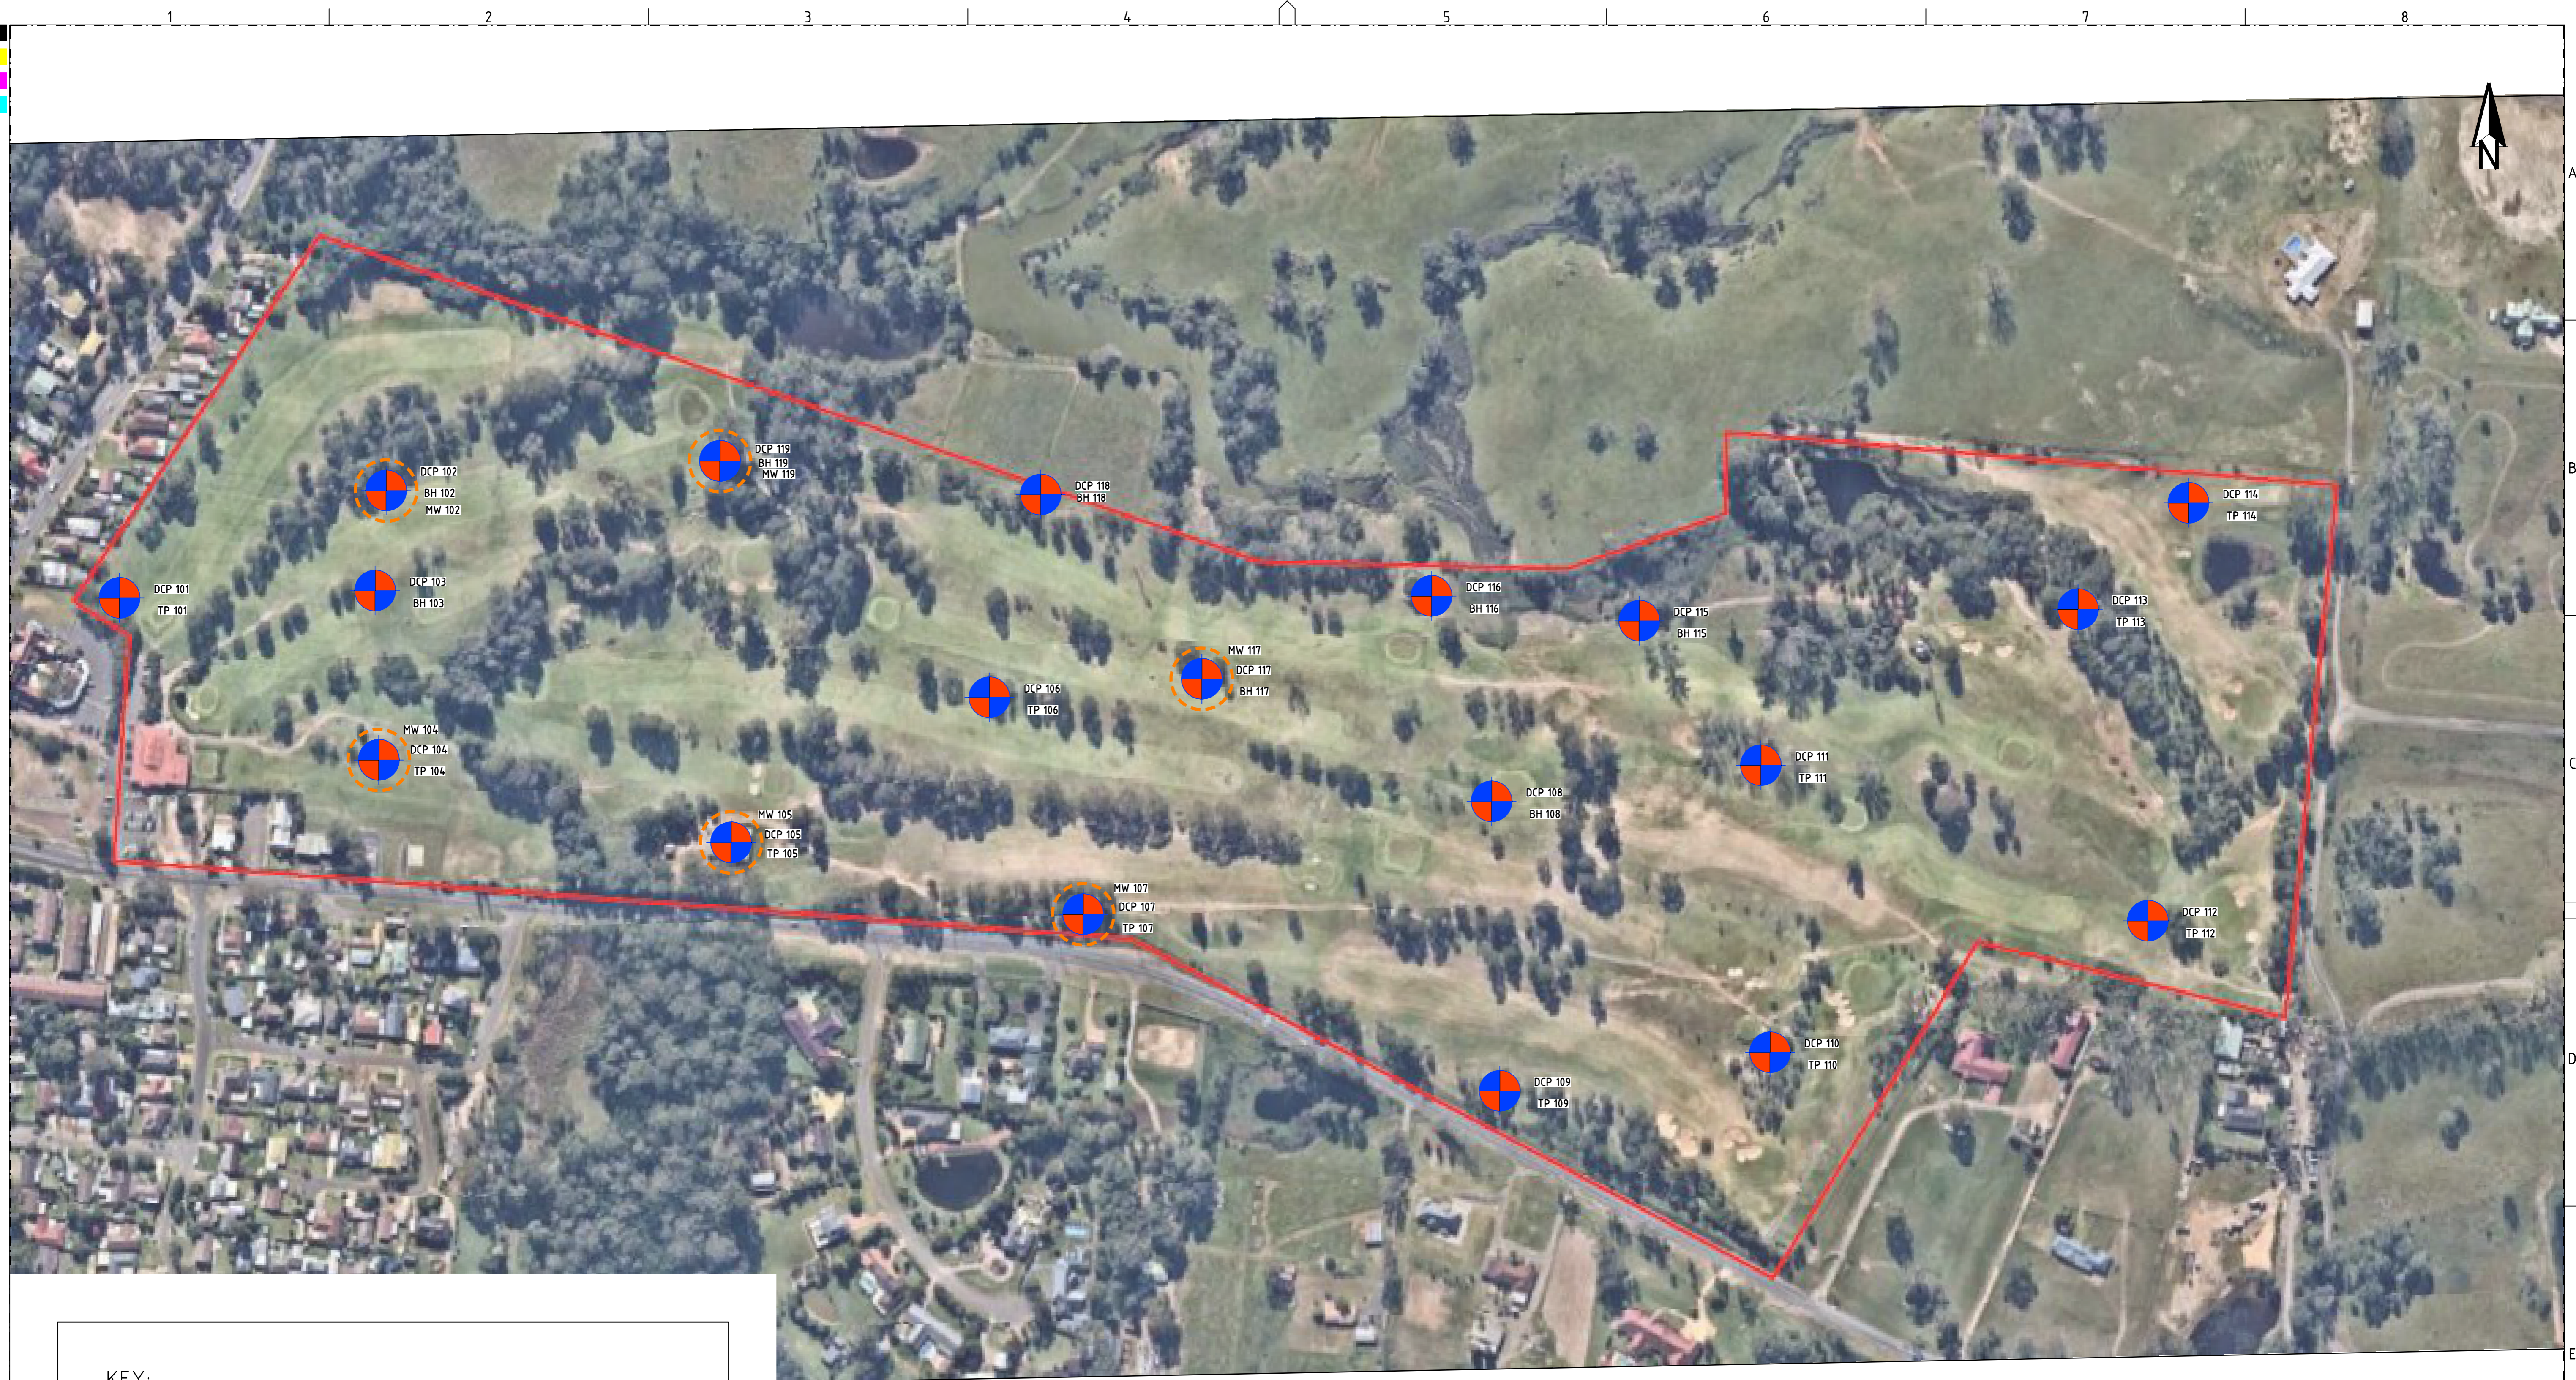
DRAWING ID: P1706171-PS01-R01-J100

KEY:

GROUNDWATER MONITORING WELL
