Comment to the Independent Planning Commission on Ulan Coal Mines Limited proposed Modification 4

by **Geoff Mitchell 23rd June, 2019** on behalf of Geoff and Mary Mitchell, owners of the property [REDACTED]. This comment will add some detail to the issues discussed on site at Woodbury on the 19th June, 2019 with Commissioners Gordon Kirkby and Brett Whelan and Planning Officer Jorge Van Den Brande and myself. The discussion was carried out at the Mona Creek Site 27 next to UCML's infrastructure pad in the shadows of the Mona Creek Cliff line. Commissioner Professor Chris Fell inspected other areas of Woodbury relating to MOD 4.

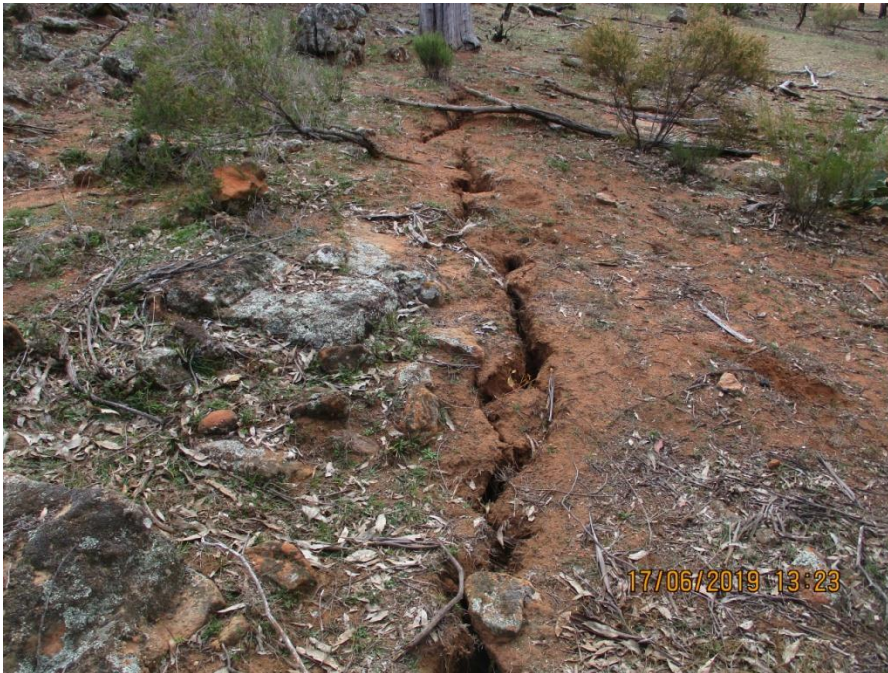
Photo 1. Subsidence crack at Woodbury from mining LWW5, 17.06.2019.

To date UCML have mined under that section of Woodbury as defined by the various diagrams illustrating LWW5.(see Charlie Allan's presentation).The mining of this section approximately began at the beginning of 2019.UCML's Lucy Stuart and myself regularly inspect the mined area. Photo 1 is of the largest crack that we have discovered so far. I will address the subject of subsidence in relationship to shallow aquifers if a crack similar to the above occurred under them later on page 16 but I will first focus on subsidence in relationship to the documented rock fall next to Mona Creek Site 27. This site is on the common boundary between UCML's Lot 8 and Woodbury , see photo 7, and situated approximately 150 metres from UCML's infrastructure pad.

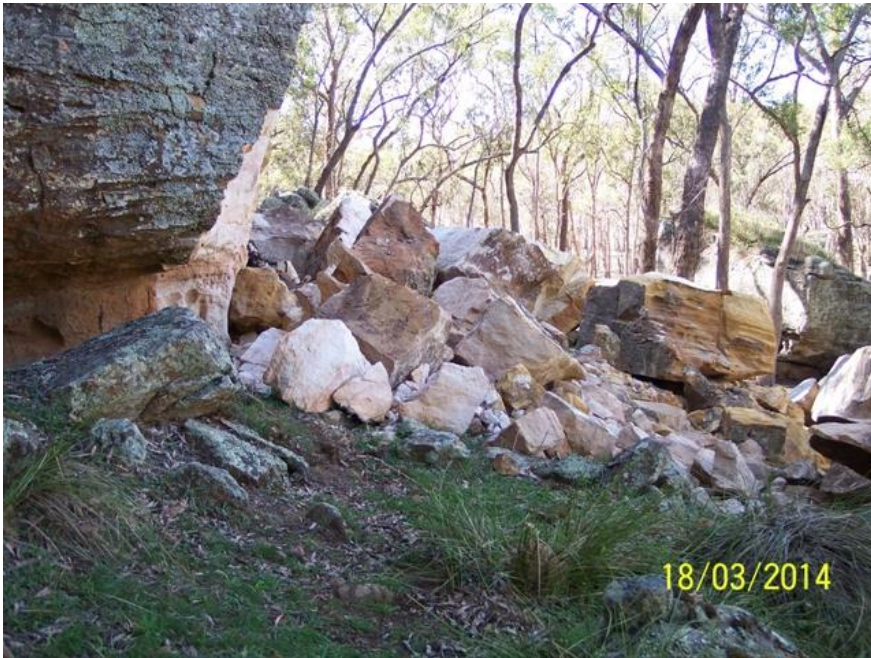
Photo 2. Rock fall next to Mona Creek Site 27

The above photo illustrates the rock fall. As noted in my email to Ken Mills dated Nov 5, 2018 and I quote:

“Mary and I met with Robyn on the 2nd November, 2018 and had another look at this rock fall and took some photos. Robyn observed both horizontal and vertical cracking and some dampness in the remaining wall behind the rock fall.

At this meeting on Friday and also in a previous phone call, Robyn explained she was under the misapprehension that we thought that some mine activity [see also her email to you] had caused this rock fall and having knowledge of mine activity at this time she thought it was impossible that UCML had caused this rock fall and therefore did not advise the relevant consultants when Mod 4 was being developed. I pointed out that having gone back through all our emails to Robyn on this subject that we had never put this proposition forward that the mine had caused the rock fall. I would observe that the extensive tree root system and water seepage had a fair bit to do with setting up this occurrence.

Our point is that if you are going to increase the length of your longwalls to gain more coal and you are assuring all parties that the cliffs will not be disturbed by Modification 4, should you not investigate the stability of this cliff line structure in the light of this rock fall. Several trees are growing along the edges of these cliffs and therefore similar situations to the current rock fall may be existing in other sections.

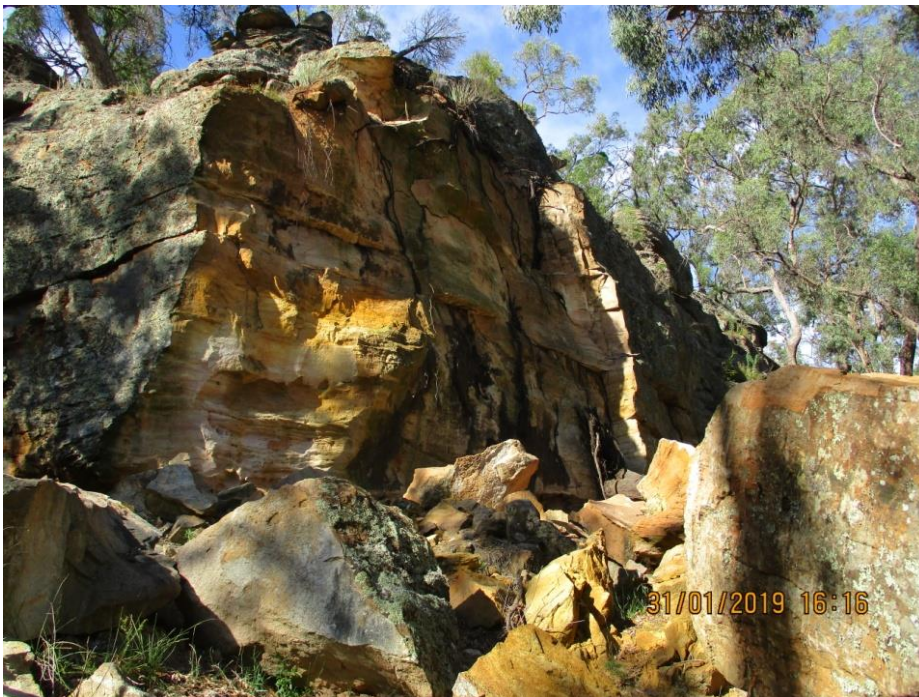
On Monday 17th June, 2019, I had a walk over the site above the rock fall. Walking along near the edge of the cliff I came across a 7 metre black pine tree leaning over. To see how stable it was I poked it with a small stick wherein it disappeared over the edge taking dirt and rocks with it. The tree movement and impact below were quite evident at the top of the cliff. Mary is considering nominating me for a Darwin Award. Ken did mention to me on the 3rd December inspection that a full geotechnical survey of the whole cliff line would take a couple of weeks. The IPC party did observe this tree [Photo 6] and what appear to be precarious rocks around this site.

Photo 3. The leaning black pine tree can be seen at the top of the photo just left of middle.

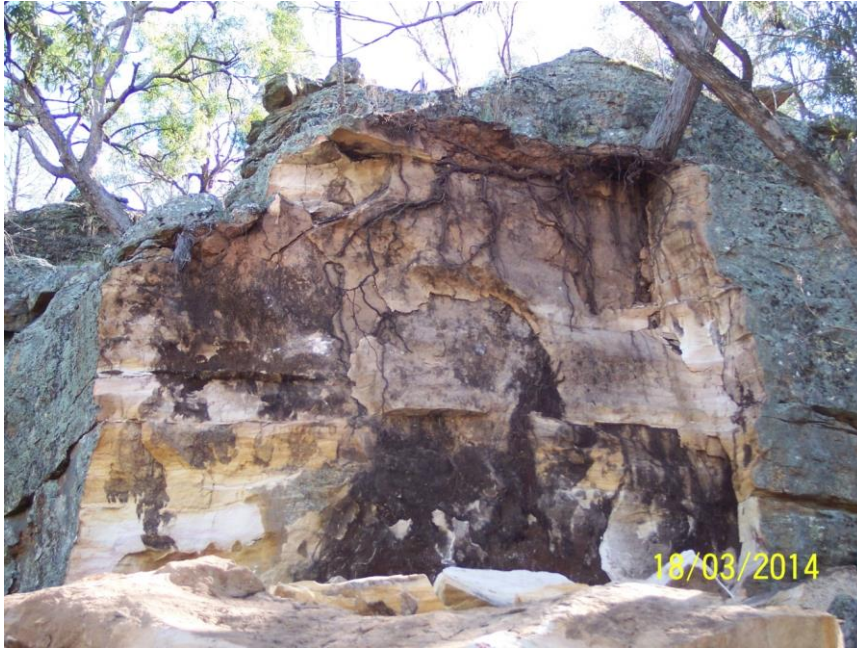
Photo 4.

There obviously has been other substantial movements at this rock fall since 2014. Comparing Photo 3 with Photo 4 below you will see that the large tree at the top right hand edge of the rock fall in Photo 4 has fallen over the cliff (see Photos 5 & 6), sometime between 18.03.2014 and 31.01.2019.

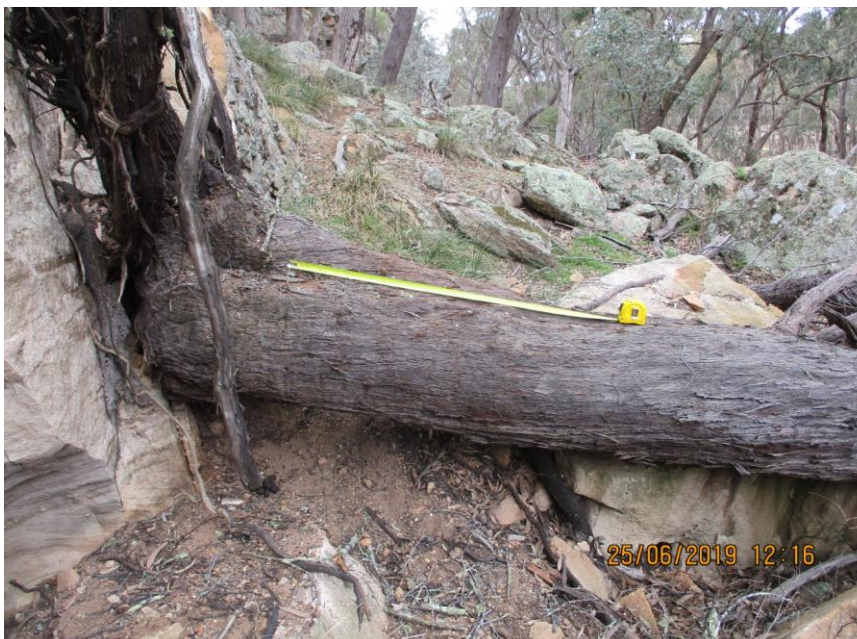
Photo 5. Large stringybark. Tape extended to 1 metre.

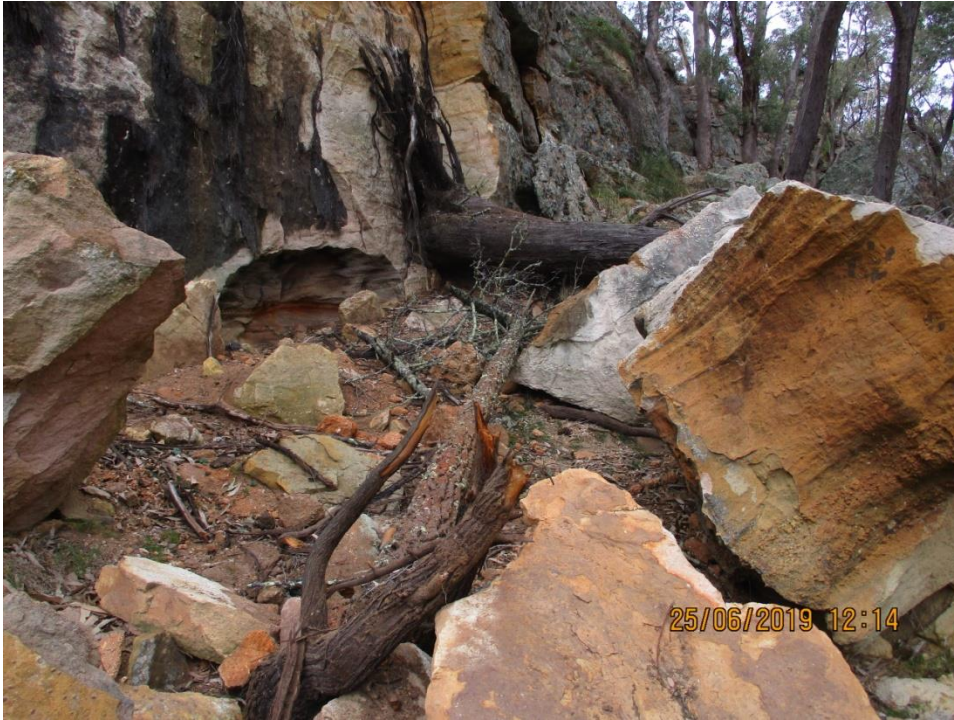
Photo 6. Rock fall. Black pine in foreground with large stringybark which has fallen between 18.03.2014 and 31.01.2019

“ a vibration monitoring system installed along the top of the Mona Creek Rock Shelter site would be helpful to confirm that there are no further vibrations occurring from the shaft construction activities that have the potential to impact the rock shelter sites - none are expected, but it would be helpful to have a record showing this is the case.”

Why not put a monitoring system in before work commenced on the infrastructure pad. Infrastructure on this pad will be utilised by some of the extensions proposed in MOD 4 and surely UCML work out the interaction between its various activities proposed and actual.

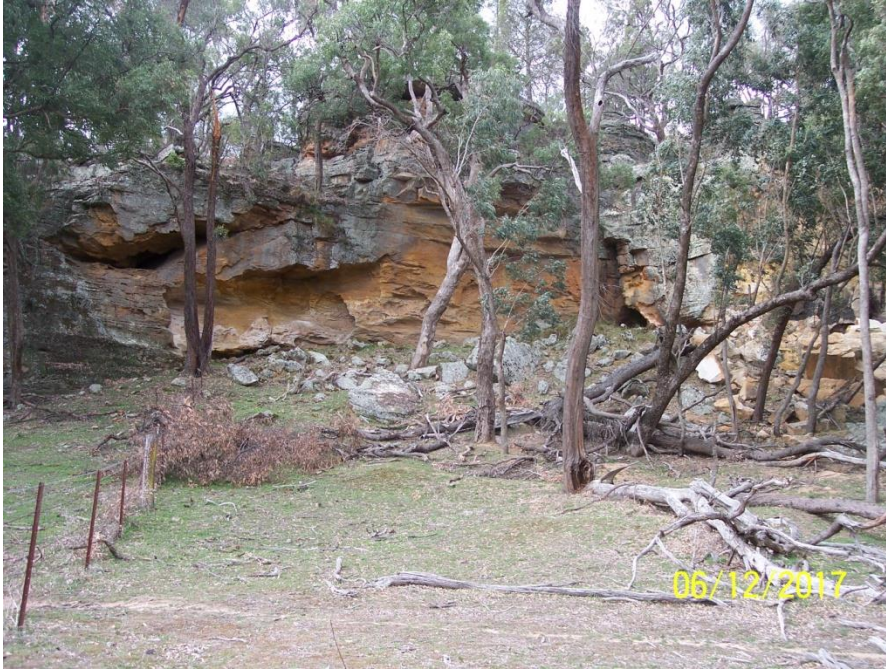
Photo 7. Boundary fence on left. Mona Creek Site 27 in middle, rock fall on right.

Peter Kuskie from SEA met on site with UCML's Brad Tanswell and myself on Tuesday 15th January, 2019 . From about 30 metres away from the rock fall Peter observed that the rock fall had not impacted on Mona Creek Site 27. Visually from that distance, see photo 7, I would agree with Peter as you get a decent perspective of the rock shelter in relation to the rock fall. Peter then proceeded to assess Mona Creek Sites 23~27. His report is on the IPC website ref:Annex E13. On his journey back to Mona Creek Site 27 Peter discovered a small quartz chip (22mm x13mm x 6mm) in a small shallow rock shelter away from the cliff line. This now becomes Mona Creek Site 372 and I presume logged in due course into the AHIMs data base.

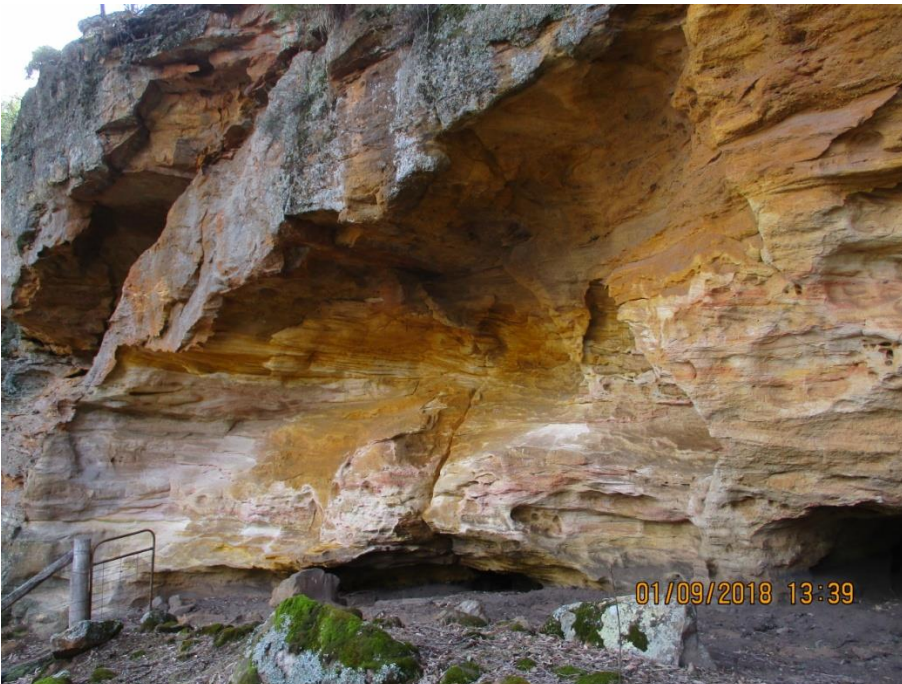
Photo 8. Mona Creek Site 27. Wombat diggings, western end. Boundary fence at bottom left.

What I find really hard to comprehend in Peter's report on Mona Creek Site 27 is that the western two-thirds of the shelter has potential deposit of moderate to high research potential and the eastern third of the shelter (next to the rock fall) has deposit of minimal potential and artifacts appear to be intentionally cached for future use at rear of shelter. Since we have owned Woodbury the resident wombats have dug relentlessly in this shelter, see burrows at the bottom of photo 8.

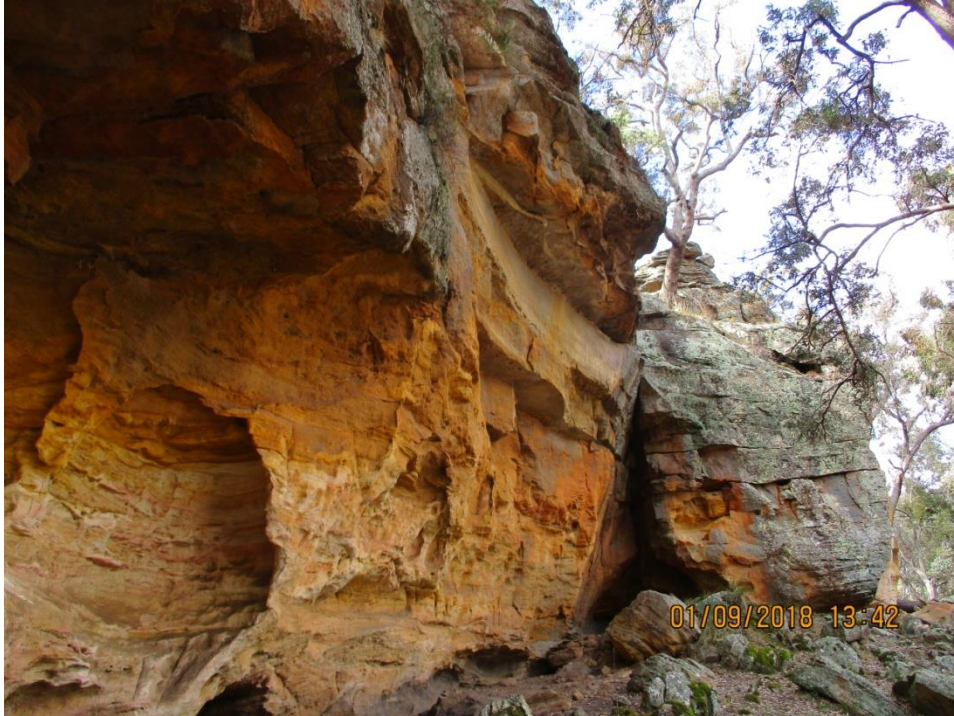
Photo 9. Mona Creek Site 27. Eastern end.

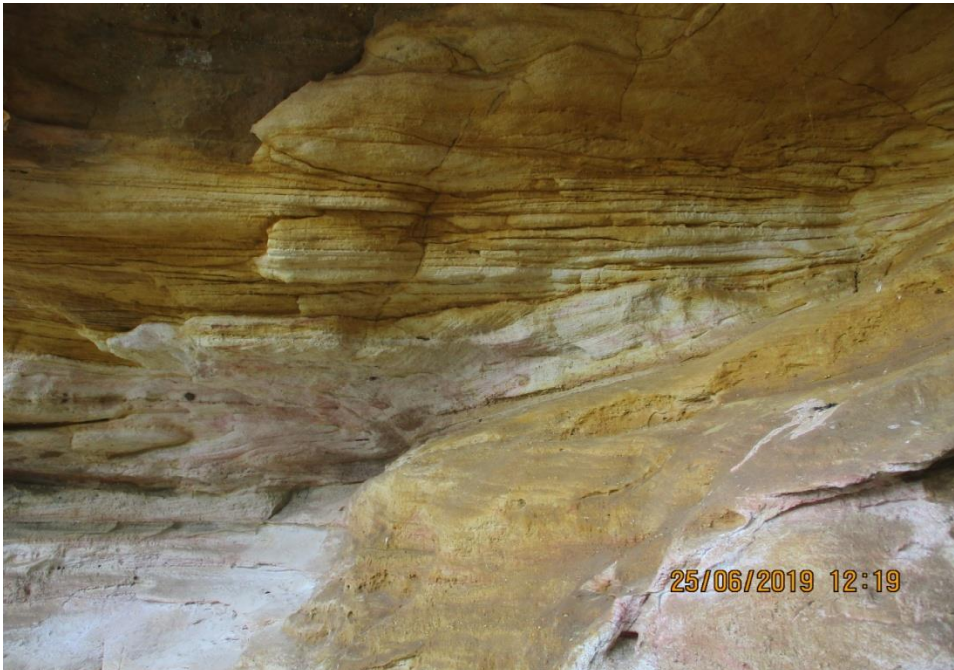
Photo 10. Mona Creek Site 27.(also identified as Ulan Site ID#184)

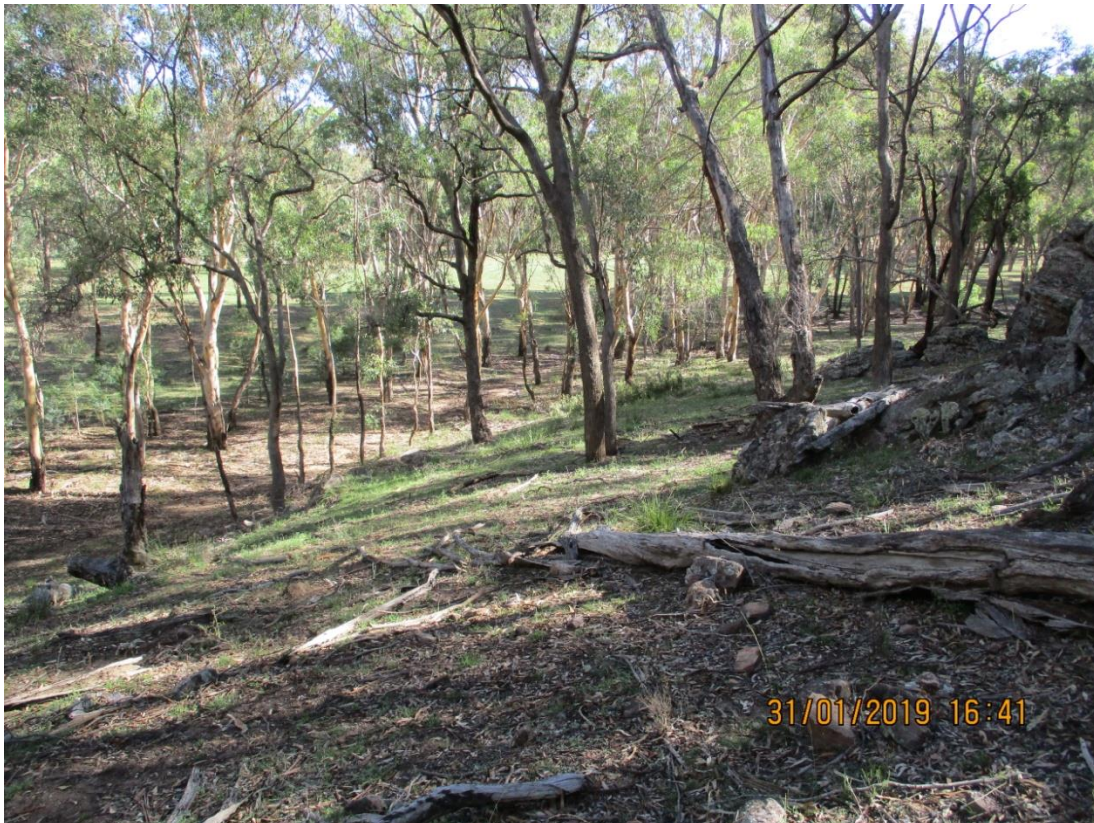
Photo 11. Mona Creek within Woodbury in the vicinity of MOD 4 extension to longwall W8. Well defined bank in this area and throughout Woodbury.

I have read most of the material related to Mona Creek re MOD 4 in the various submissions. **Ephemeral** ~ yes. **Not a well defined watercourse and does not have defined bed or banks** ~ well on Woodbury the banks are defined and water runs down exactly the same route when it flows. **Water holes** ~ two on the previously mentioned Lot 8. There are no natural permanent water holes in Mona Creek that I am aware of on Woodbury.

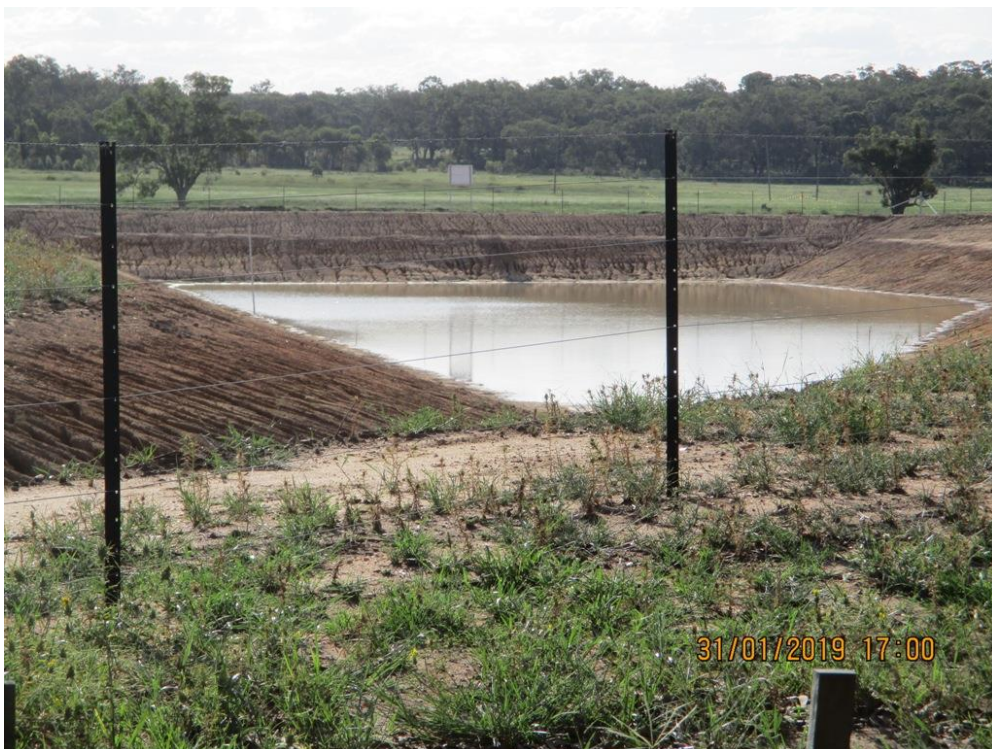
I believe it was crucial that UCML should have carried out rudimentary water pre activity checks before proceeding with MOD 4 and the infrastructure carried out on Lot 8. Below is Photo 12 of a borrow pit dam constructed in 2018. The soak my neighbour and I found noted on page 13 was in Mona Creek just to the north of this dam.

Photo 12. Borrow Pit Dam on Lot 8.(31.01.2019)

This dam filled up very quickly. As we had not had a lot of rain generally most of this water is from drilling three dewatering bores approx. 25 metres from our boundary. The dam is approx. 120 metres from our boundary. So my question is, what underground source is supplying this water. Approx. 150 metres from our common boundary with UCML there is on Woodbury the confluence of two main sections of Mona Creek. This confluence should be the first point of investigation re shallow aquifers. So where is this abundant water coming from. Aquifers on Lot 8? Aquifers on Woodbury? Without any pre activity ground monitoring or investigation we do not really know. Photo 13 below indicates the water activity from drilling the 3 dewatering bores. I note that on page 17 of the DP & E MOD 4 Assessment that UCML are proposing to install at least three monitoring bores in the Mona Creek alluvium in the area north of UWO LWs 6-8. This may achieve the stated purpose but could also aid investigations into a possible future extension of UWO LWs 9-11.

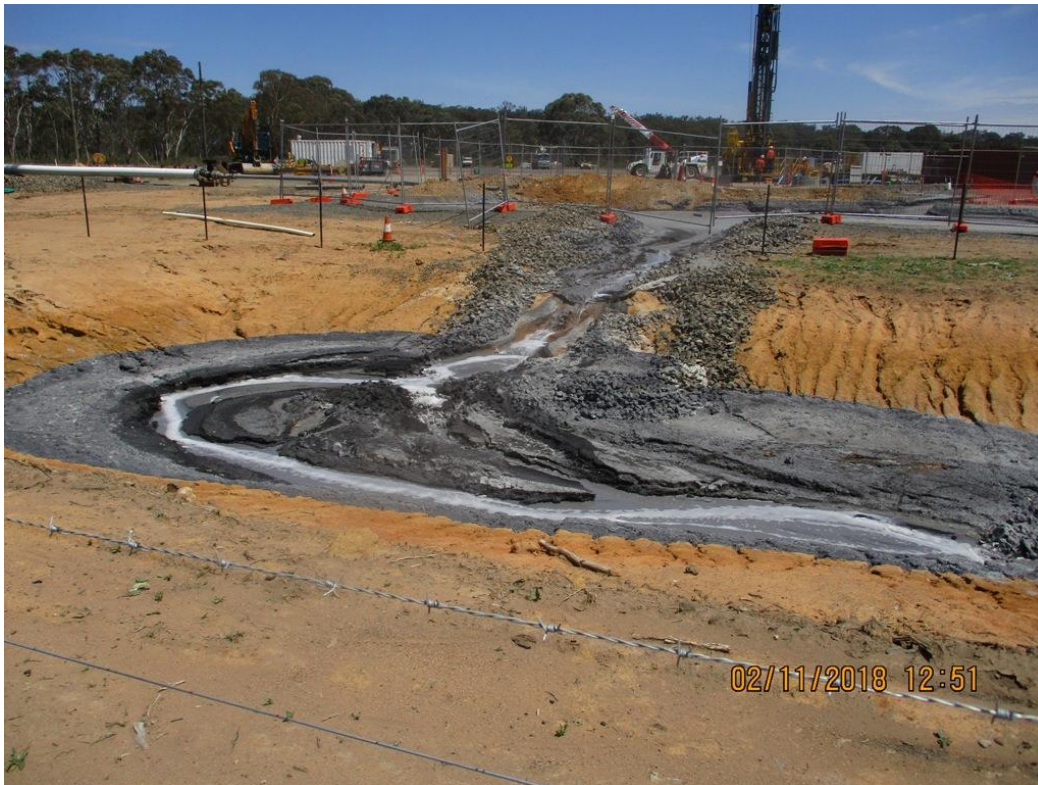
Photo 13. Run off from drilling dewatering bores on UCML's Lot 8 draining to Borrow Pit dam.

We think that several investigative sites should have been established within the Mona Creek MOD 4 site to monitor any water assets and that the interaction between the proposed MOD 4 and current and proposed mining activity on Lot 8 should have been considered. It has been pointed out to me by UCML and their consultants that the shallow aquifers and the deeper groundwater are not connected. I say, and referring to Photo 1, if a subsidence crack similar to what is illustrated here develops under a shallow aquifer, it will drain.
