Phase 1 Contamination Assessment

1-17 Grey Street and 32-48 Silverwater Road, Silverwater NSW

16 MAY 2018

Project No. SES_481

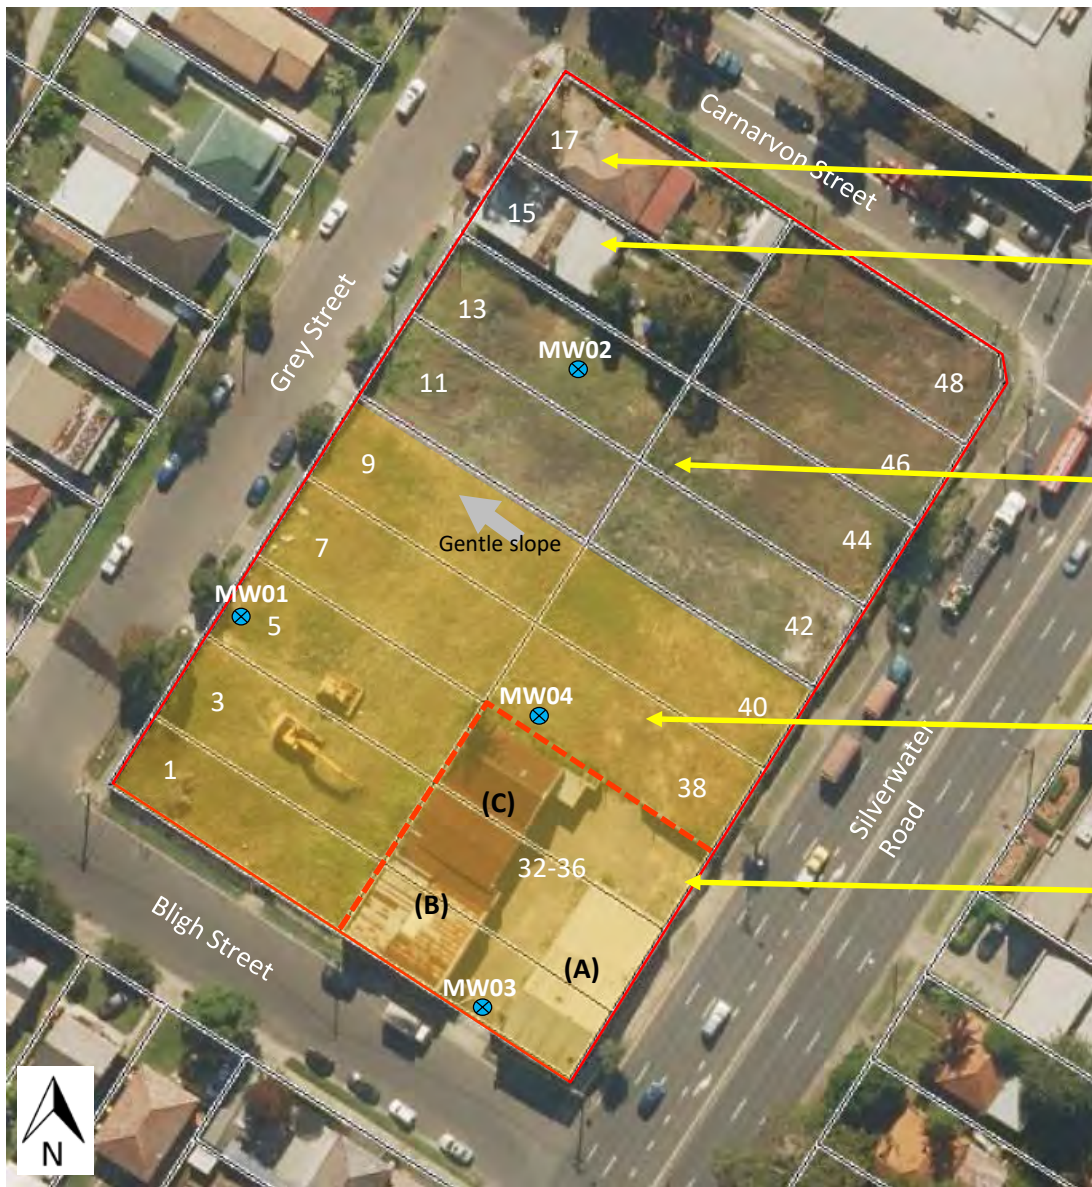
Figure 2: **Site Layout**

Three buildings presently exist in the southern corner relating to a former dry-cleaning business. These are annotated on Figure 2 as Buildings A, B and C. Building A appeared to be used for vehicle maintenance, storage of various equipment and probably the main operations area of the former dry-cleaning business. Of note were concrete block plinths that may be evidence of machine foundations and infilled and sealed drainage lines and drain openings. Building B is being used as a vehicle parts storage area and appeared damaged by a recent fire. Building C was used as a store room for various equipment and parts for the rental business with a wash room and toilet facilities at the north end.

Remaining residential home (#17 Grey St)

Corner shop (Mekhael's) at #15 Grey Street

The following features were observed during the site inspection conducted on 18 April 2018. The site layout is presented on Figure 2 in **Appendix A** and photos of the site are presented in **Appendix B**.

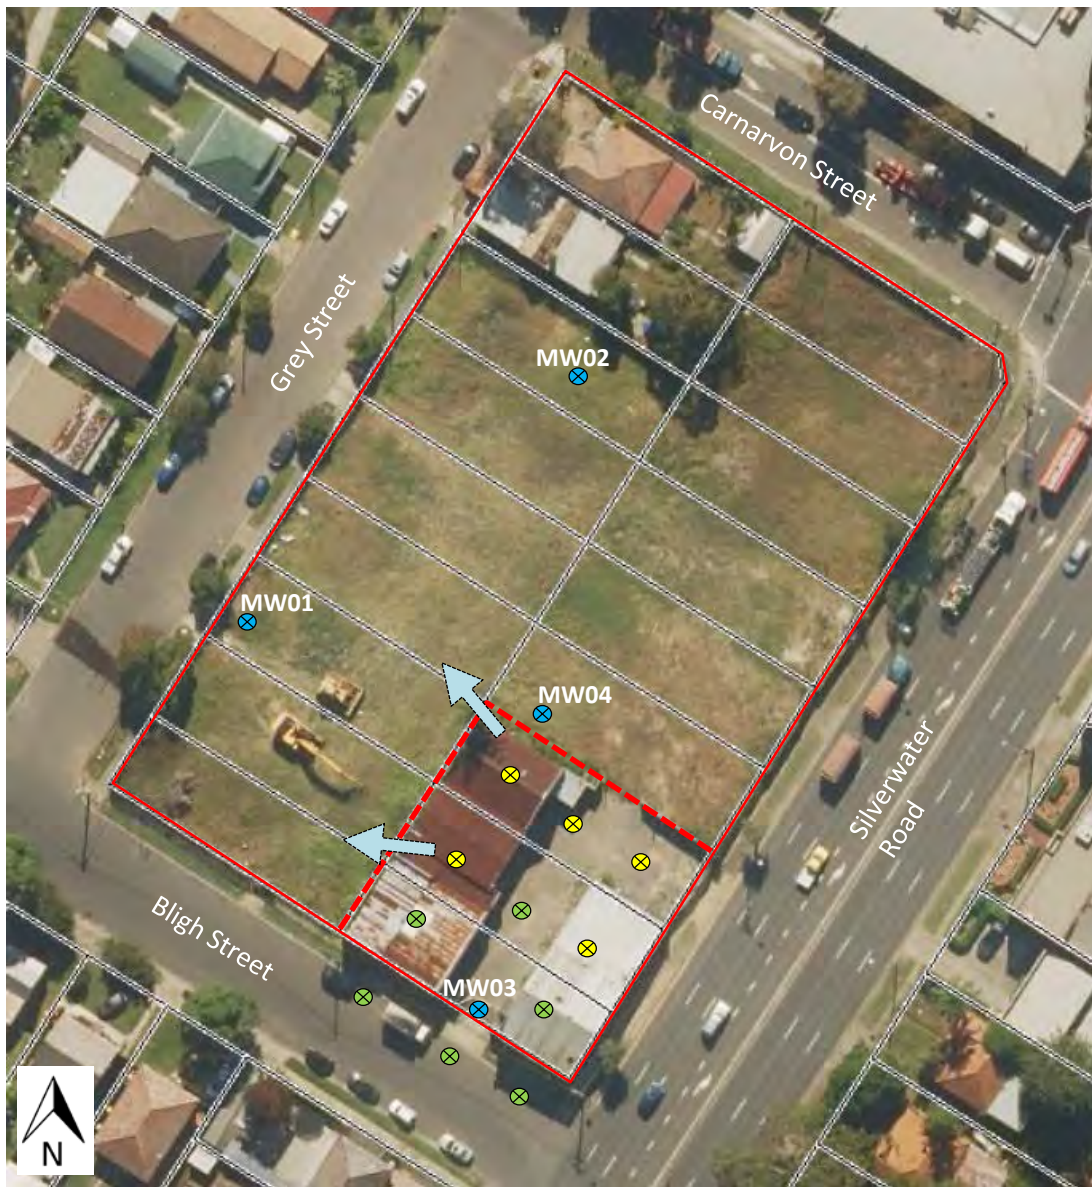
Figure 3: **Recommended Delineation Sampling**

- Sampling soils in and around the former dry-cleaning business at locations shown on Figure 3 (**Appendix A**). Consideration should be given to target areas known to have stored PERC waste, and around underground stormwater drains, sumps and sewerage pipes. Analysis should include TRHs, VOCs and metals.

- Installing a series of new groundwater monitoring wells at locations shown on Figure 3.
 - Collect groundwater samples from the new wells and all existing wells (if they can be located and accessed). Analysis should include TRHs, VOCs and metals.

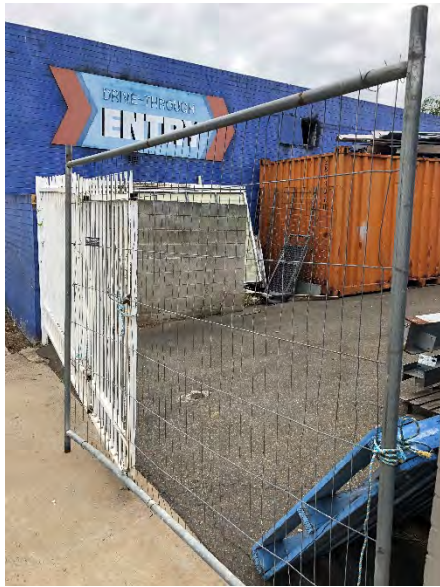
- Fragments of fibro were observed in random locations on the ground surface.
- An existing groundwater monitoring well (MW03) was observed on the sealed entry driveway to the former dry-cleaning business. Other groundwater wells MW01, MW02 and MW04 that were previously installed (WSP, Nov 2012) were not observed.

Entry to former dry cleaner off Bligh Street. Note groundwater well cap on driveway (MW03).

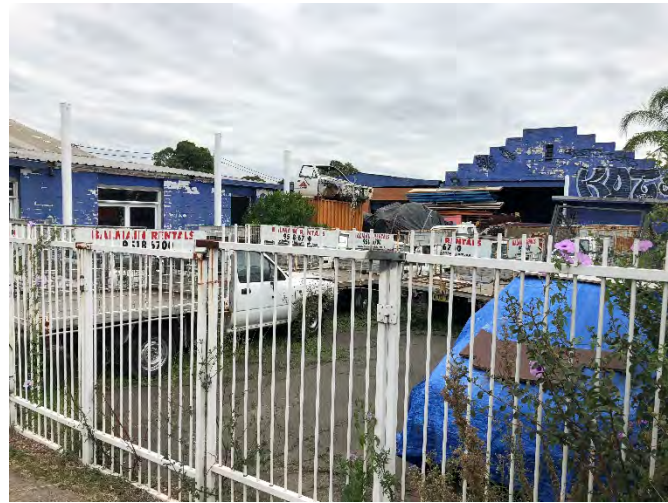
Leased area yard storage facing Building C with Building A on the left.

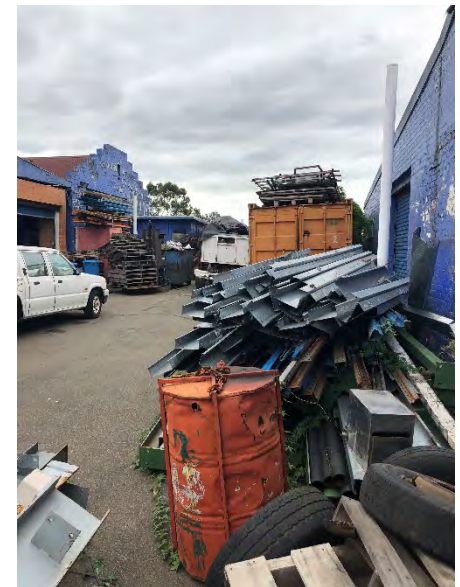
Leased area yard storage.

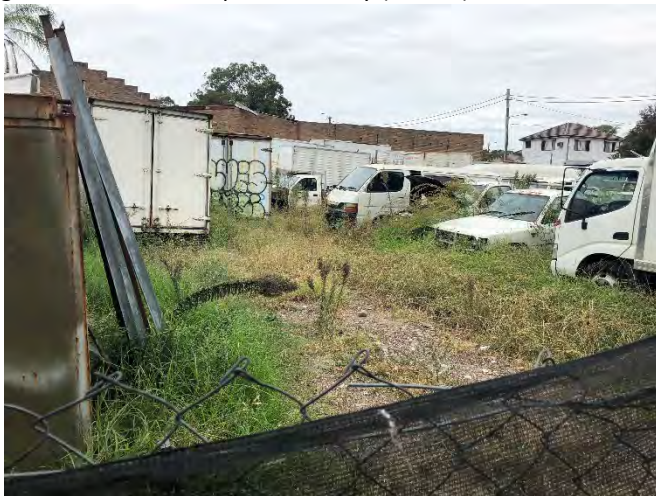
- No indications of underground tanks were observed.
- One empty aboveground tank (2,000 litre capacity).
- Rental vehicles, truck cabins, trailers and various other vehicle apparatus are positioned in rows that cover most of the leased area external to the buildings. These areas are unsealed and overgrown with grass/weeds.

Leased area storage of rental vehicles behind Building B.

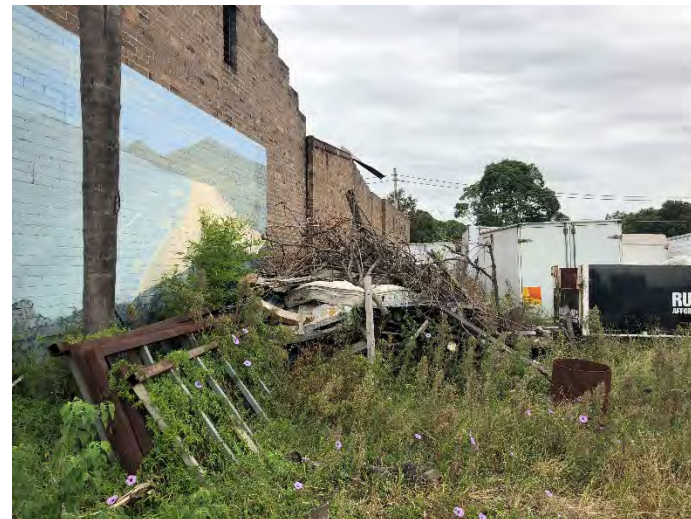
- The leased area is poorly kept with numerous piles of haphazardly stored materials such as car bodies, metal and timber framework, pallets, tyres, dead vegetation, general refuse (mattresses, rubbish, plastic), rusted empty drums, and bricks.

Piles of waste in leased area behind Building B and C.

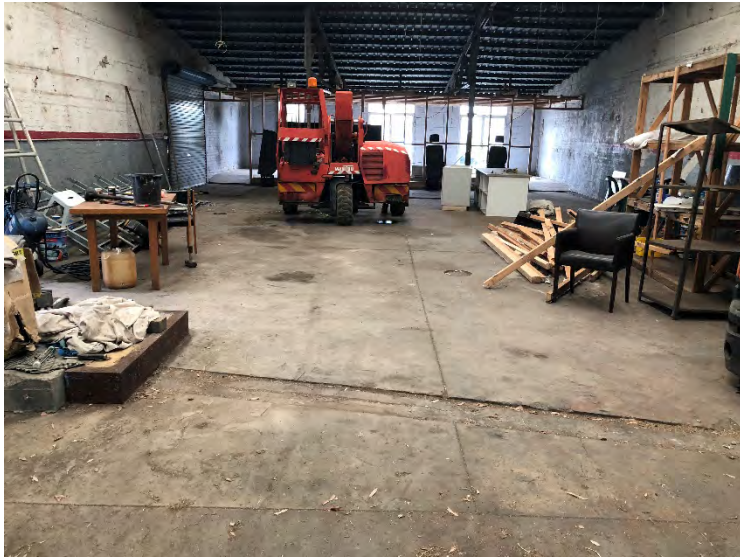
Building A interior – raised plinth and infilled drain and opening.

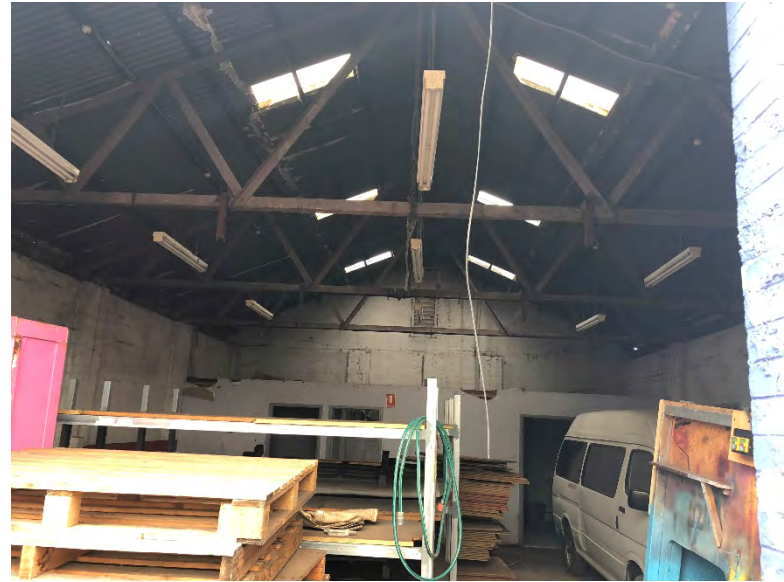
Building C interior – north end.

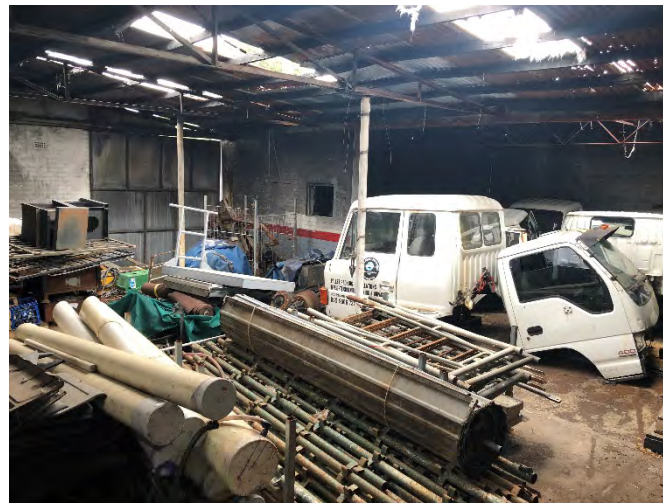
Building B interior.

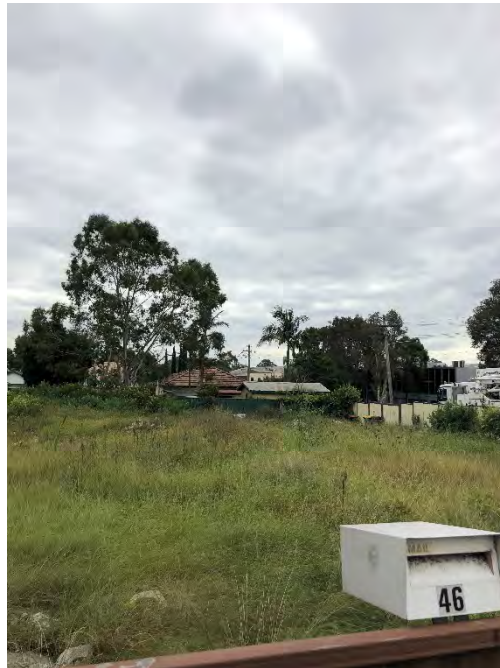
Vacant land area (#46 Silverwater Road) behind the Corner Shop and remaining residential building.

- Collect limited verification surface soil samples from around the existing structures at #15 and #17 Grey Street where weathering of old building materials containing asbestos and lead-based paints; or use of pesticides or grease trap leaks/spills may have caused surface soil impacts. Samples should be analysed for petroleum hydrocarbons, metals, asbestos and pesticides.

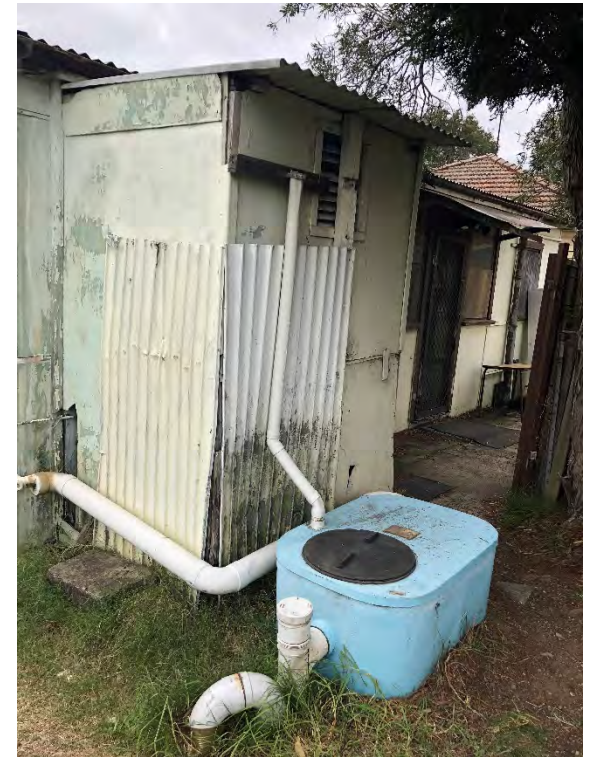
A corner shop currently exists at #15 Grey Street and anecdotally has operated for many years from that location. Of note is the use of a grease trap system that may cause an increased contamination risk within that locality.

- Localised leaks/spills from the grease trap system within the Corner Shop lot (#15 Grey Street).
- Use of pesticides within the Corner Shop (#15 Grey Street) and existing residential building at #17 Grey Street.

Grease trap system at the rear of the Corner Shop.
