Site Location
 Phase 1&2 ESA, 32-46 Silverwater Road, Silverwater, NSW
 00034924
FIGURE 1

Site Layout
 Phase 1&2 ESA, 32-46 Silverwater Road, Silverwater, NSW
 00034924
FIGURE 2

Criteria Exceedances
Phase 1&2 ESA, 32-46 Silverwater Road, Silverwater, NSW
00034924
FIGURE 4

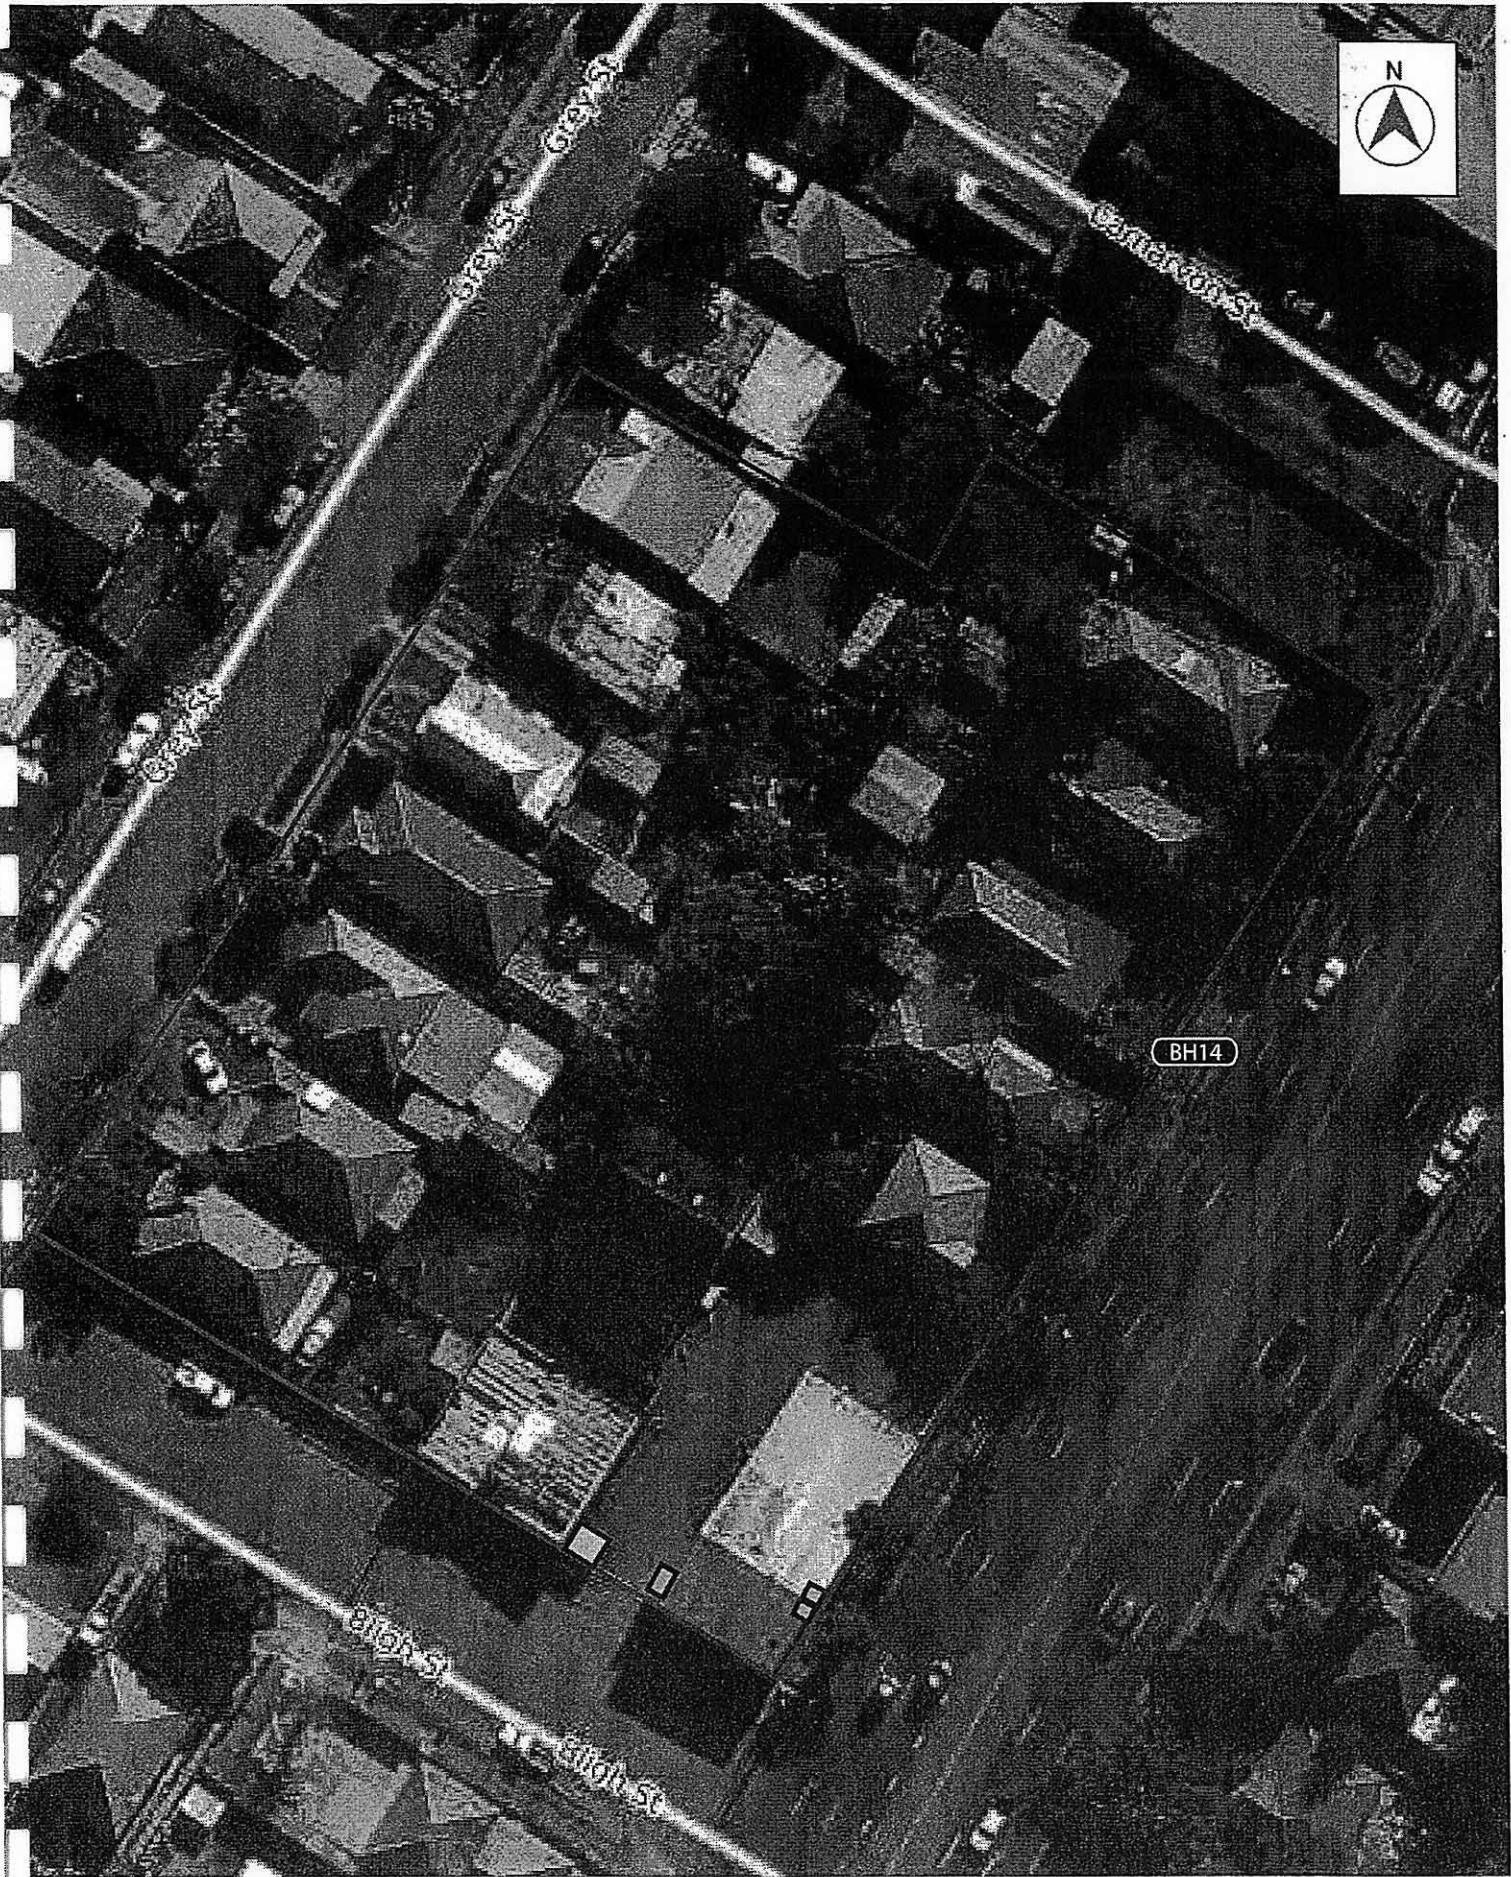
AST
-

Chemical Storage Bund Area

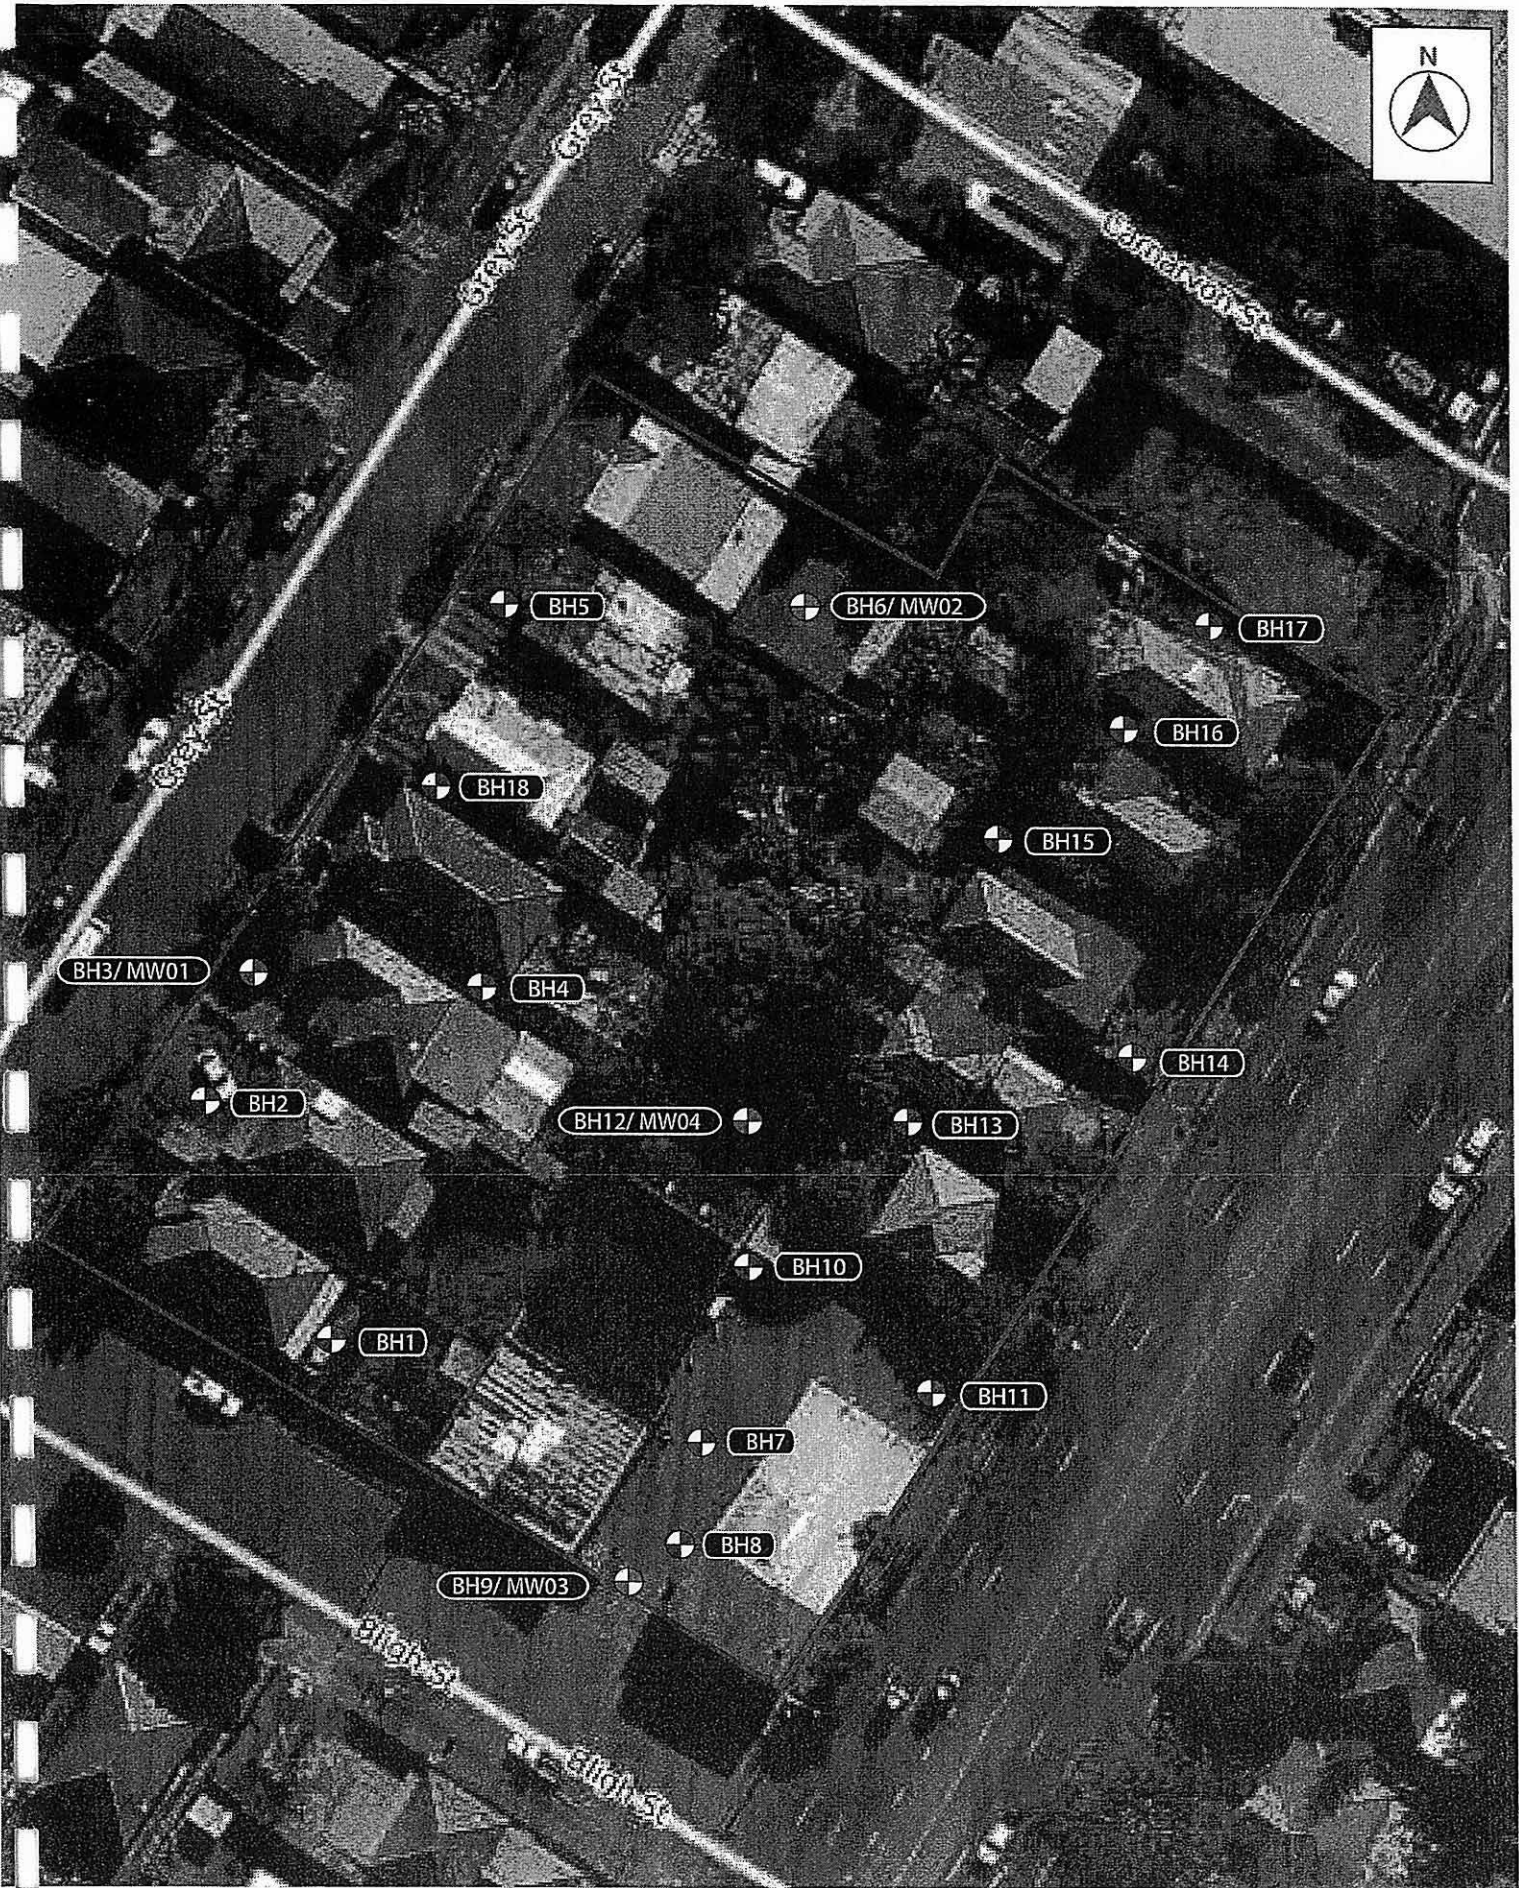
FIGURE 3

BH01 Soil Bore
-

BH01/MW01 Soil Bore Covered to Monitoring Well

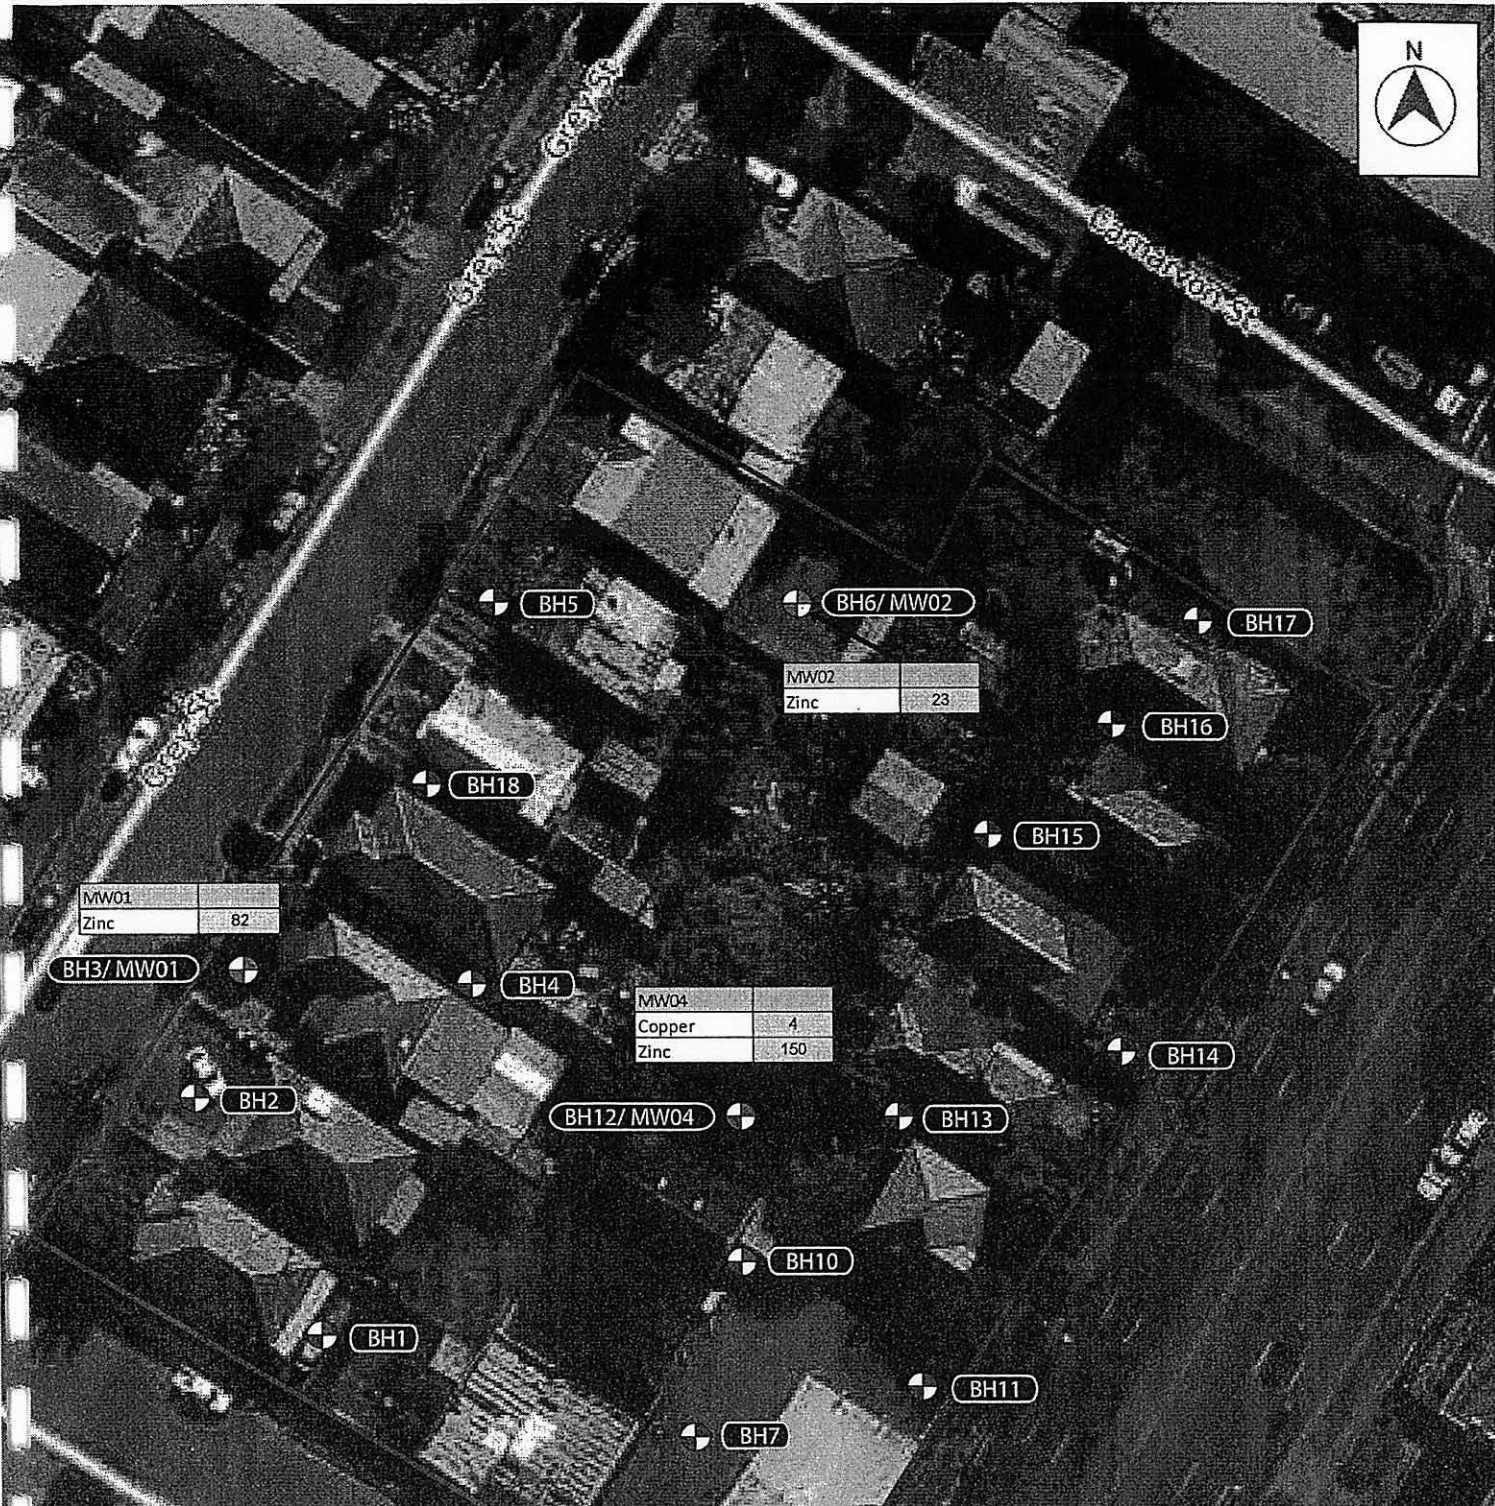
MW01	
Zinc	82

MW02	
Zinc	23

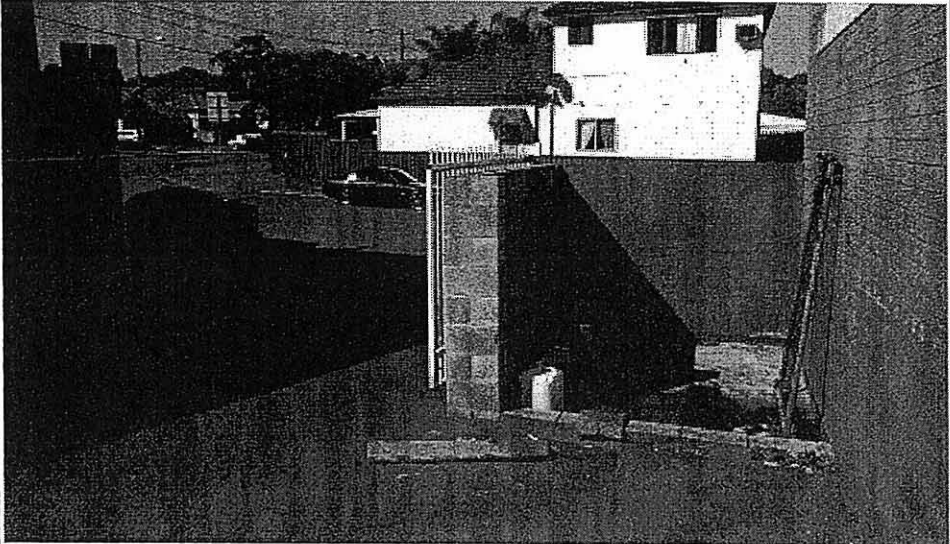
Photo No.	Date	
<p>1</p> <p>Description View towards the Bligh St access gate to 32 Silverwater Rd.</p> <p>Immediately west of the access gat there is a bund area, formerly used for chemical storage. Some containers remain.</p>	<p>15 October 2012</p>

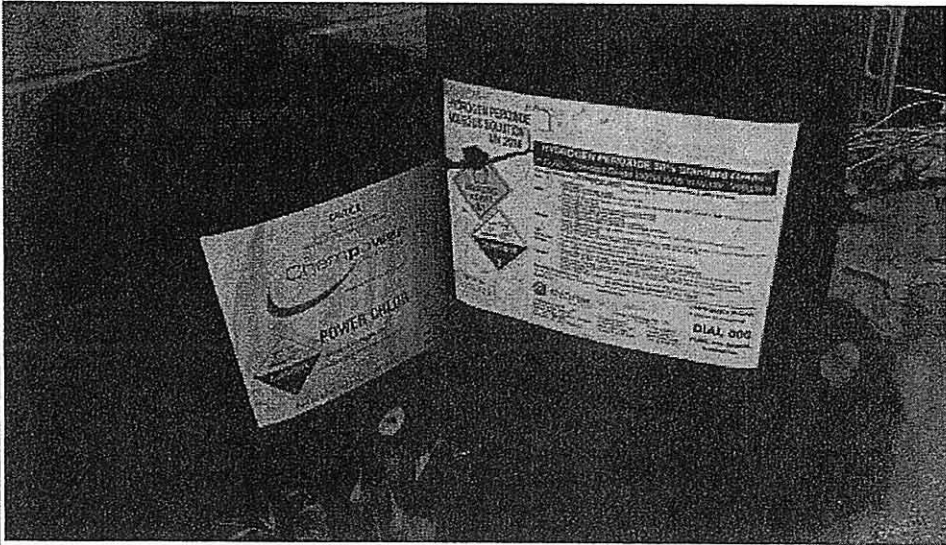
Photo No.	Date	
<p>2</p> <p>Description Sodium hypochlorite and hydrogen peroxide were observed to be stored in the bund area.</p>	<p>15 October 2012</p>

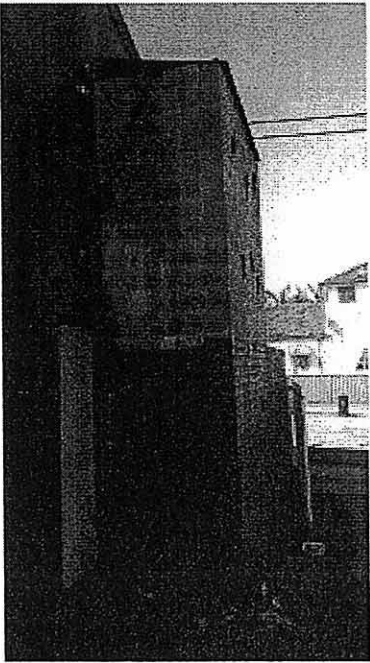
Photo No.	Date	
3	15 October 2012

Description On the western wall of the eastern building located at 32 Silverwater Rd, a suspected former AST was observed.

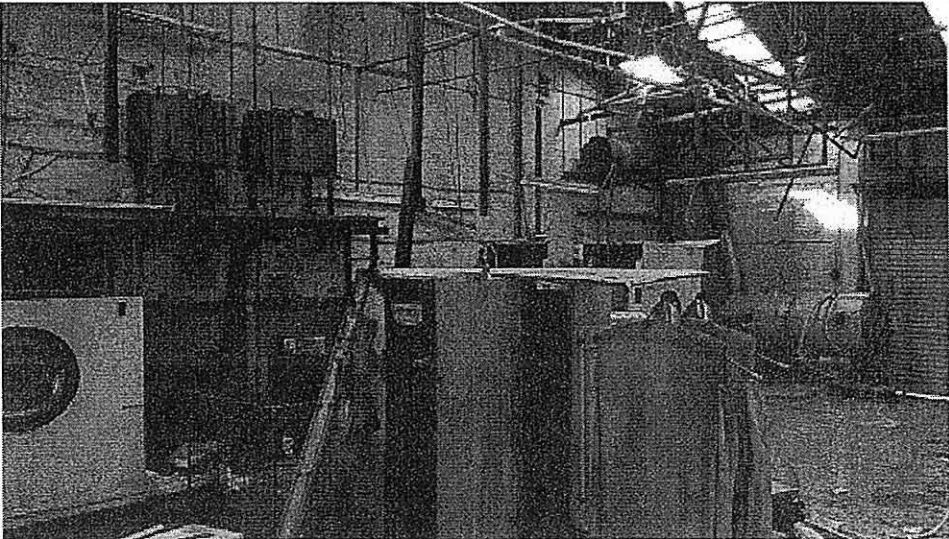
Photo No.	Date	
4	15 October 2012

Description View from the eastern access door to the southeast. Two ASTs and an elevated drum storage area were identified. Some non-operational machinery remains at the property.

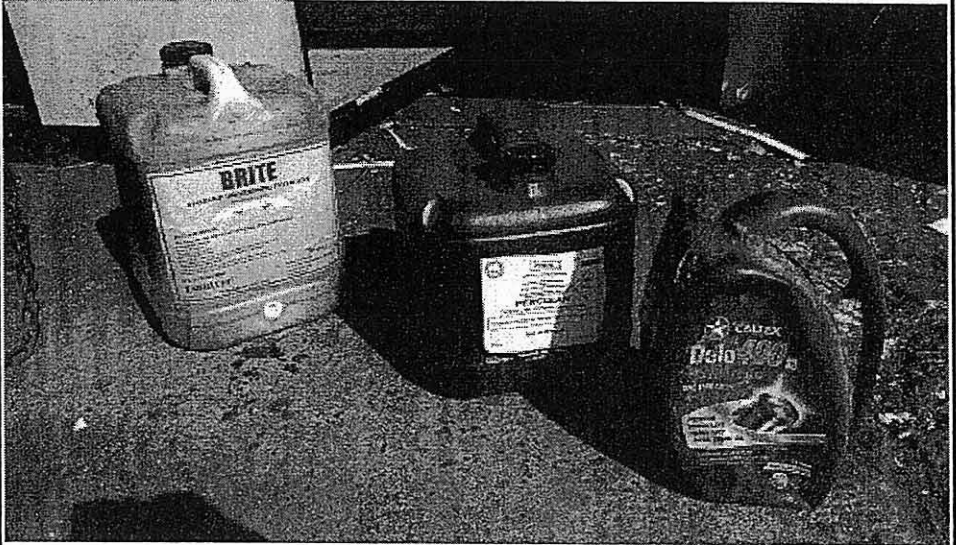
Photo No.	Date	Description	Image
5	15 October 2012	<p>View to the central portion of the western building at 32 Silverwater Rd.</p> <p>Some liquid chemicals remain at the property – including Perclean which uses Tetrachloroethylene (PCE) as the active ingredient.</p>

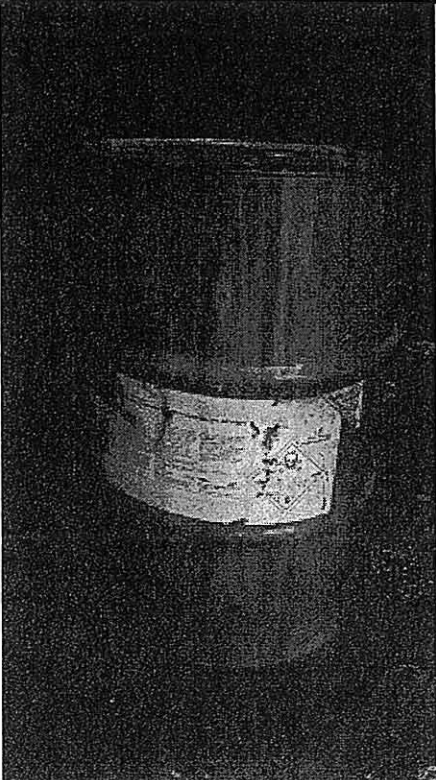
Photo No.	Date	Description	Image
6	15 October 2012	<p>Similarly to Photo 5 above, Photo 6 shows the view to the central portion of the western building at 32 Silverwater Rd.</p> <p>Some liquid chemicals remain at the property – including Perclean which uses Tetrachloroethylene (PCE) as the active ingredient.</p>
