Splendour in the Grass 2019

Traffic Evaluation Report

14 August 2019
Revision 0

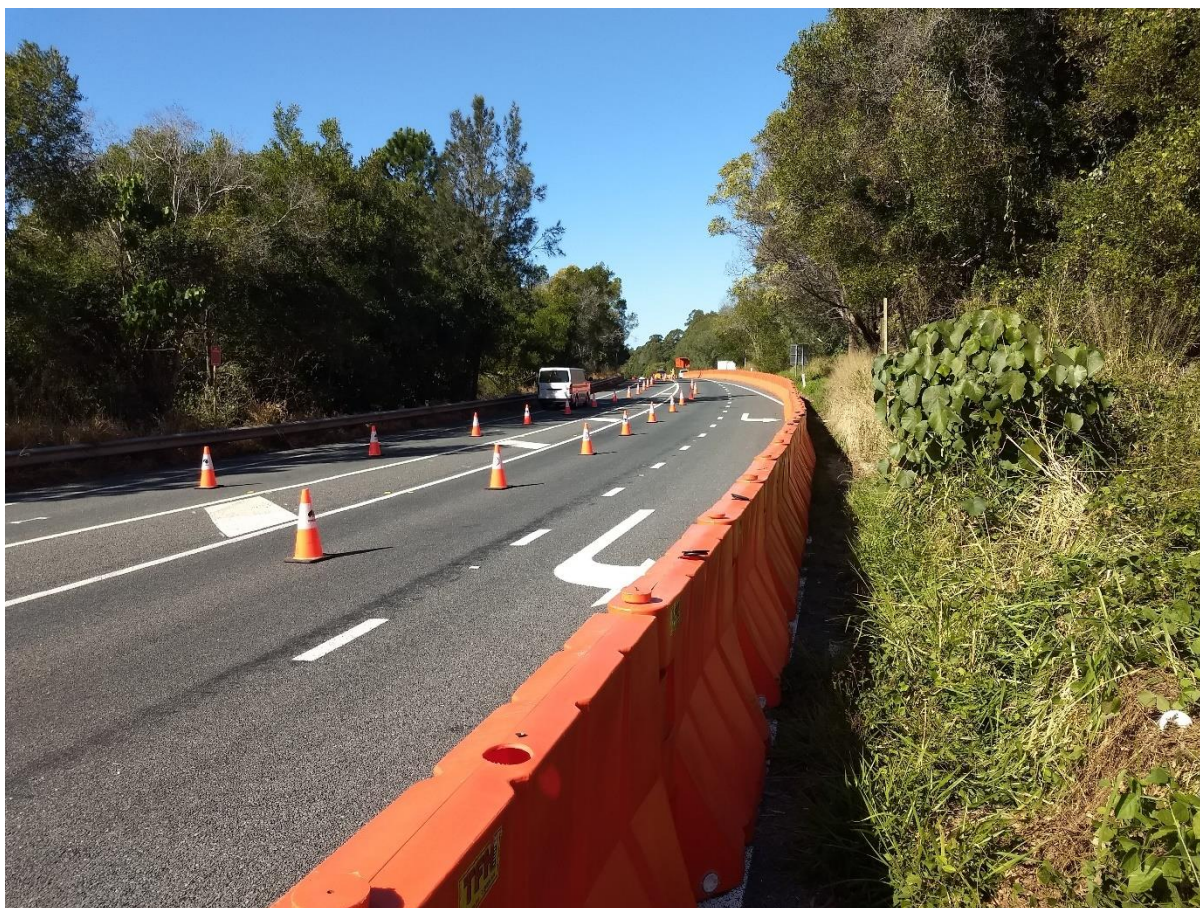
The camper arrival period started on Wednesday the 17th of July. The reduced speed zones on Brunswick Valley Way and the Yelgun Interchange were not implemented this day as no risk of congestion was expected. This way, the impact on through traffic was minimised. All the no-stopping zones were in place and all VMS boards were operating adequately. The delineated turning lanes at Gate D (Figure 2) were installed as per the approved drawings.

Figure 2 | Gate D channelization, looking south

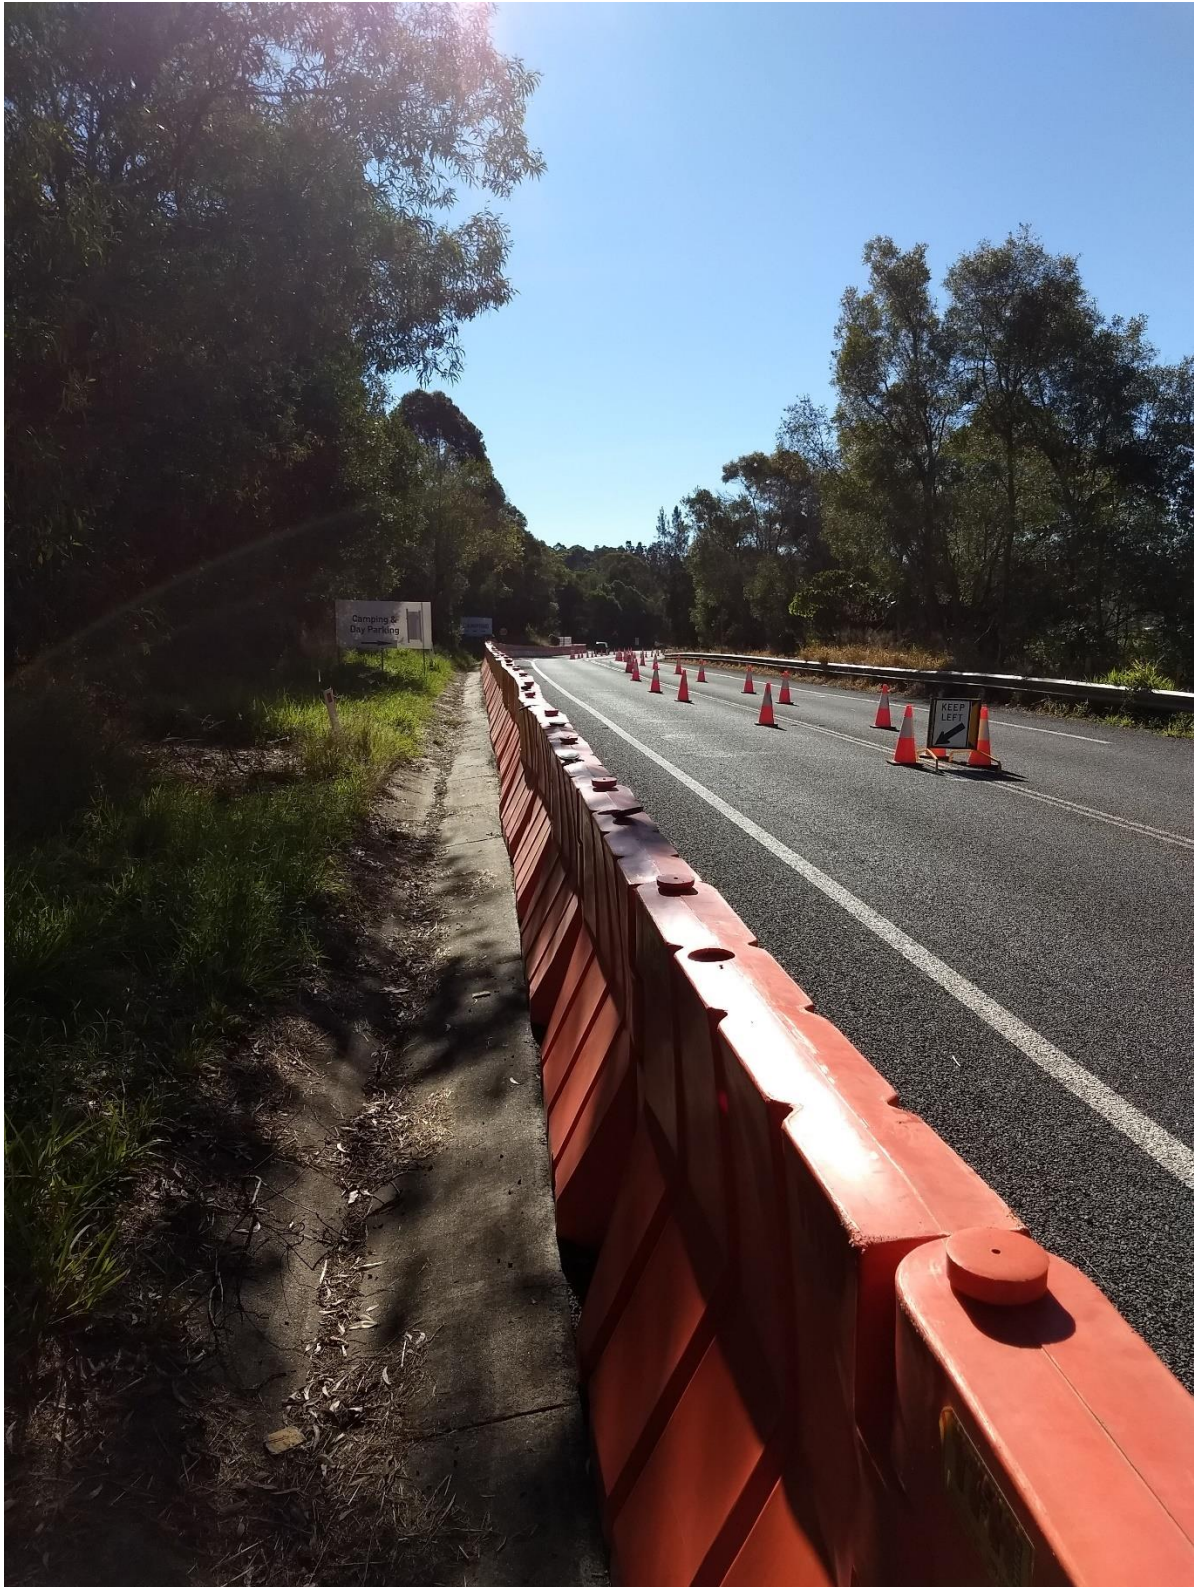
Gate D directional signage was installed in the morning, which helped with directing road users into the correct lane on approach to Gate D (Figure 3).

Figure 3 | Gate D approach looking north

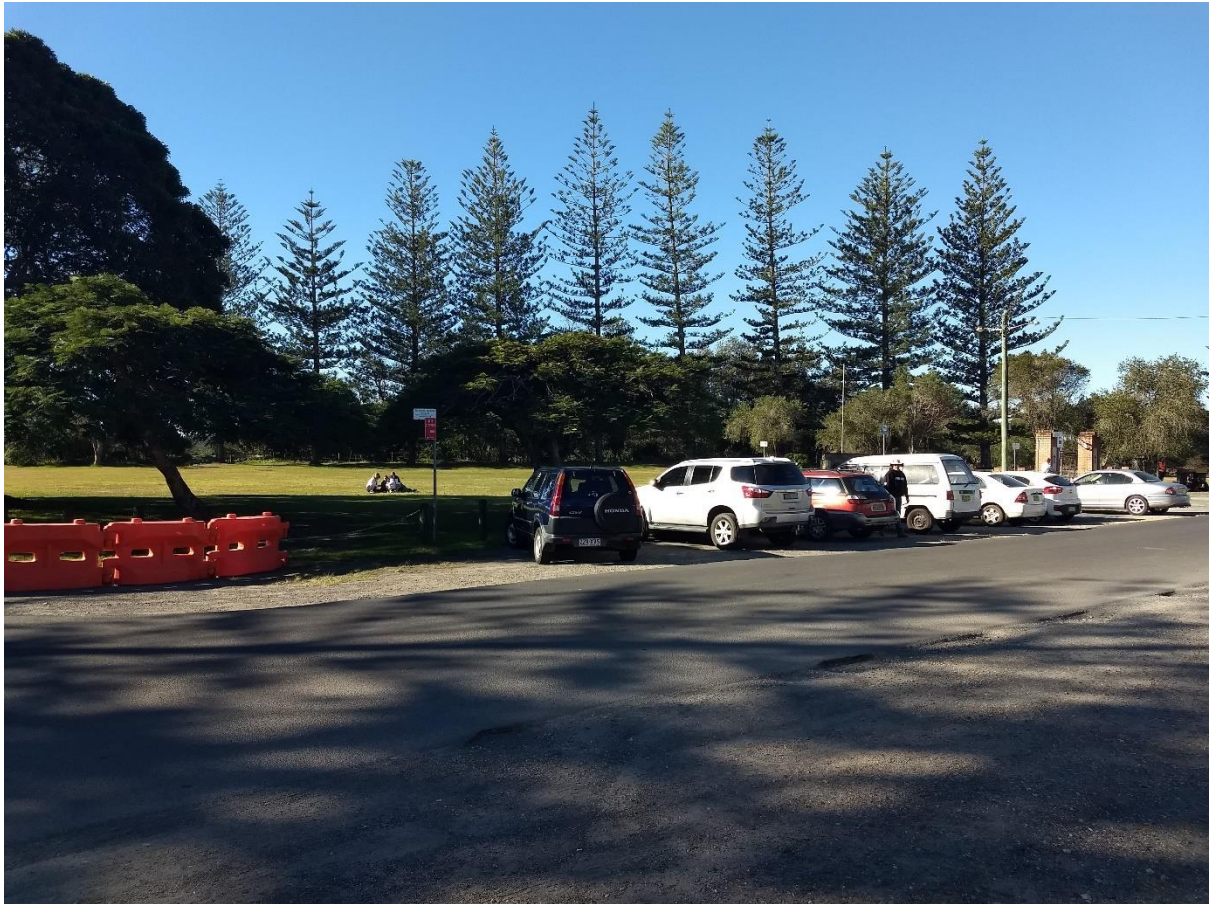
In the afternoon it was identified that the Brunswick Bus Bay was not setup up as per the approved plans, resulting in cars parking in the bus area (Figure 4). Festival management was notified and this was corrected by Friday.

Figure 4 | Cars parked in Brunswick Bus stop area

The Brunswick Bus Stop setup was much improved this day, but there continued to be issues with some vehicles parking in the bus stop area, forcing the buses to load and unload in front of the Memorial instead. This was all done safely and well managed by the staff on the ground.

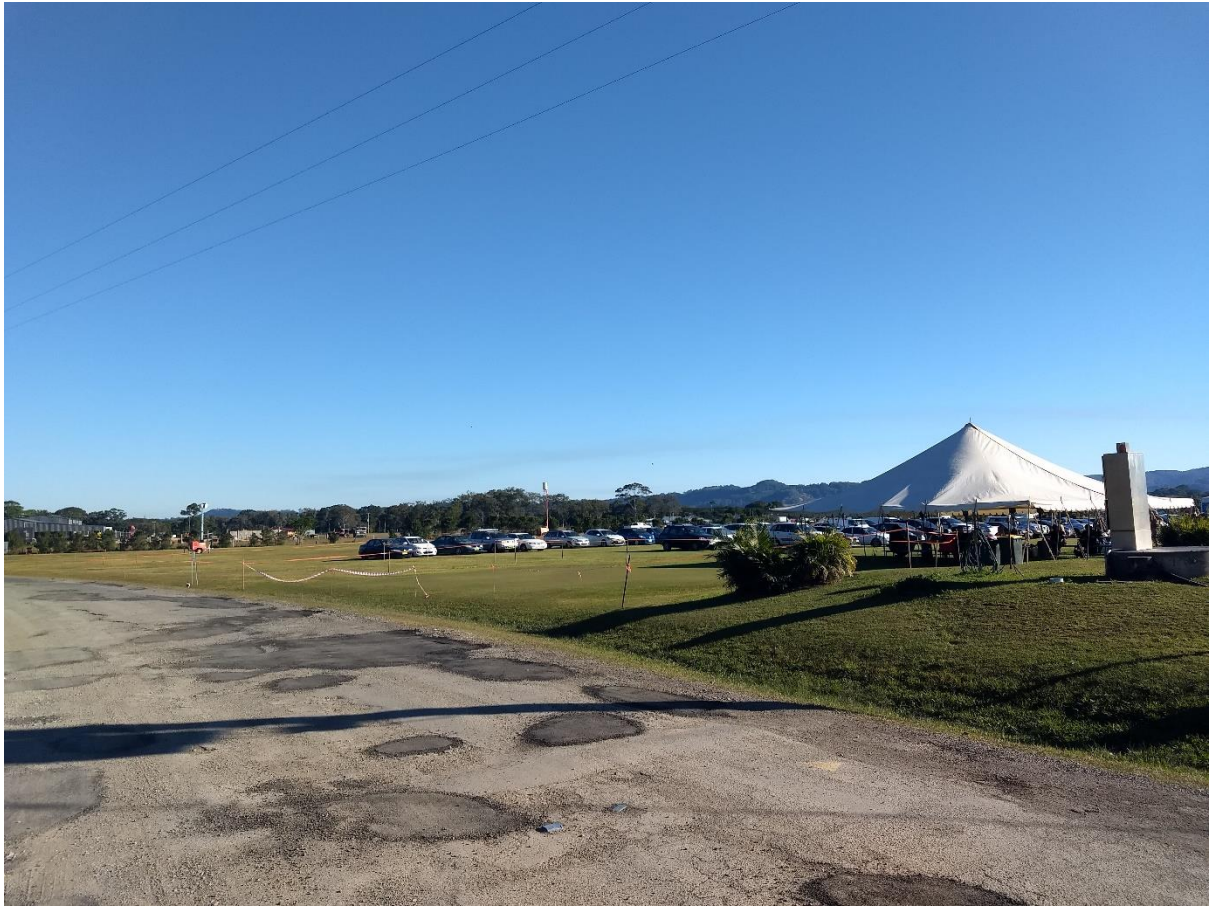
Mooball, Pottsville, Brunswick Heads and the Mullumbimby Leagues Club (Figure 5) were inspected several times on Thursday and no issues were observed. All the site gates were working well, and there was no congestion on the Spine Road. Border Control (Figure 6) worked well throughout the campers arrival period.

Figure 5 | Mullumbimby Leagues Club setup

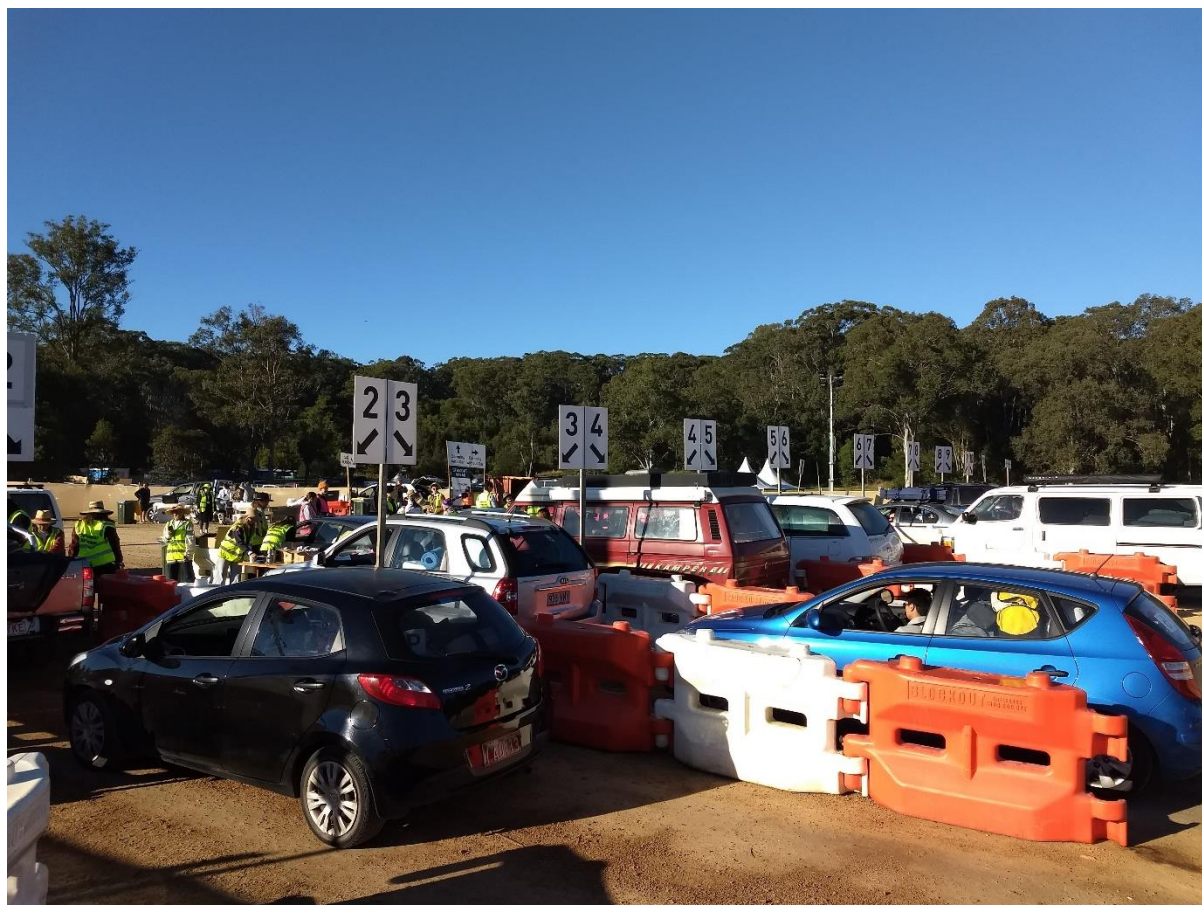
Figure 6 | Border Control in operation

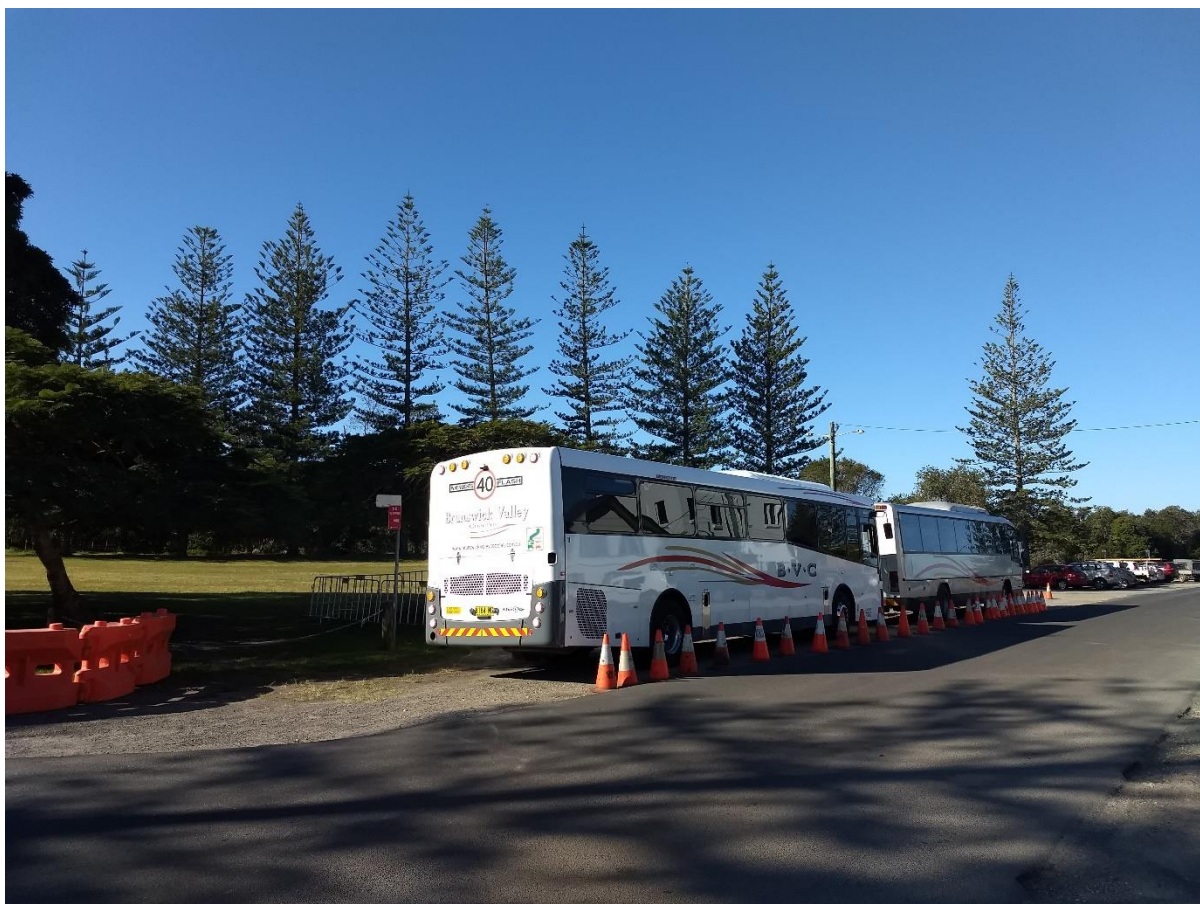
From Saturday onwards, the Brunswick Bus Bay worked well. There were no more issues of illegal parking due to the additional cones placed between the bitumen and the gravel bus area (Figure 7).

Figure 7 | Brunswick bus bay

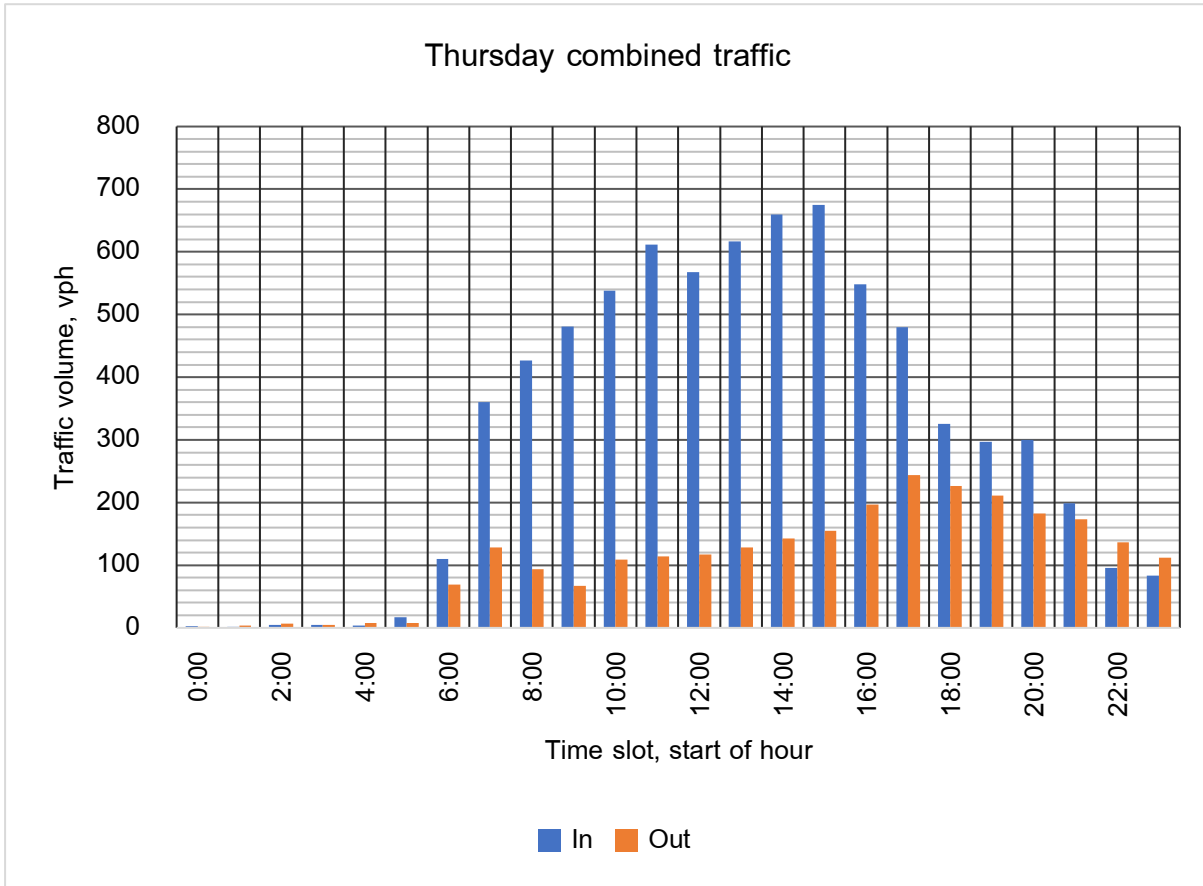
The graphs below depict the arrival and departure profiles per day, gate and direction as well as combined for all gates per day.
