Phase I Preliminary Site Investigation

27 Derriwong Rd, Dural NSW

27 Derriwong Rd, Dural

Report No: 9315 / PSI2 / v2 final

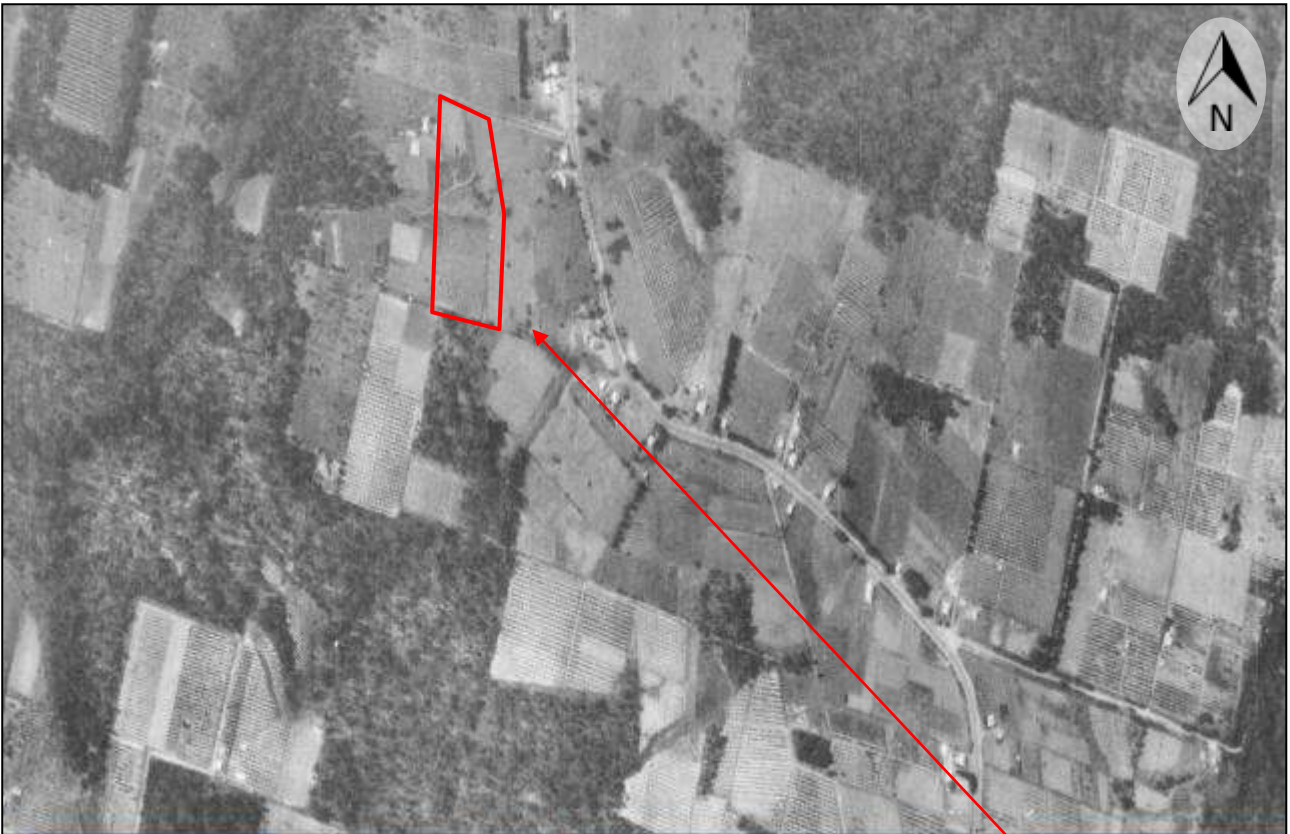
Aerial Photograph 1. Aerial photograph of the site dated 1930 with approximate site boundary. Sourced from the Department of Finance and Services records, accessed on the 20.07.2015.

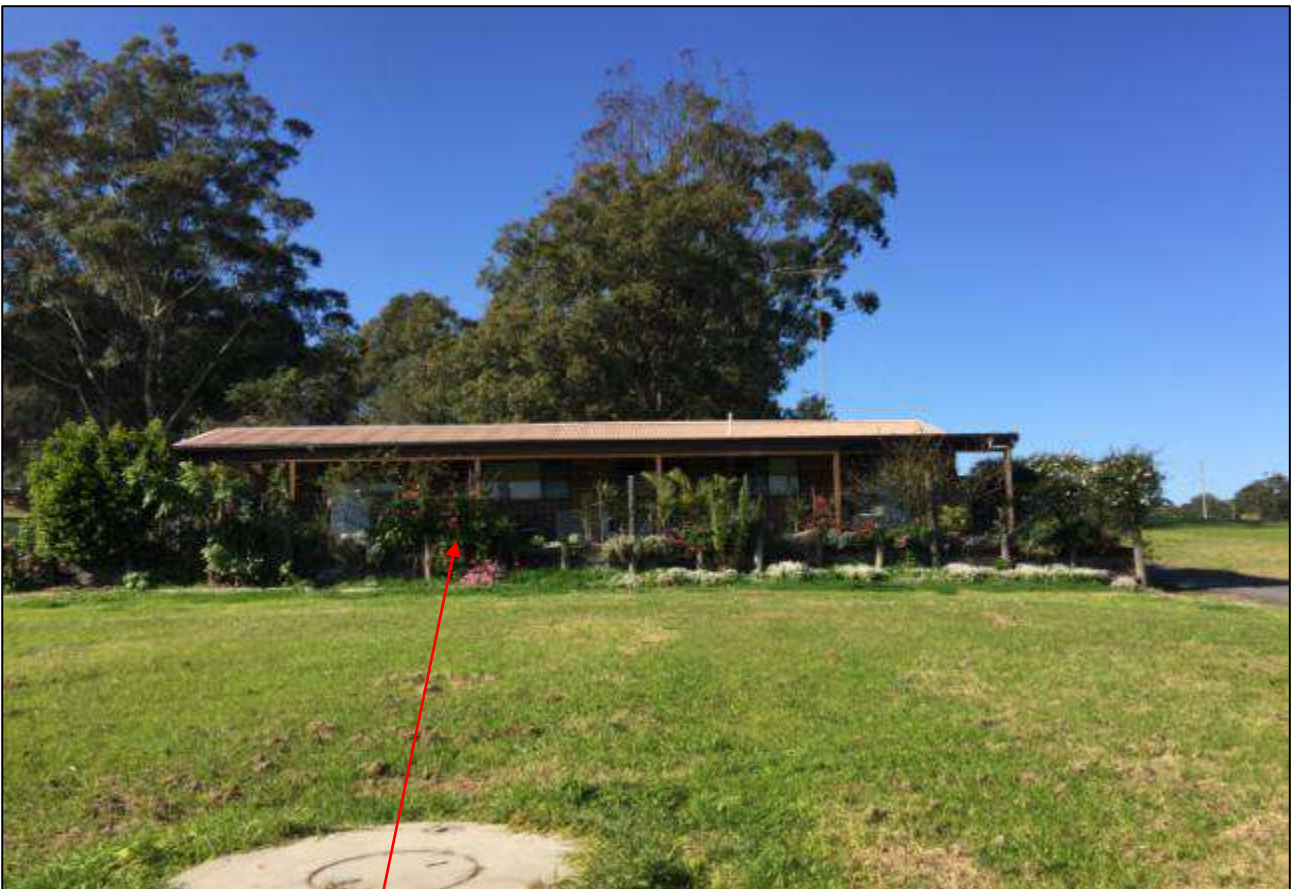
Photograph 2 – Residential house in the south-eastern corner of the site

Due to the age and design of the site there is the potential for asbestos containing materials to be present in the building fabric. A hazardous materials survey should be undertaken prior to any demolition practices being undertaken. All hazardous materials are to be removed by a suitably qualified contractor prior to demolition of the house. Prior to disposal offsite, building rubble present on the northern boundary of the site should be inspected for potential asbestos contamination.

- Based on the age of the house there is the potential for asbestos materials to be present within the building fabric of the house. A hazardous materials survey should be undertaken prior to any demolition practices being undertaken and recommendations adhered; and

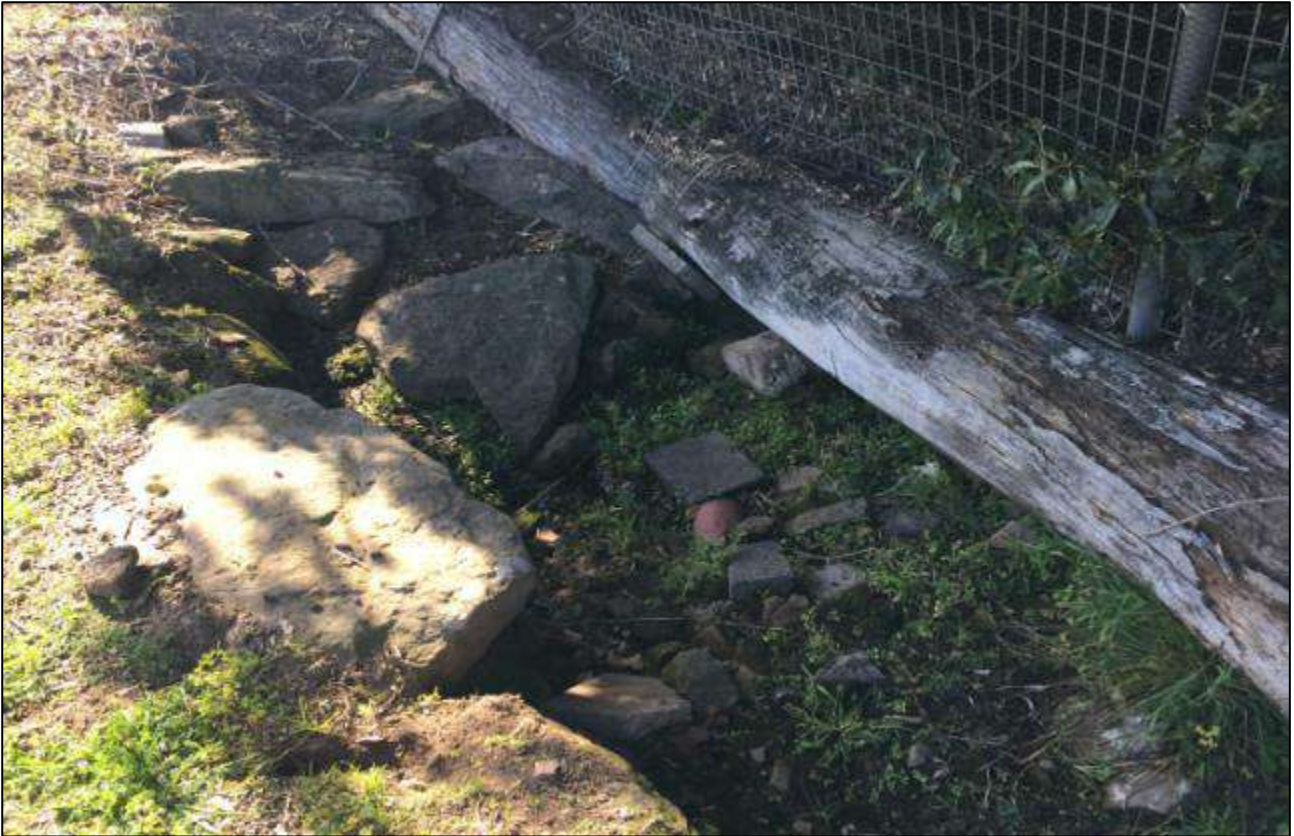
Photograph 3 – Small water outlet on the eastern boundary of the site which feeds into the “drainage line” dissecting the site.

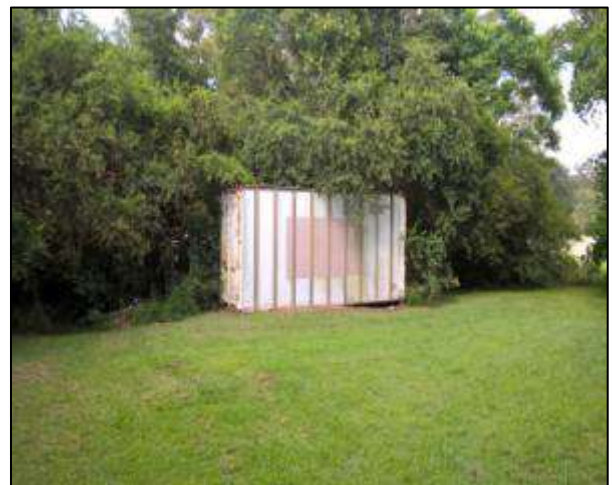
Photograph 6 – Shipping container in backyard, observed to store documents

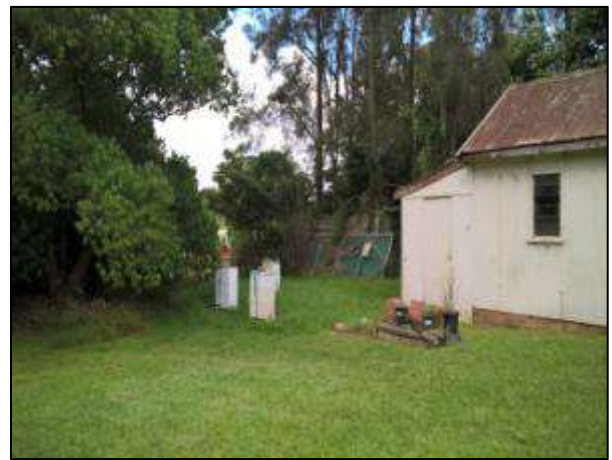
Photograph 10 – North-western corner of subject site with small amounts of household rubbish observed.

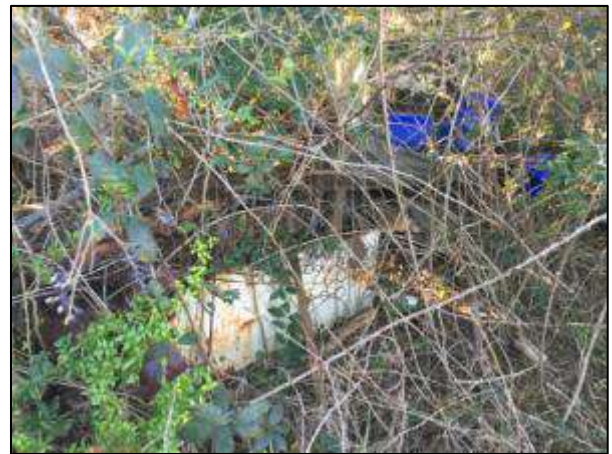
Photograph 5 – Chlorine and chemical storage containers observed associated with rubbish.

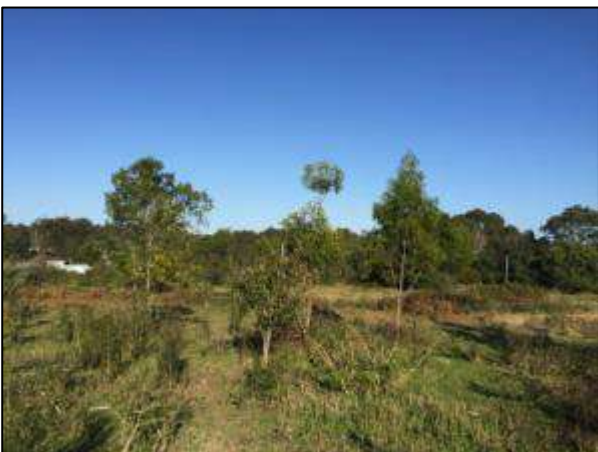
Photograph 3 – Regrowth across area of former market garden
