SITE INSPECTION NOTES

Project	Dendrobium Extension project (SSD-8194)
Meeting Location	Bluescope Port Kembla, Mine expansion site and surrounds - as per inspection map included as Attachment A
Date	24 November 2020
Time	8.00 am– 5.30pm

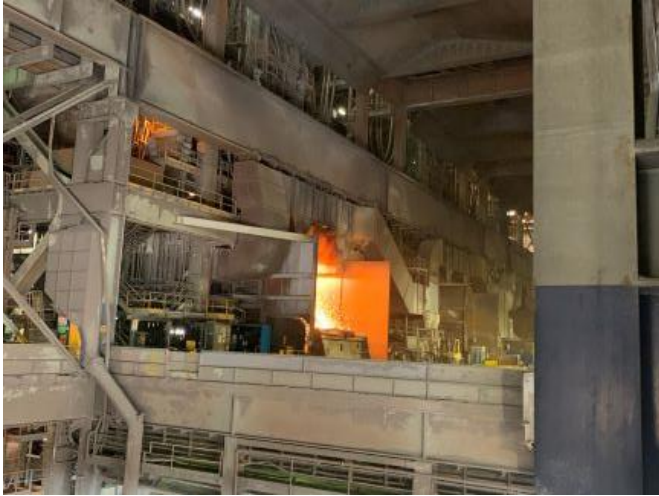
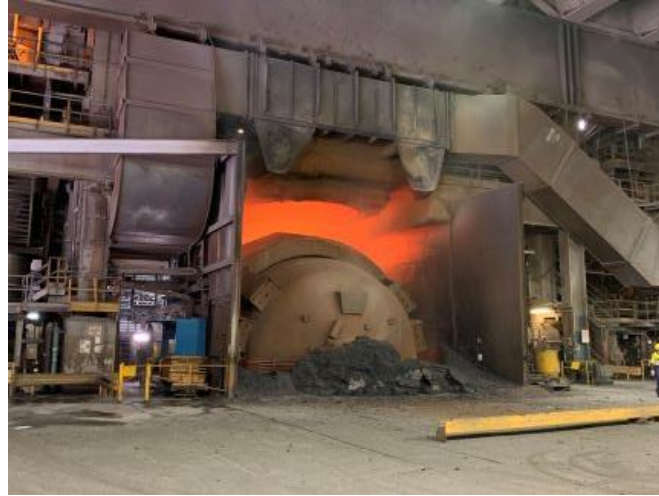
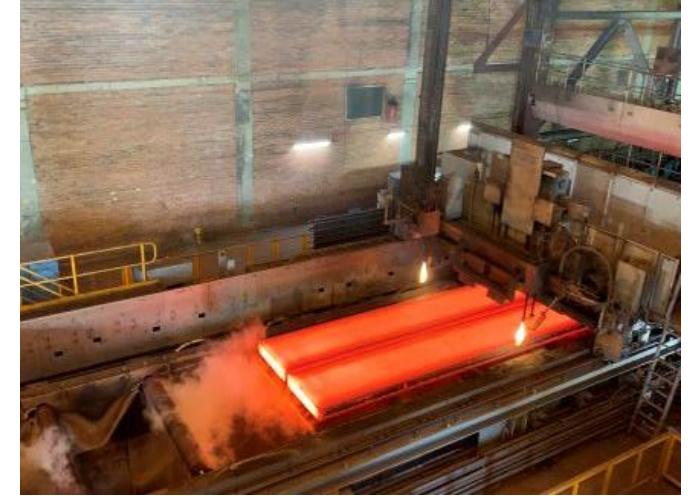
Stop 1 – Bluescope

- Opening Statement and Introductions
- Safety induction and overview of the Steelworks Visit
- Escorted bus tour of the Steelworks
- Escorted visit to Blast Furnace No.5 and control room

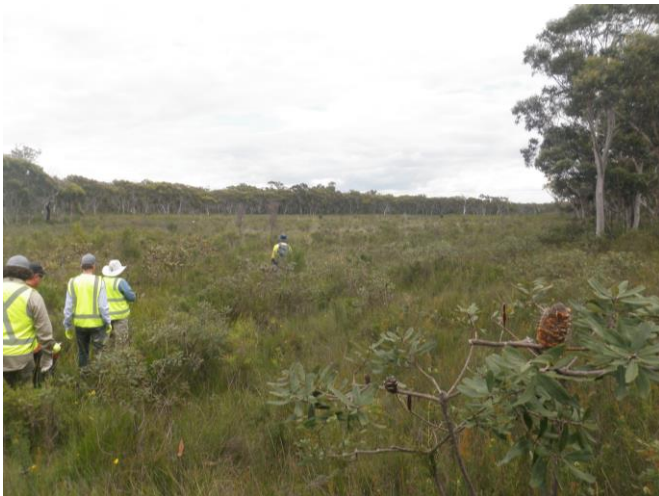
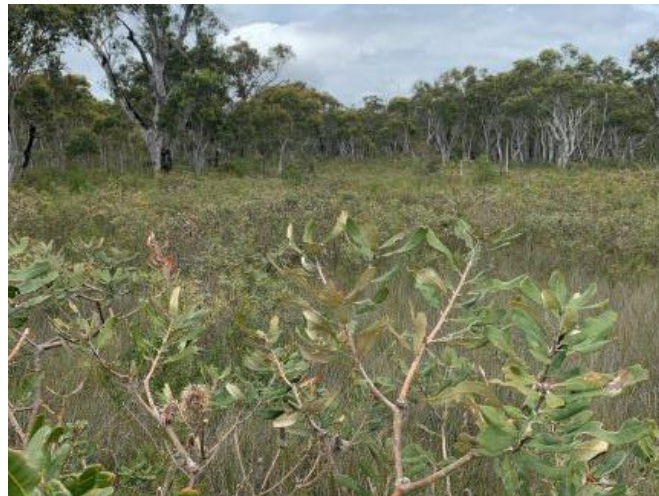
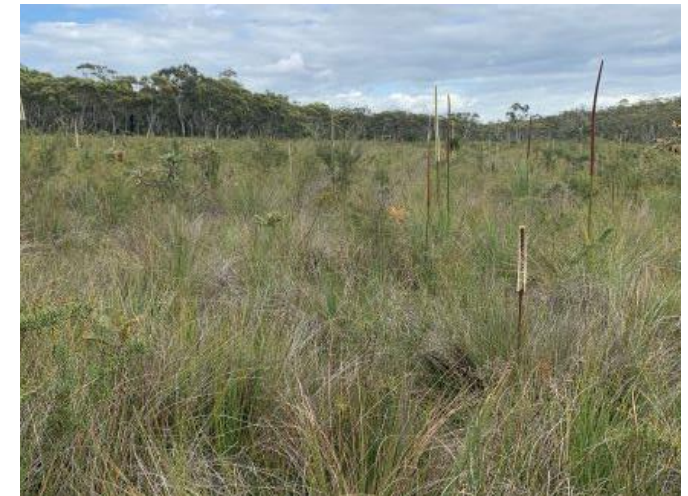
Stop 2 – Swamp APP07 (Area 4)

- Upland swamp, located near the Illawarra Escarpment (high rainfall area: 1,500mm - 2,000mm per annum)
- Location of Cordeaux Mine longwalls in 1990s
- The area has subsided by 1-2 metres
- Lower area has a higher water table with wet areas and grassy vegetation
The surrounding drier ridges contain trees

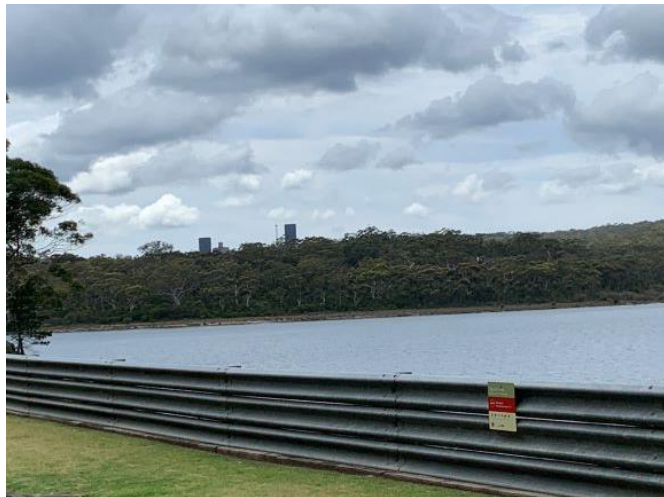
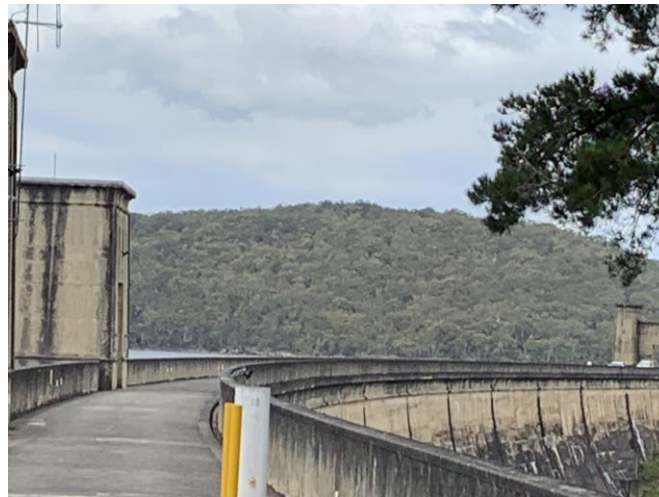
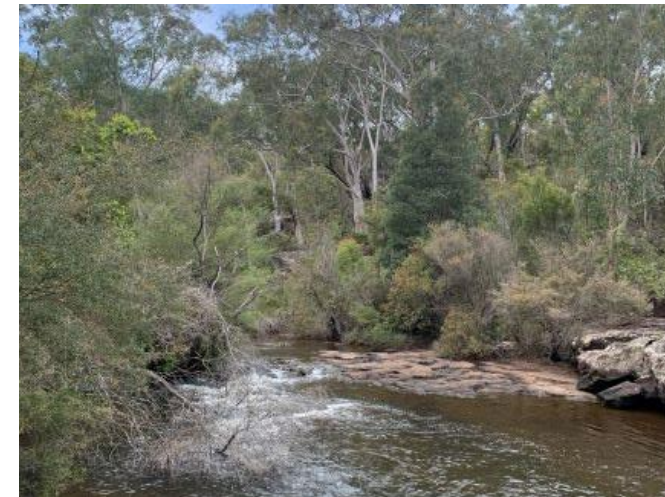
Enroute to Stop 3 – Cordeaux Dam and Cordeaux River

- Drive-by visit only of Cordeaux Dam wall on way to Stop 3
- Entered WaterNSW Metropolitan Special Area through locked gates
- Crossed Cordeaux River, Wongawilli Creek and Donalds Castle Creek
- Previously mined area (Longwall 9 in 2013 and Longwall 10 in 2014)
- The swamp experiences a faster rate of water recession after rain (pre-mining vs post mining)
- Fracturing of rock is greater
- Vegetation observed was grasses, banksia and hakea
- The swamp was observed to be relatively dry
- Applicant discussed a 2:1 offset site negotiated at Maddens Plain

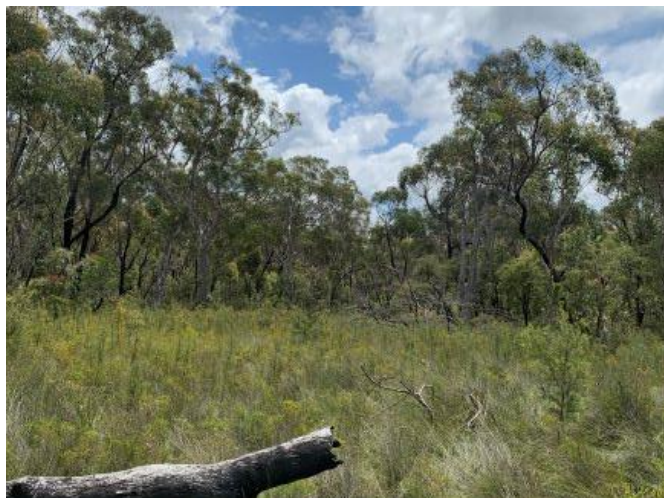
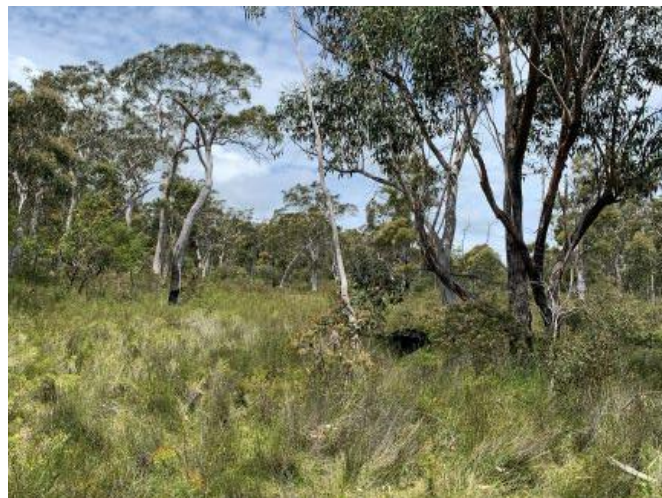
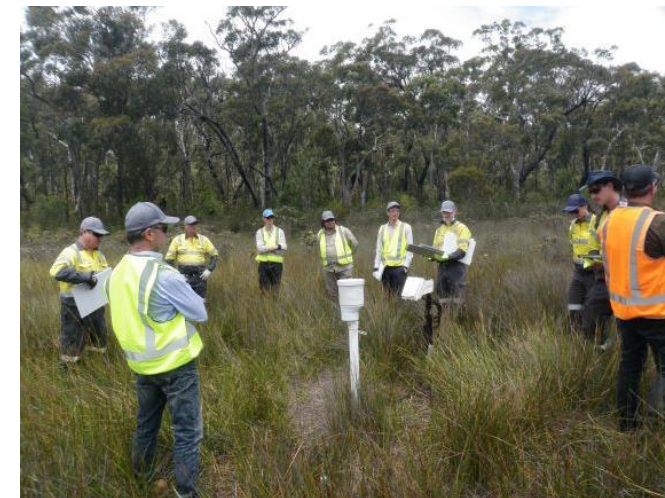
Stop 4 - Swamp 99 (Area 5)

- Observed mature eucalypts and more flowers
- The swamp was observed to contain moisture in the soil
- The site is further from the Illawarra Escarpment, hence receives less rainfall

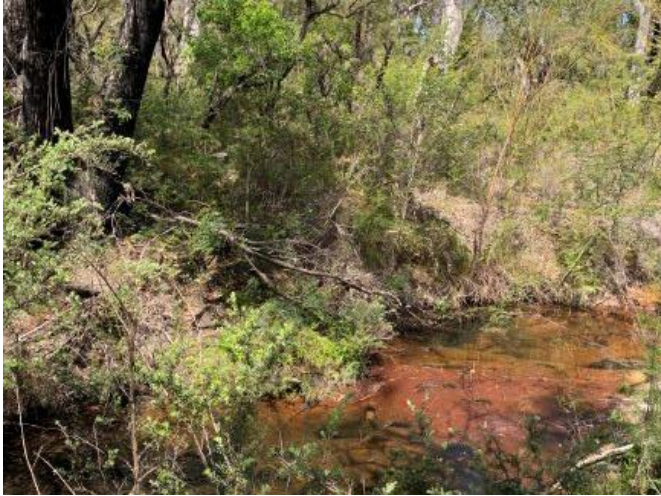
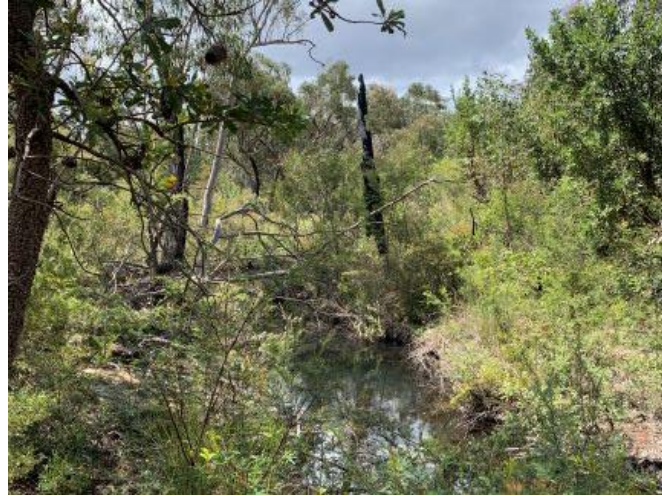
Stop 5 – Key Stream Feature Pool 63 (Area 6)

- The pool is located in a flowing, unnamed stream
- Pool size is in the order of 135m³
- Criteria have been developed to determine key stream features

- A 100 metre longwall mining buffer is proposed on either side of this key stream feature
- The stream would be impacted upstream when mining (predicted to reduce flow)
- Remediation of stream features has been undertaken in other mine impacted areas through grouting

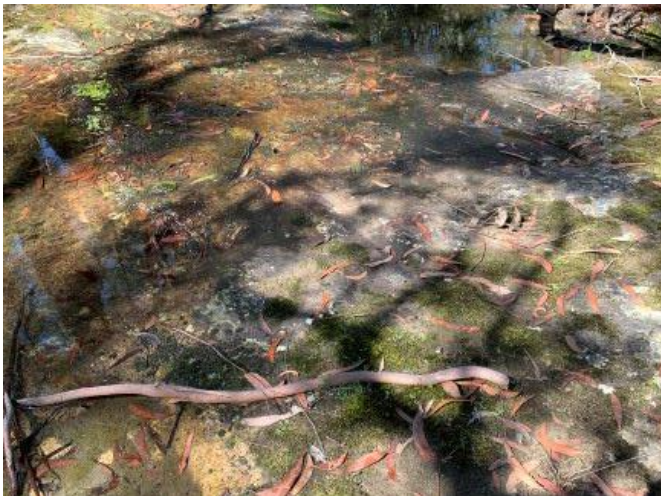
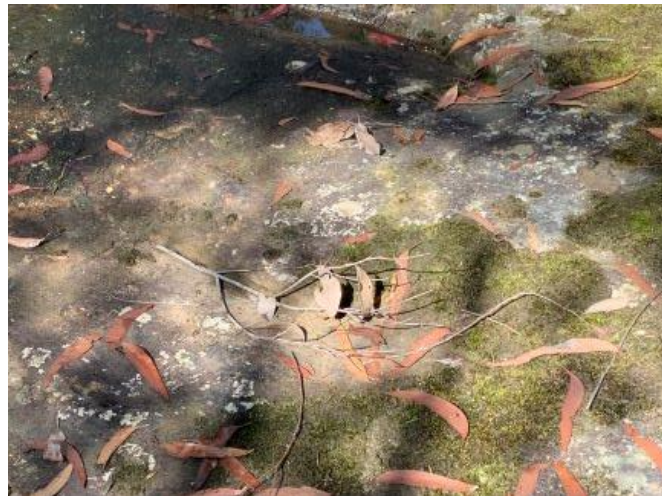
Stop 6 – Nearby Grinding Grooves (ACHA # 52-2-1566)

- The 28.5 hectares area is located at the junction of Roads 6 and 6A
- Site clearing of 15 hectares is proposed
- All surface activities are to be consolidated in one place
- At this location service boreholes would be created to allow materials to be placed into the mine
- The applicant will transfer 28.5 hectares of land to WaterNSW as an offset
- Walked to Donalds Castle Creek Grinding Grooves (ACHA Site # 52-2-1566). Longwall mining is proposed beneath the site hence it may be impacted
- Potential for loss of water in the Creek has implications for grinding grooves site even if they are not impacted by fracturing
