Report on
Preliminary Stability Assessment

Proposed Memorial Park
167 – 177 St Andrews Road, Varroville

Prepared for
Catholic Metropolitan Cemeteries Trust

Project 73732.01
March 2017

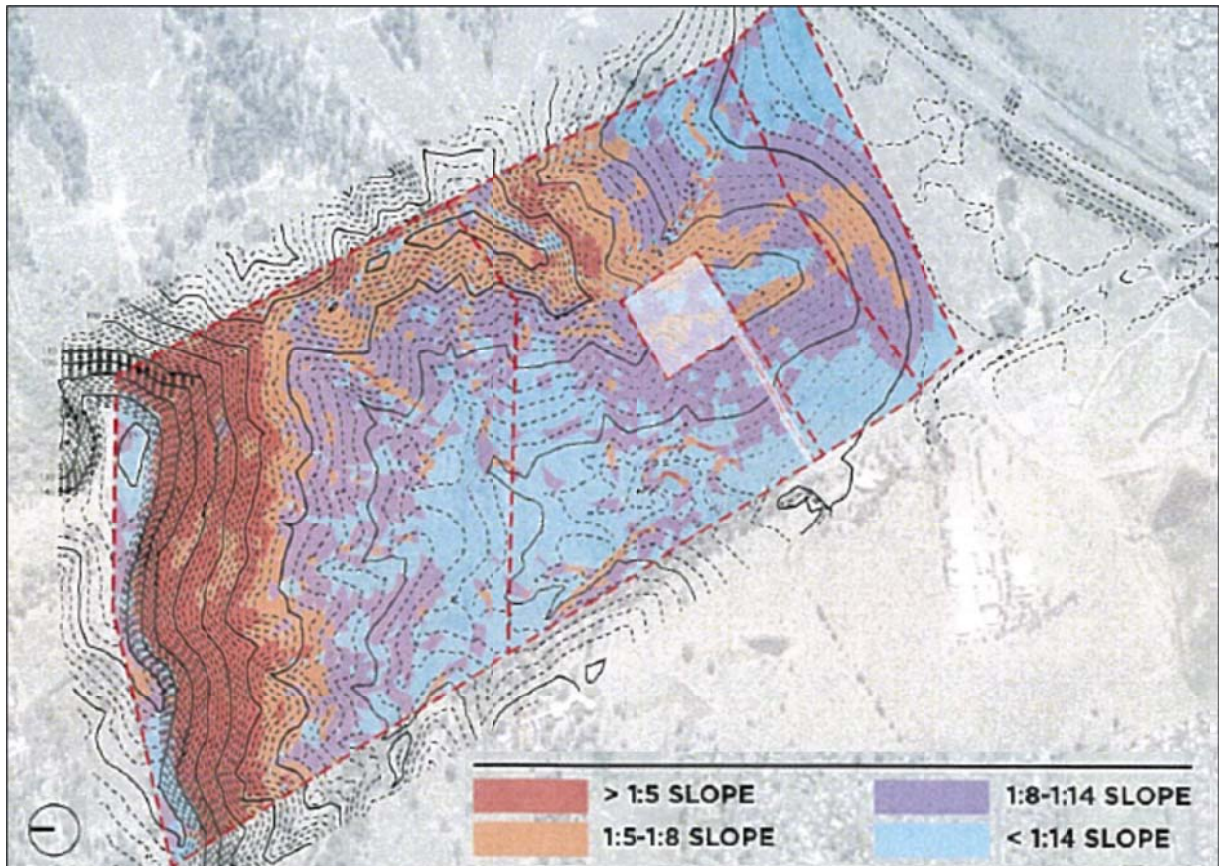
Figure 1 – Site contours (extract from Macarthur Memorial Park Masterplan)

The latter provided the site contour map (Figure 1) and the location of proposed structures within the site. The site contour map suggests the natural batter grade across the majority of the site is relatively flat or gently inclined with slopes between 10 – 12%. The Masterplan, indicates the general topographical features of the site (eg. existing ground slopes, dams, vegetation, etc) will be kept during the site development.
