Presentation to Independent Planning Commission

Hills of Gold Wind Farm

February 2, 2024

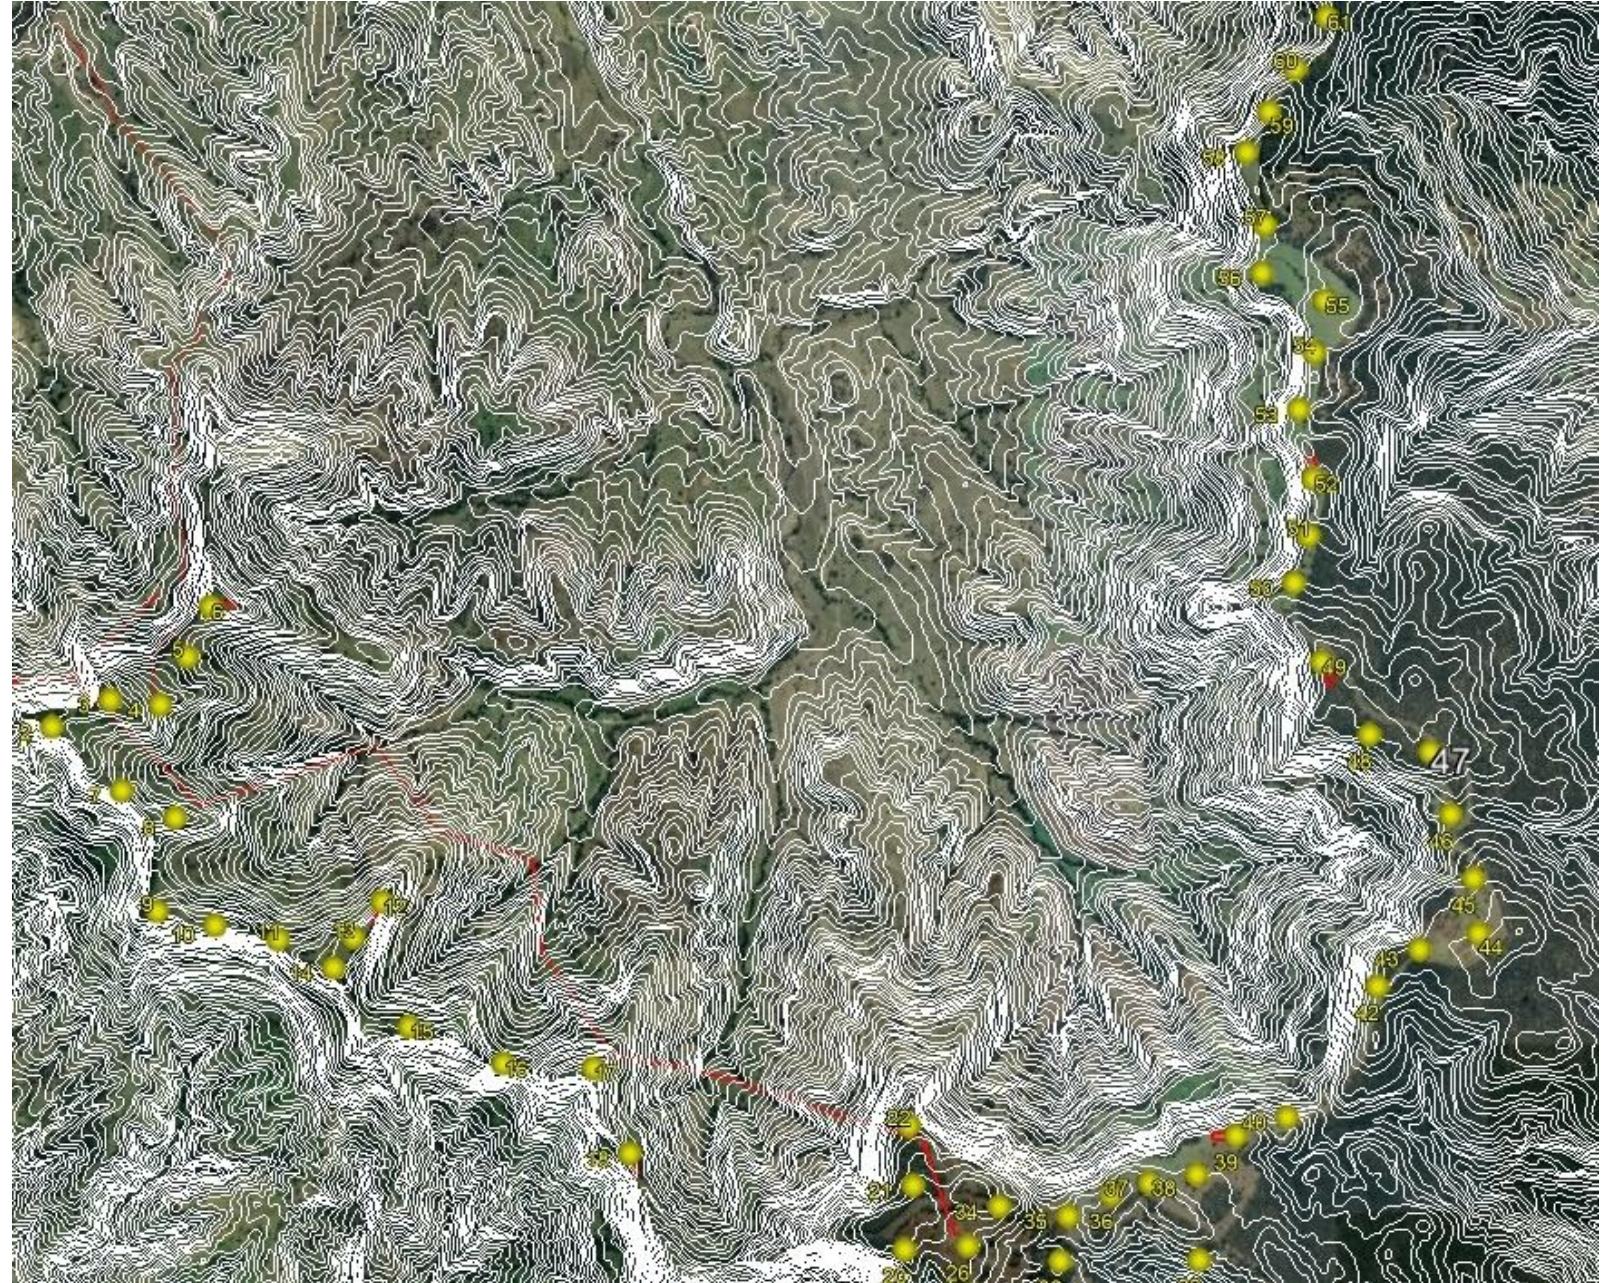
- Extreme slope gradients
- 24 WTGs proposed within 10-30 metres of the escarpment edge - no room for 100 metres of micro sighting
- The initial drop of the 1st order stream south of WTG2 falls 60 metres in 35 metres.
- The 1st order stream west of WTG42 falls 490m in 1400m.
- WTG6 sits on a 10-15m wide ridge which drops 90m in 150m.

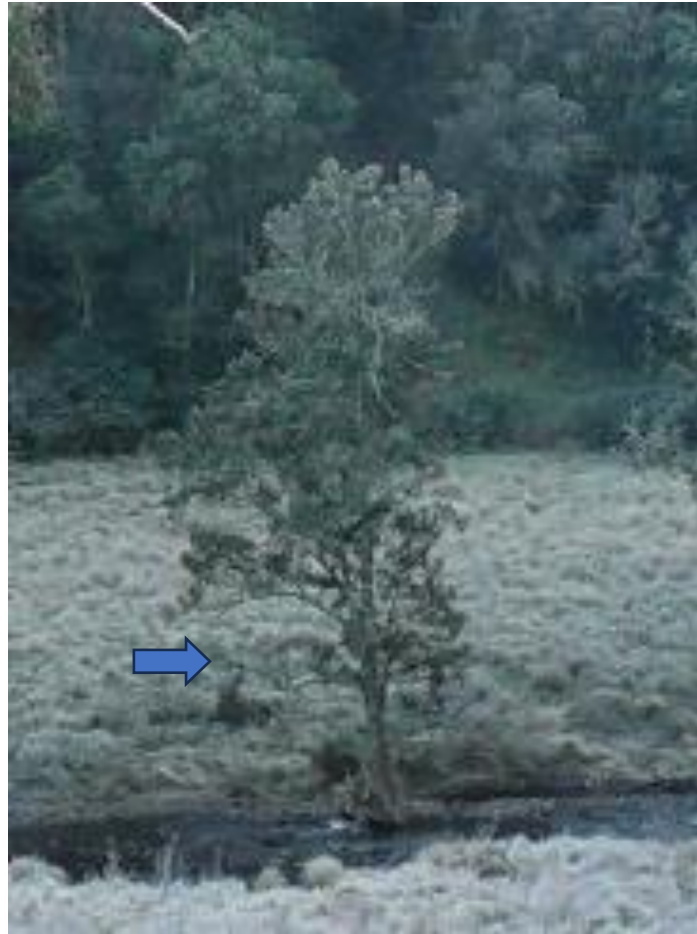
Barnard River Flood January 2, 2010

Illustration of the volume and velocity of runoff from the tops between Hanging Rock and Crawney Pass
Eastern fall and western fall streams experience the same conditions

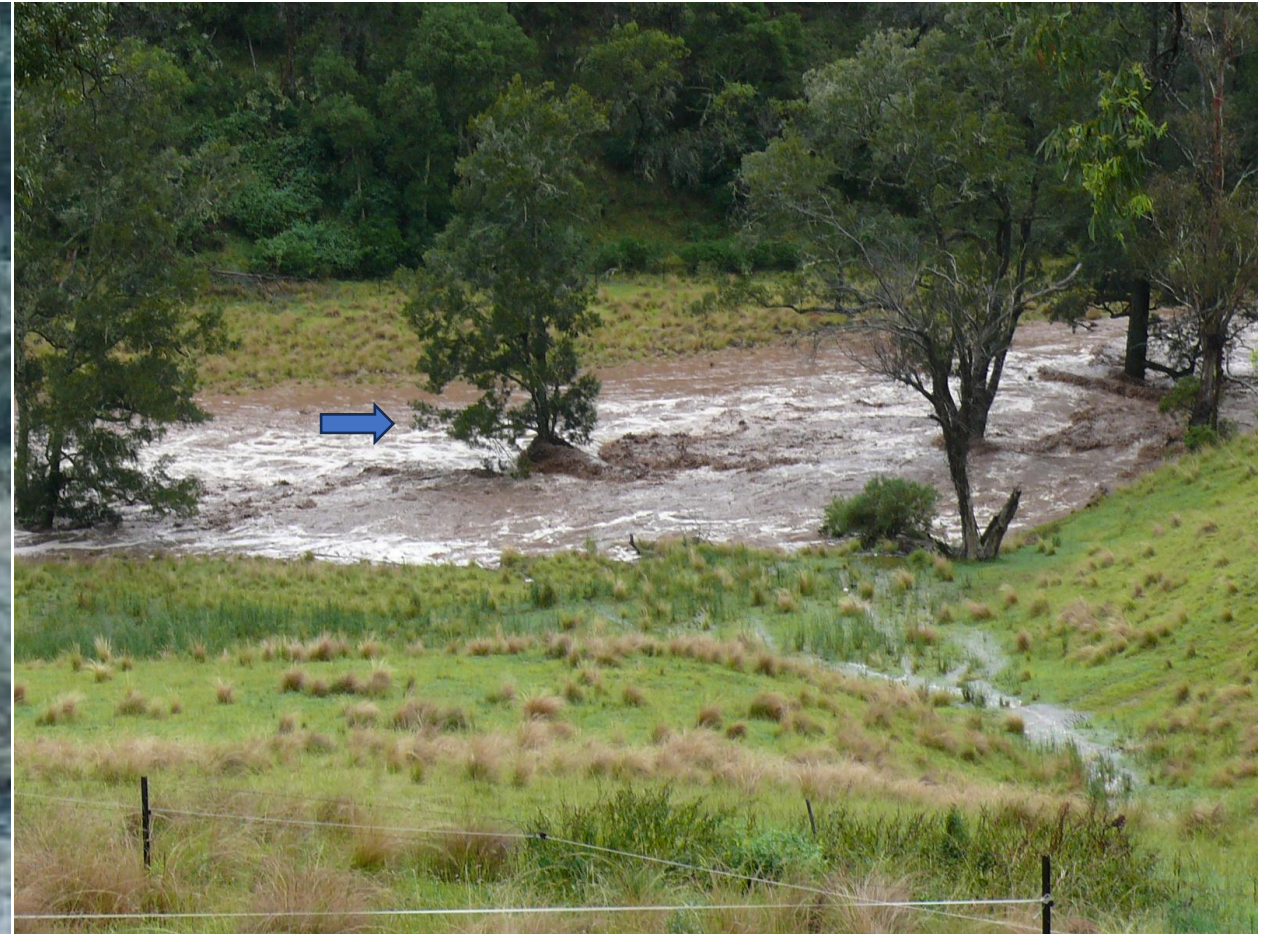
The Barnard River at normal flow level

The Barnard River, same location, January 2, 2010, after 40 minutes of rain which dropped 74mm at that location (850m)
Note the lowest lateral branch on the left. At this point a 4th order stream

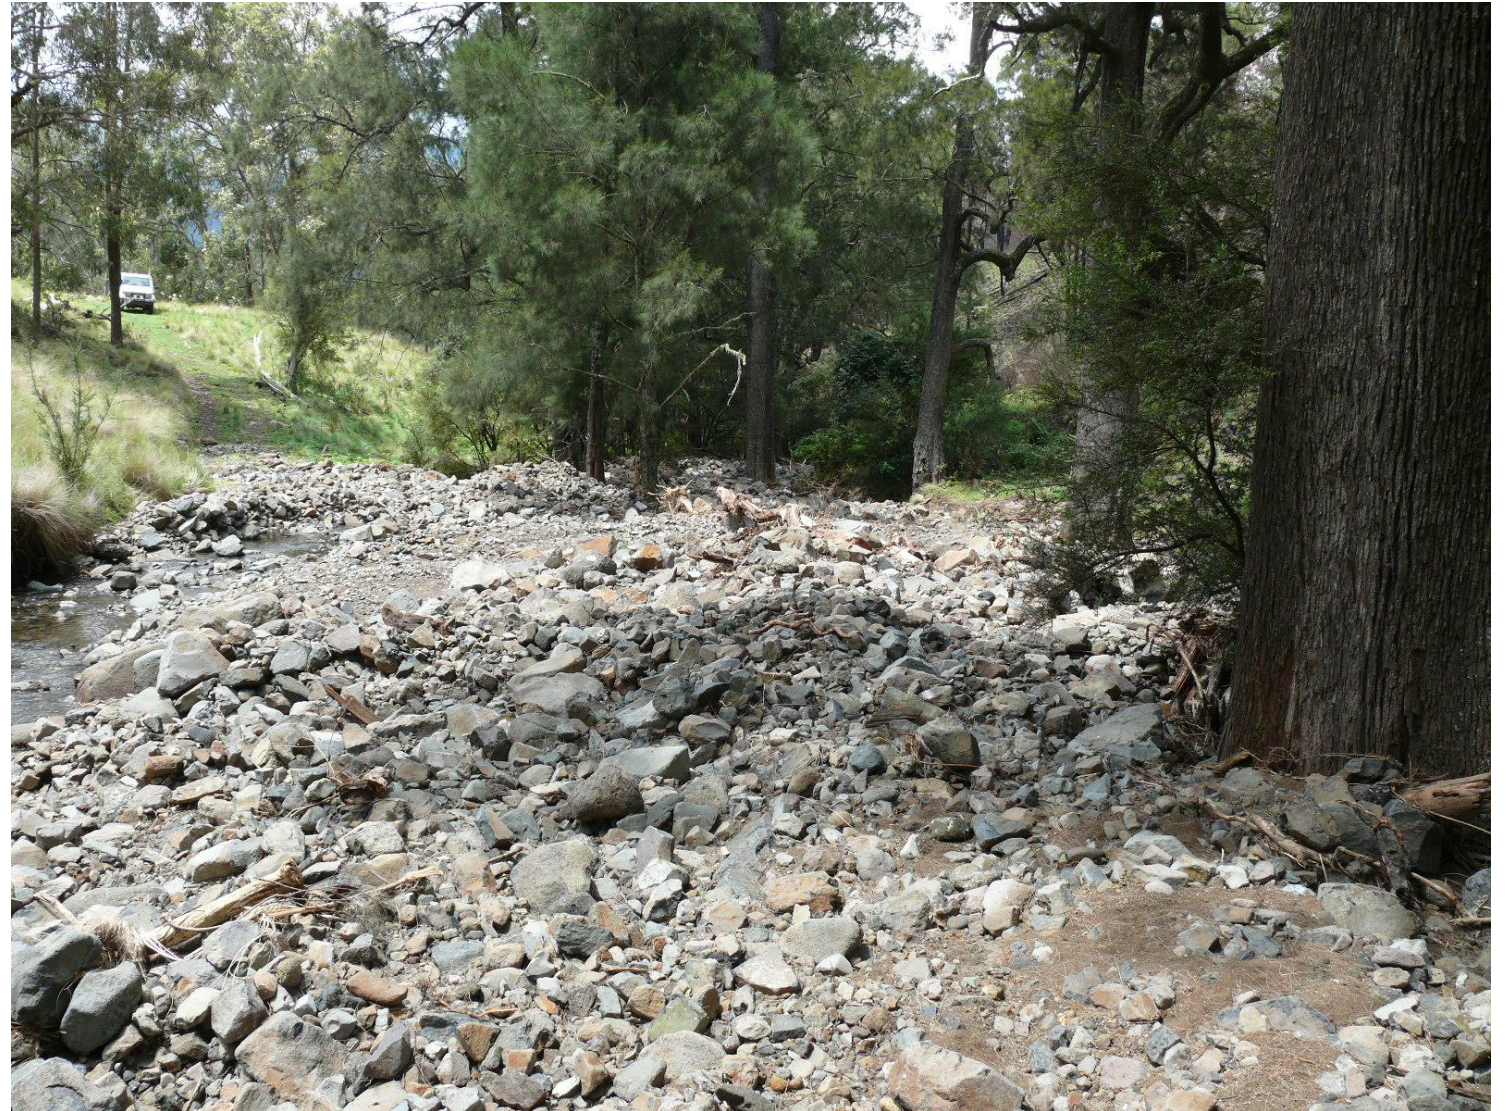
Flood debris in 2nd order stream after January 2, 2010, flood on internal farm track following 40 minutes of rain which dropped 74mm at 850m. This location is 1050m with a fall of 300m in 2000m. Judging by the erosion at 1250m with a fall of 100m in 1000m the rainfall at the top of the stream would have been considerably more than 74mm

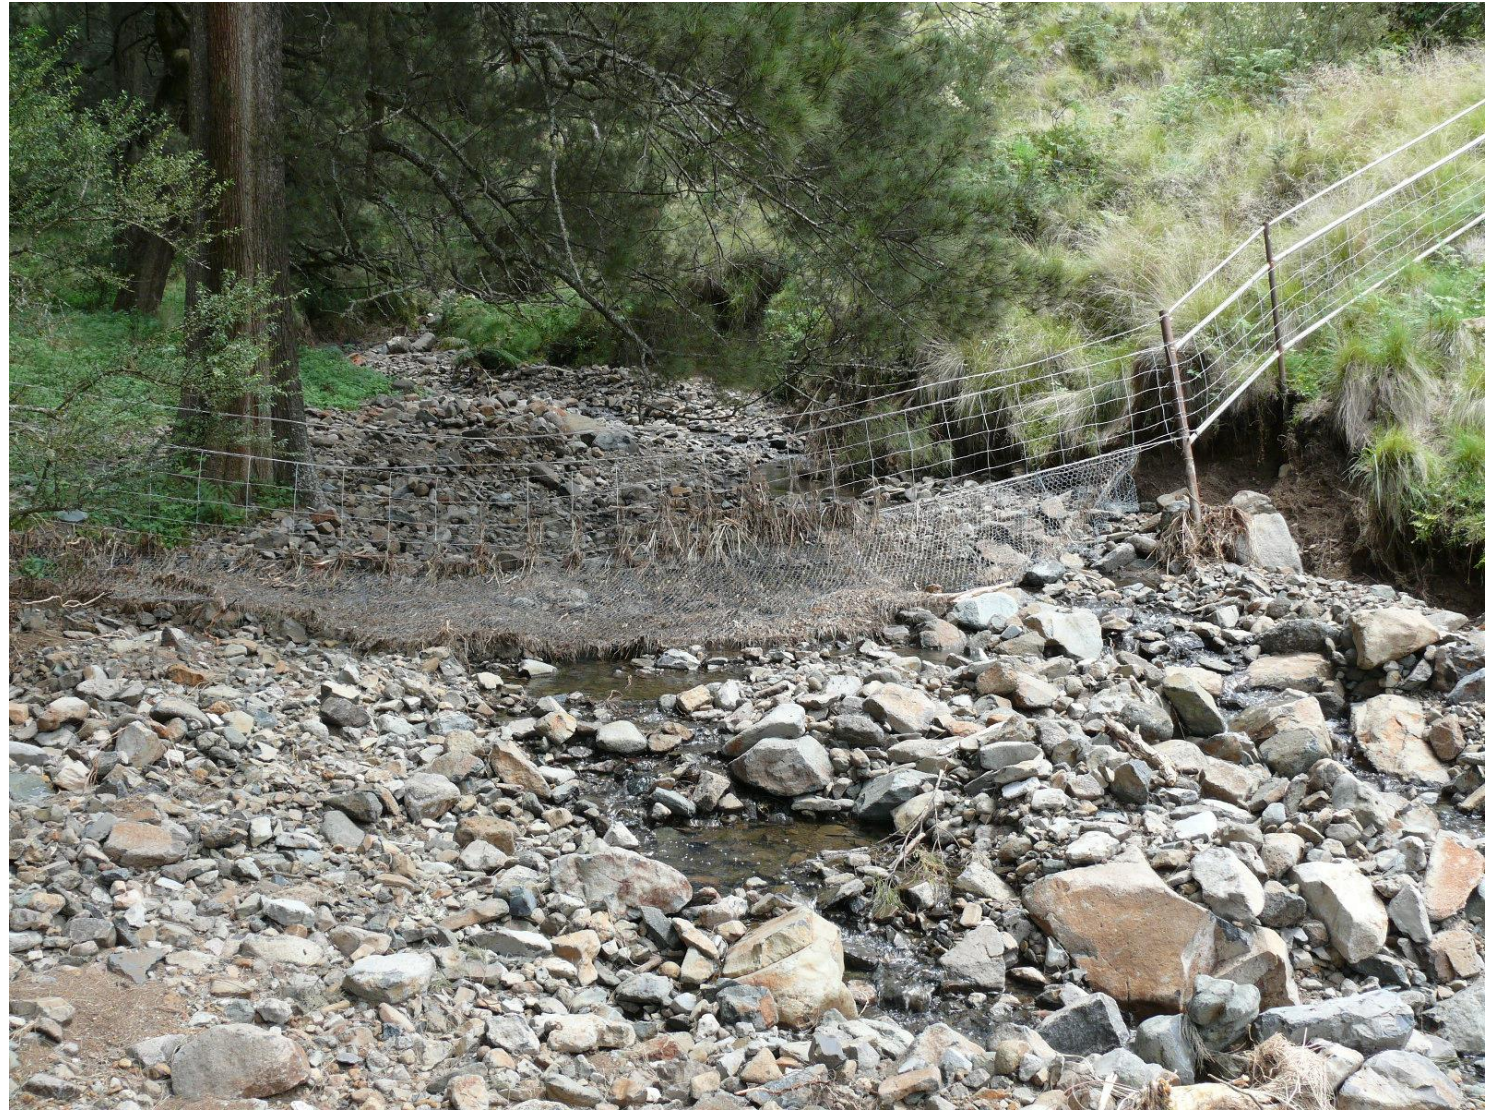
Erosion and flood debris after January 2, 2010, flood in 2nd order stream before joining Brayshaws Creek. At this point the creek drops 300 metres in 2,000 metres. Judging by the erosion at 1250m with a fall of 100m in 1000m the rainfall at the top of the stream would have been considerably more than 74mm

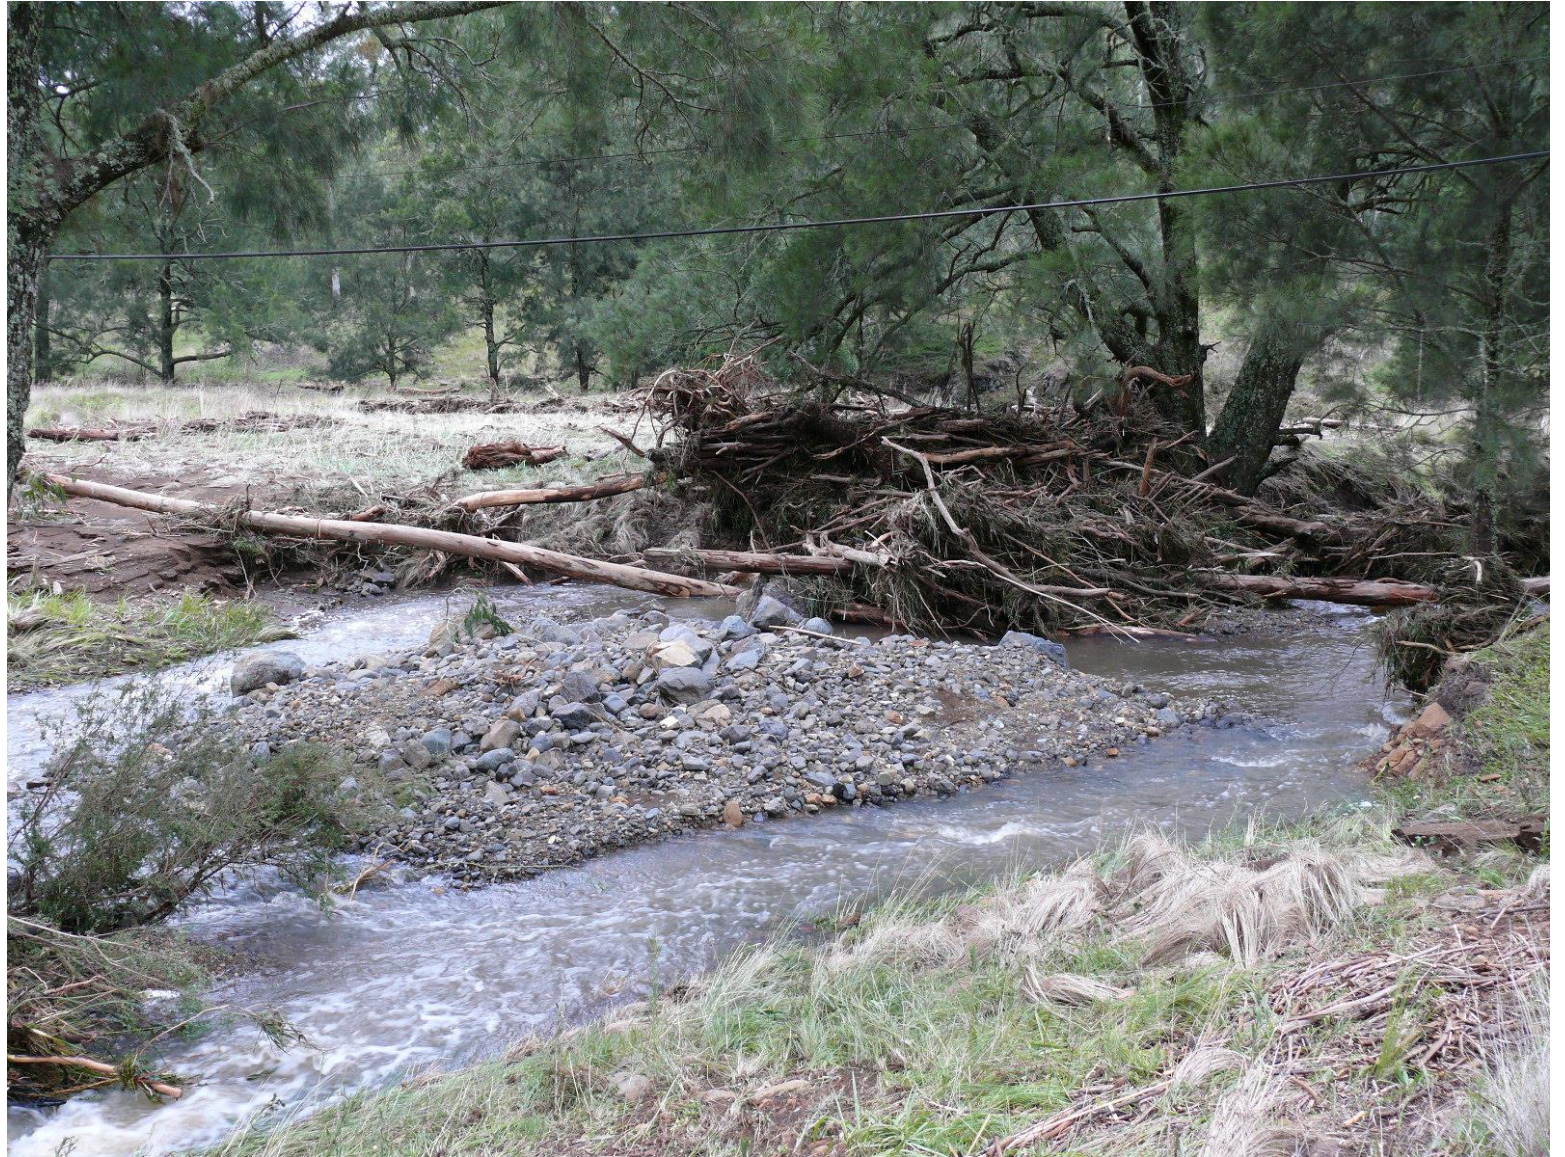
Flood debris on Shearers Road Stockyard Creek culvert after January 2, 2010 flood
Stockyard Creek is a 3rd order stream
