1.0 SSHEG Review of Major Community Concern

SSHEG Document 2010 Blast Gassing Extracts

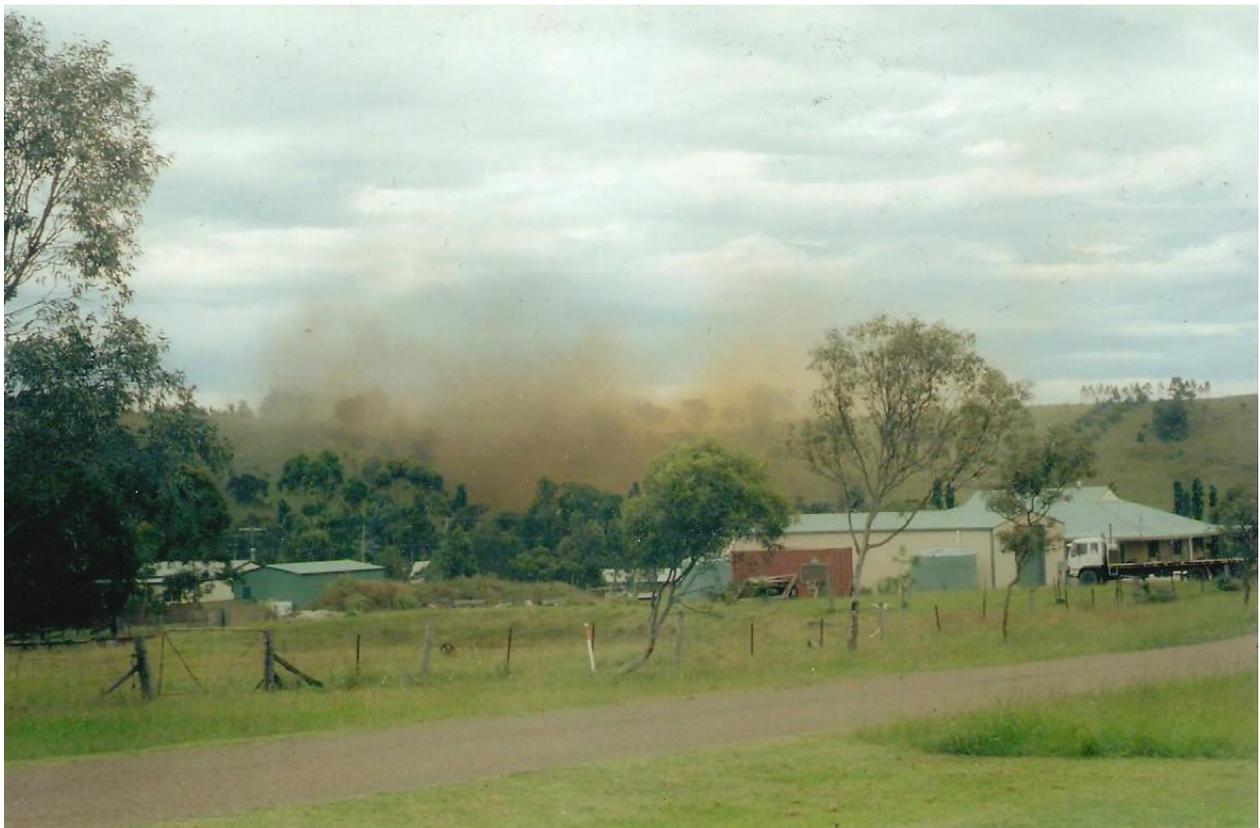
Photo 1 ***Camberwell Gassing Incident 2010 type viewing West***
Mine Blast over the Ridge is sucked down to Glennies Creek
and drifts over Camberwell Residents in Bridge Street

It is surprising that the Authorities did not prohibit the Blasting in the entire period 2004 to 2010 that allowed the Blast Plumes to descend onto the Camberwell Residents; in this case at the Glennies Creek end of Dawson Street within 500 metres of Aston Mine over the Ridge to the west in Photo 1.

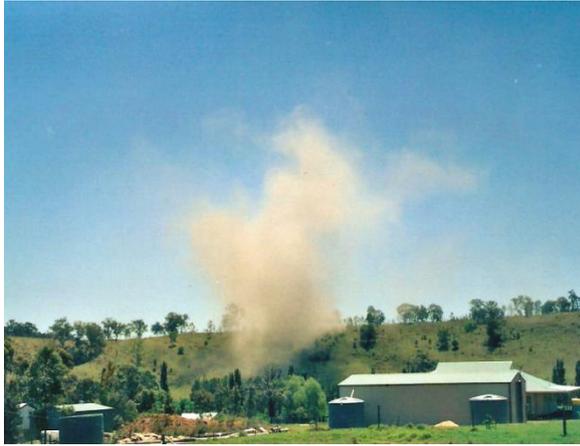
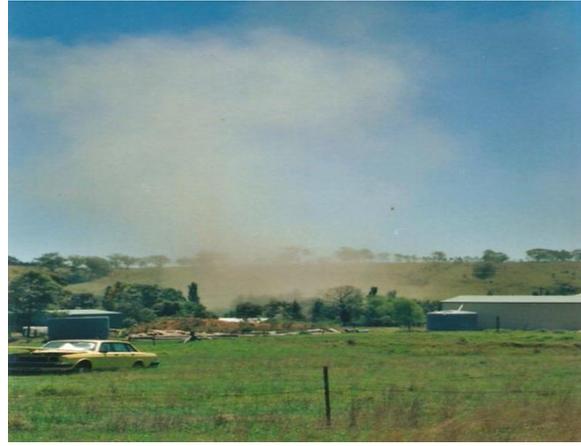
Blast Plume sucked down slope to Glennies Creek Slow dissipation over Camberwell

Camberwell Gassing Incident 2004 Lethridge St. area viewing North

The drifting of Blast Plumes in 2004 identified to the Aston Mining Company and the Authorities that the Plumes instead of rising and dissipating, were sucked over the ridge and down into the creek gully where it lingered and spread over the Residents of Lethridge Street as in Photos 2 & 3. A different Blast Plume drifting pattern also in 2004 is shown in Photos 4 & 5.

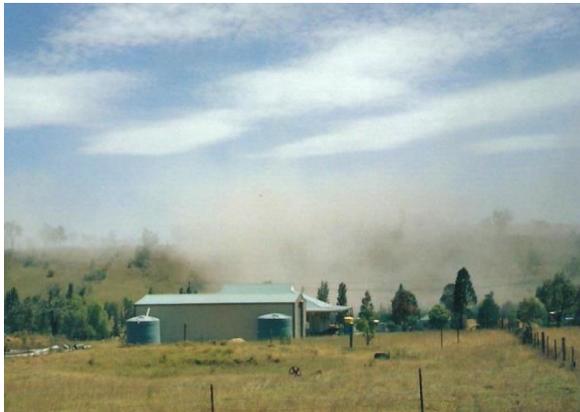
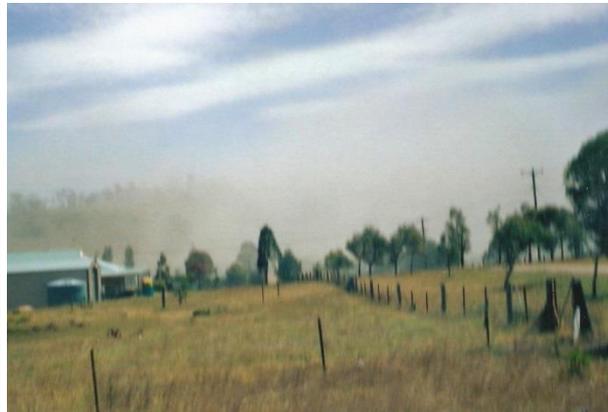
Blast Plume drifting at ground level over Camberwell Village Residents in 2004
