Integrated Water Cycle Management Strategy, Mixed Use Urban Development at West Culburra, NSW

Prepared for Sealark Pty Ltd

Report No: 1203365JR07

17 November 2020

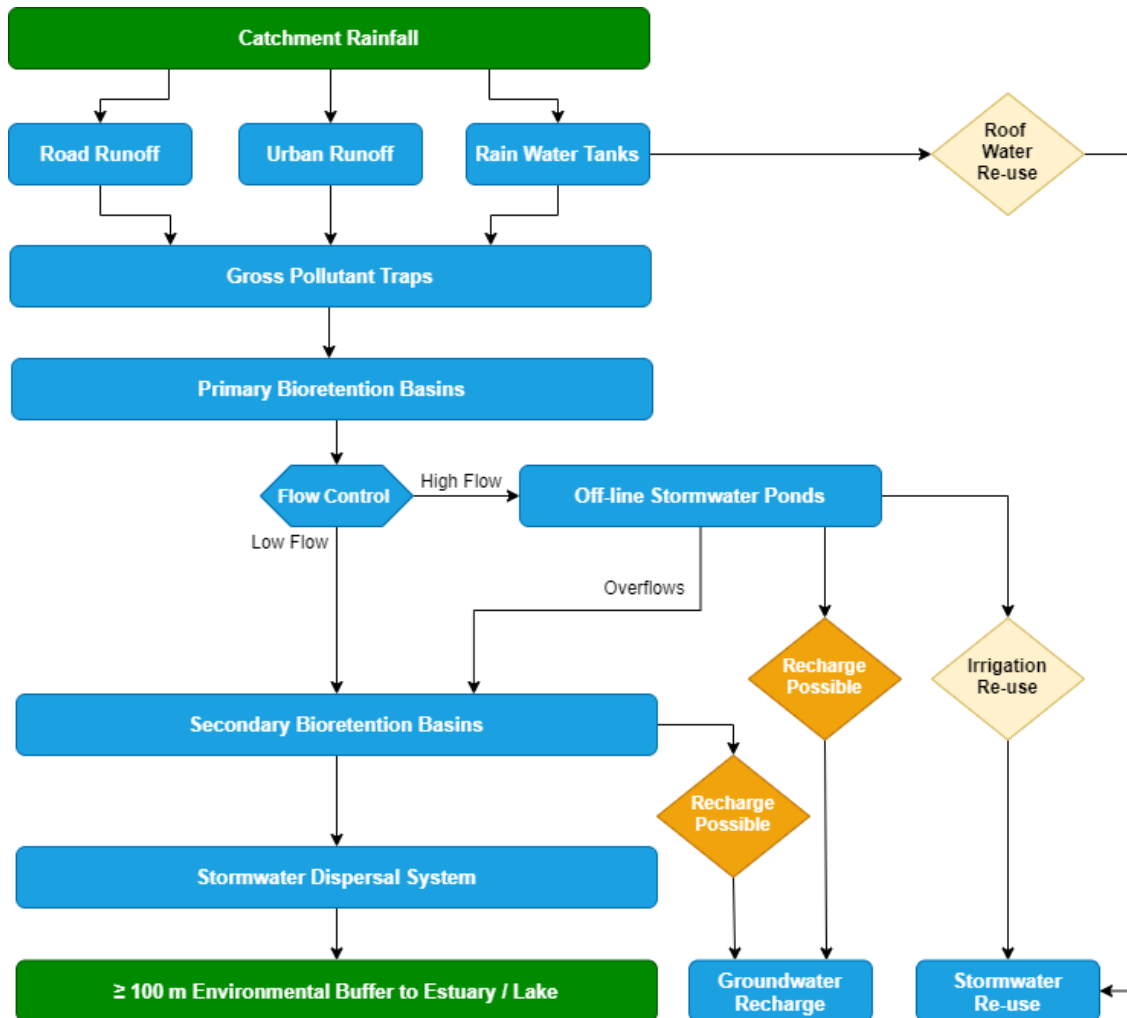
recharge. These general concepts are illustrated in the figure below, which broadly describes the stormwater scheme layout for the majority of the site. Only a small portion of the Proposal area is not serviced by an off-line stormwater pond and a secondary bioretention basin.

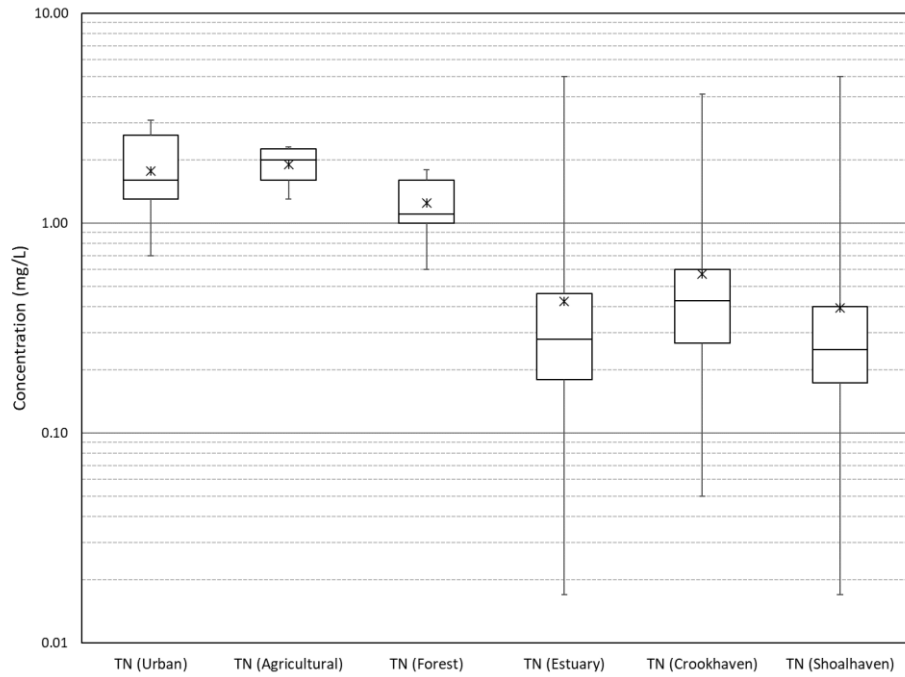
Diagram 6: Total nitrogen (TN) box-whisker comparisons between observed surface runoff and estuary concentrations.

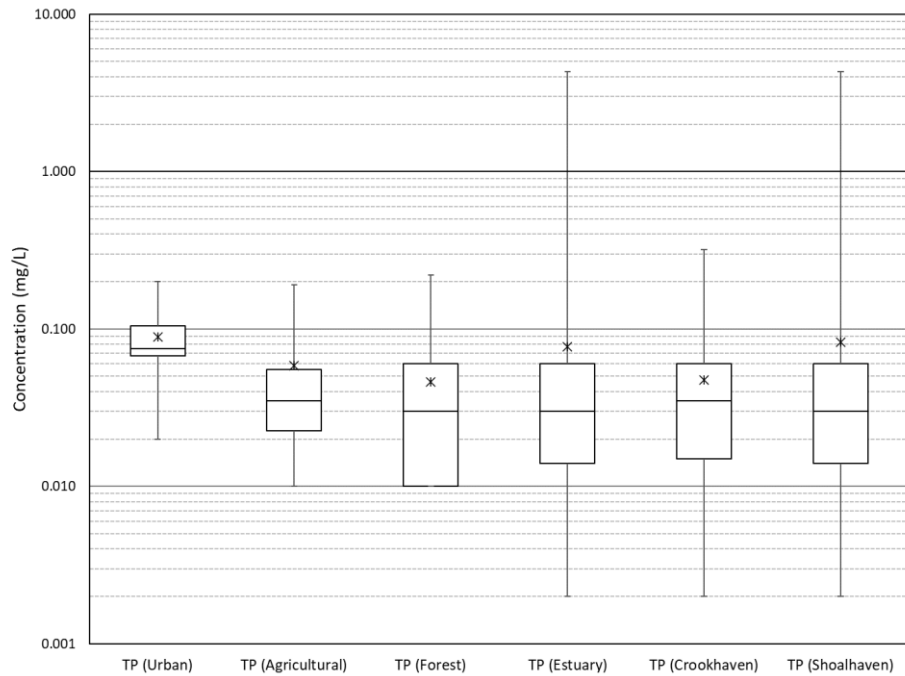
Diagram 7: Total phosphorus (TP) box-whisker plots of observed surface runoff and estuary concentrations.

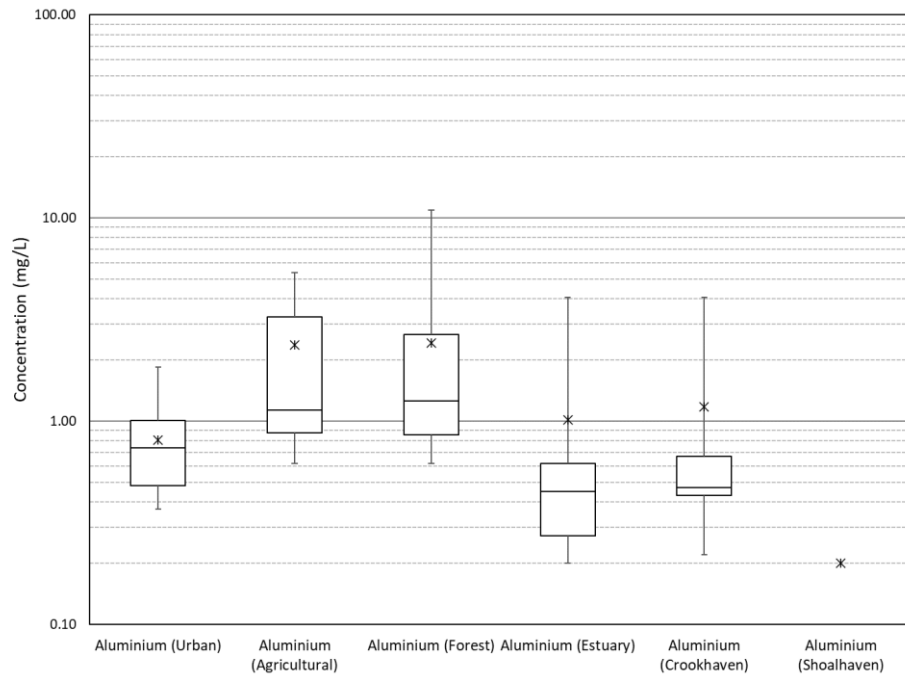
Diagram 8: Aluminium box-whisker plots of observed surface runoff and estuary concentrations.

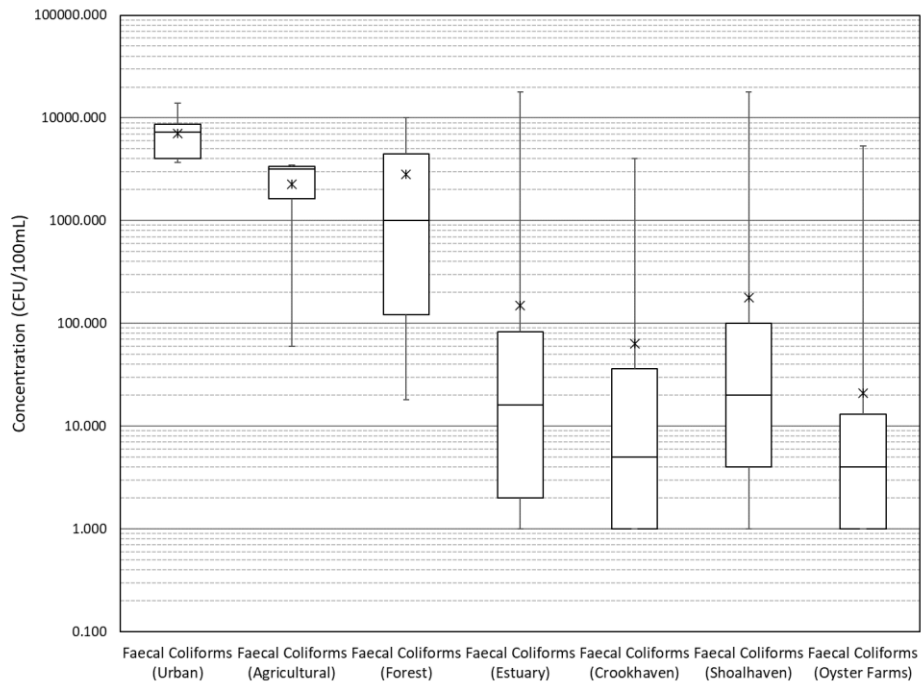
Diagram 9: Faecal Coliform (FC) box-whisker plots of observed surface runoff and estuary concentrations.

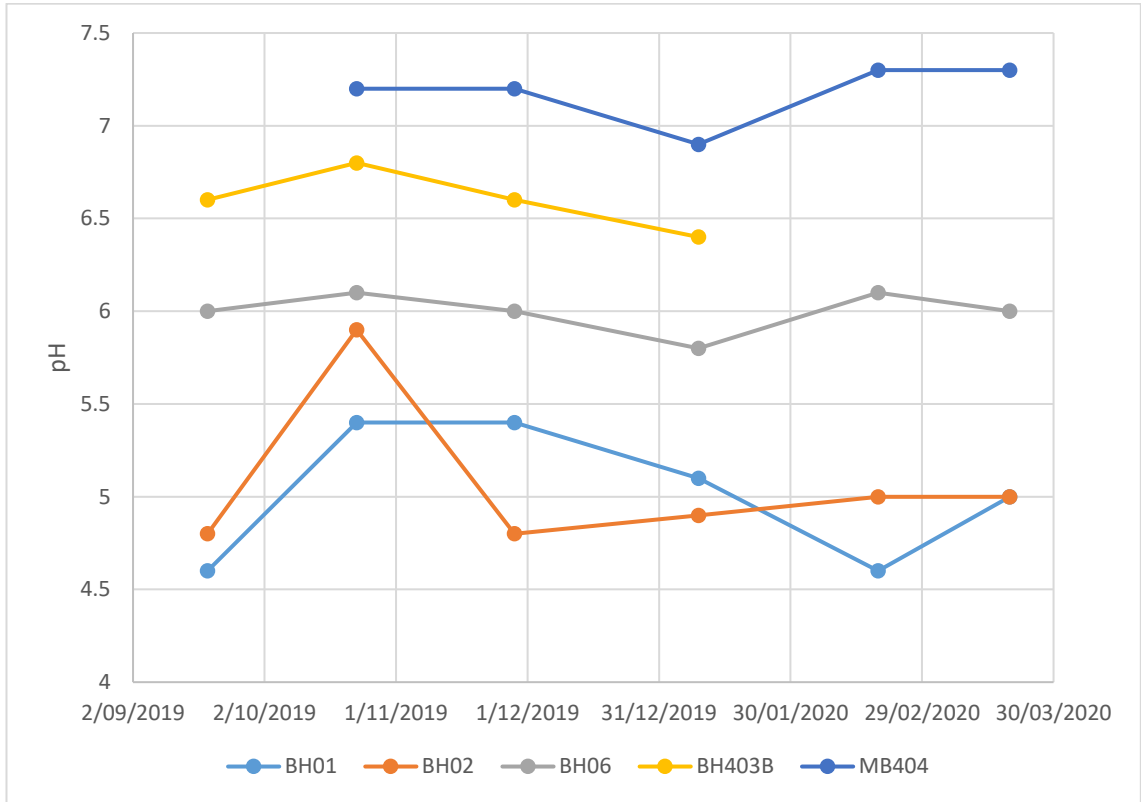
Figure 7: Observed pH readings.

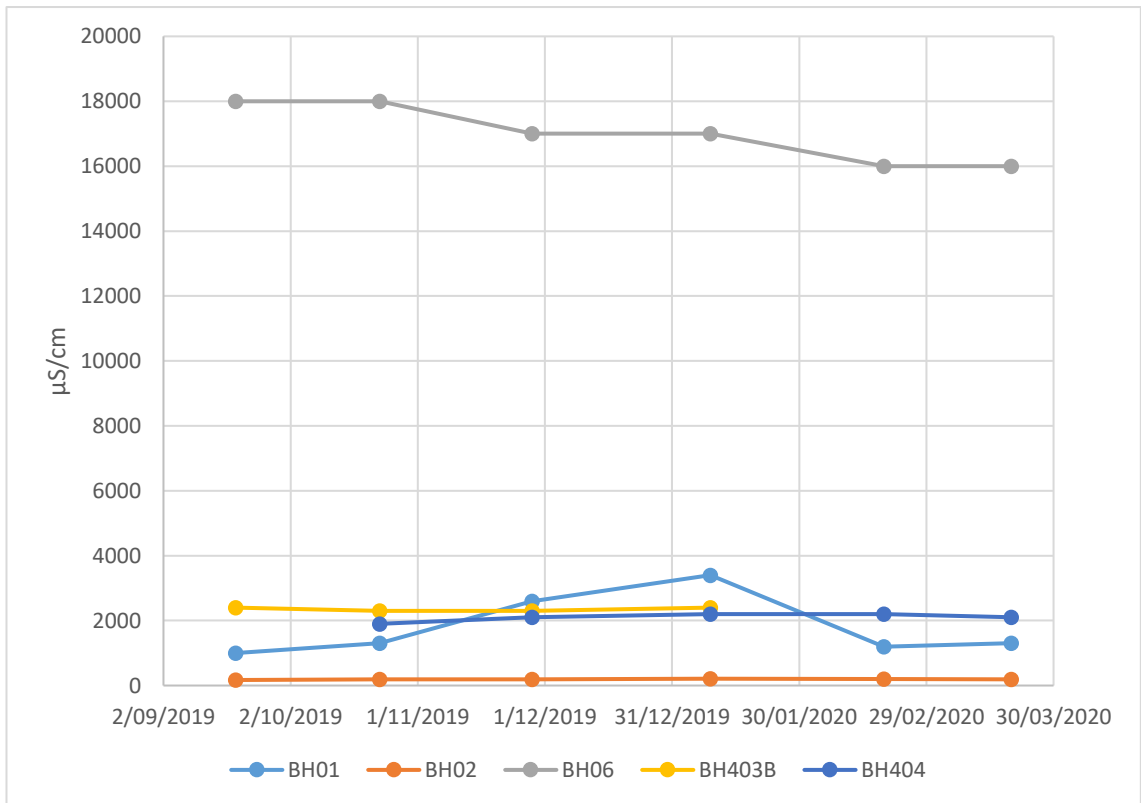
Figure 8: Observed electrical conductivity readings.

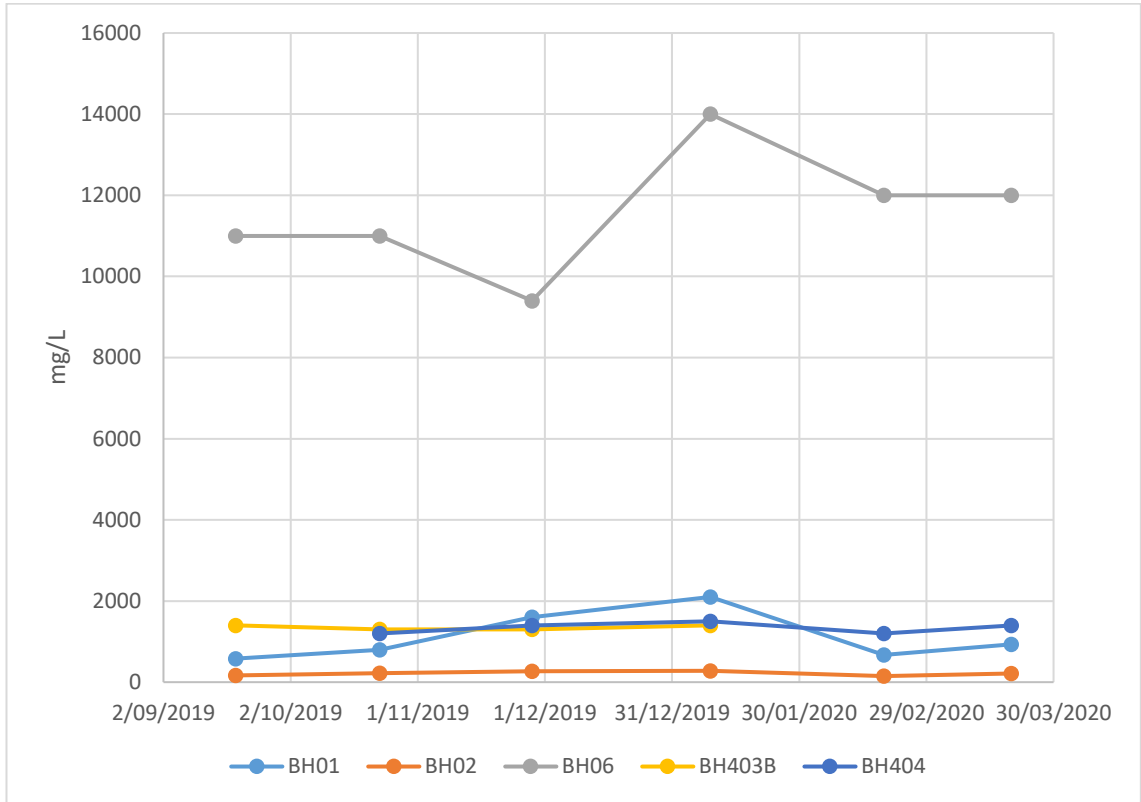
Figure 9: Observed total dissolved solids readings.

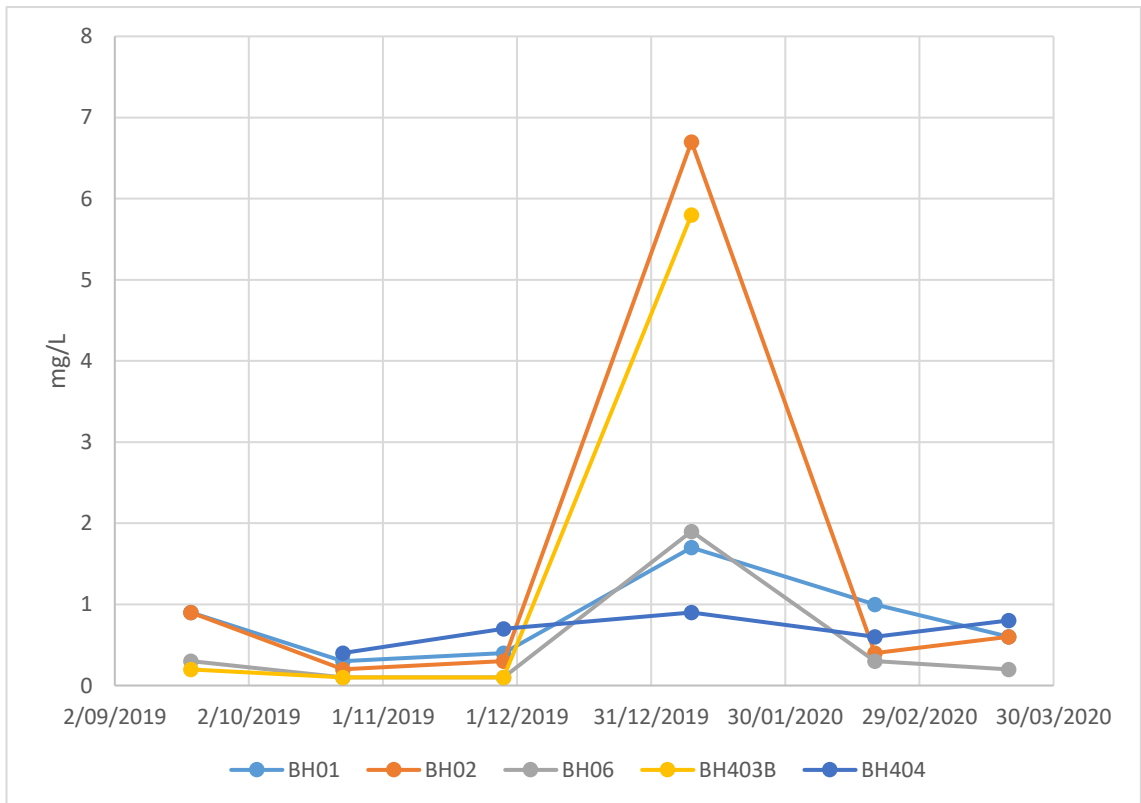
Figure 10: Observed total nitrogen readings.

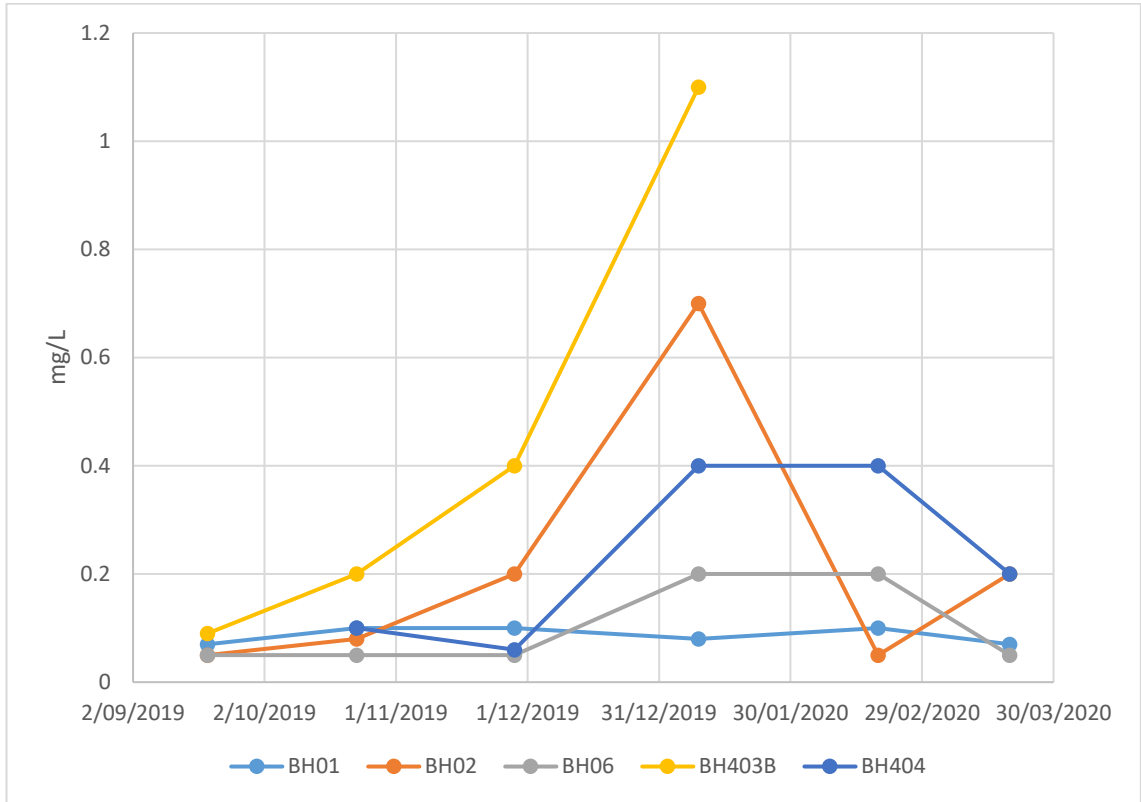
Figure 11: Observed total phosphorous readings.

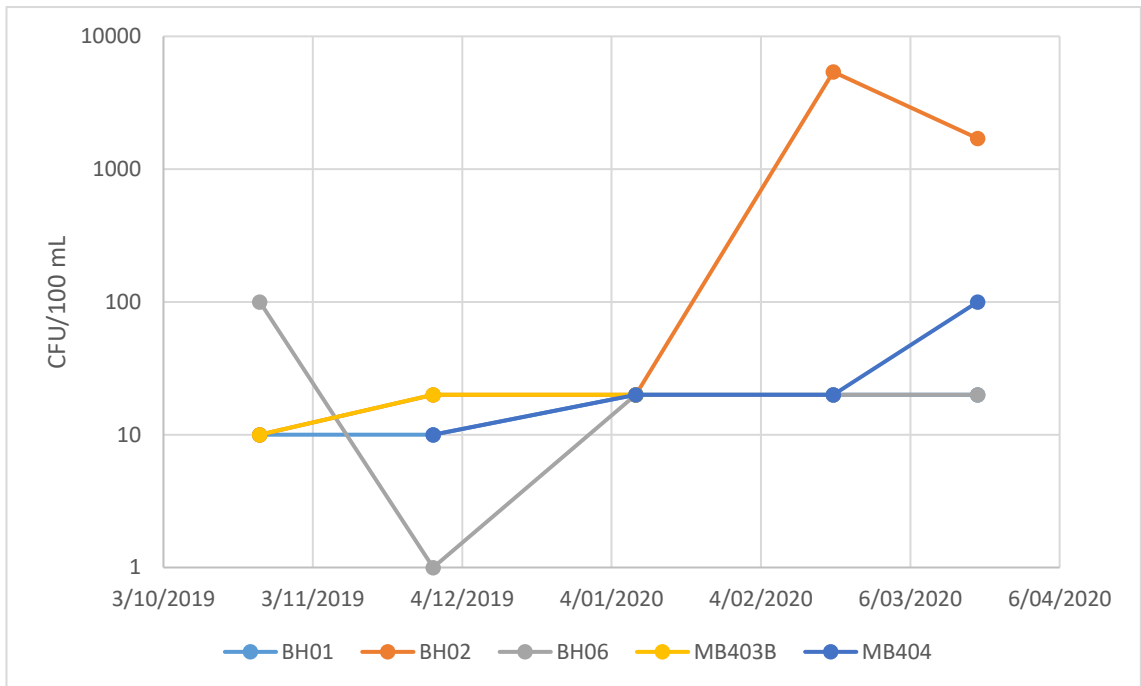
Figure 12: Observed faecal coliforms readings.

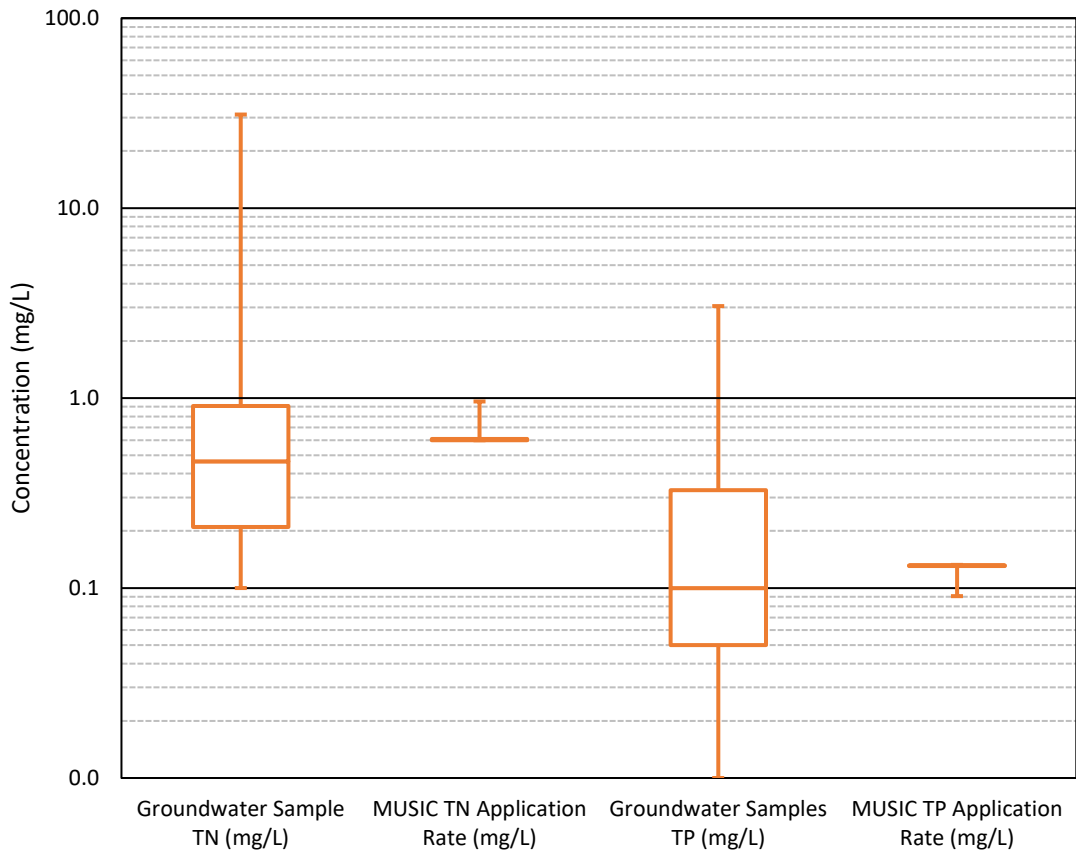
Figure 14: Groundwater samples compared to MUSIC modelled concentrations.

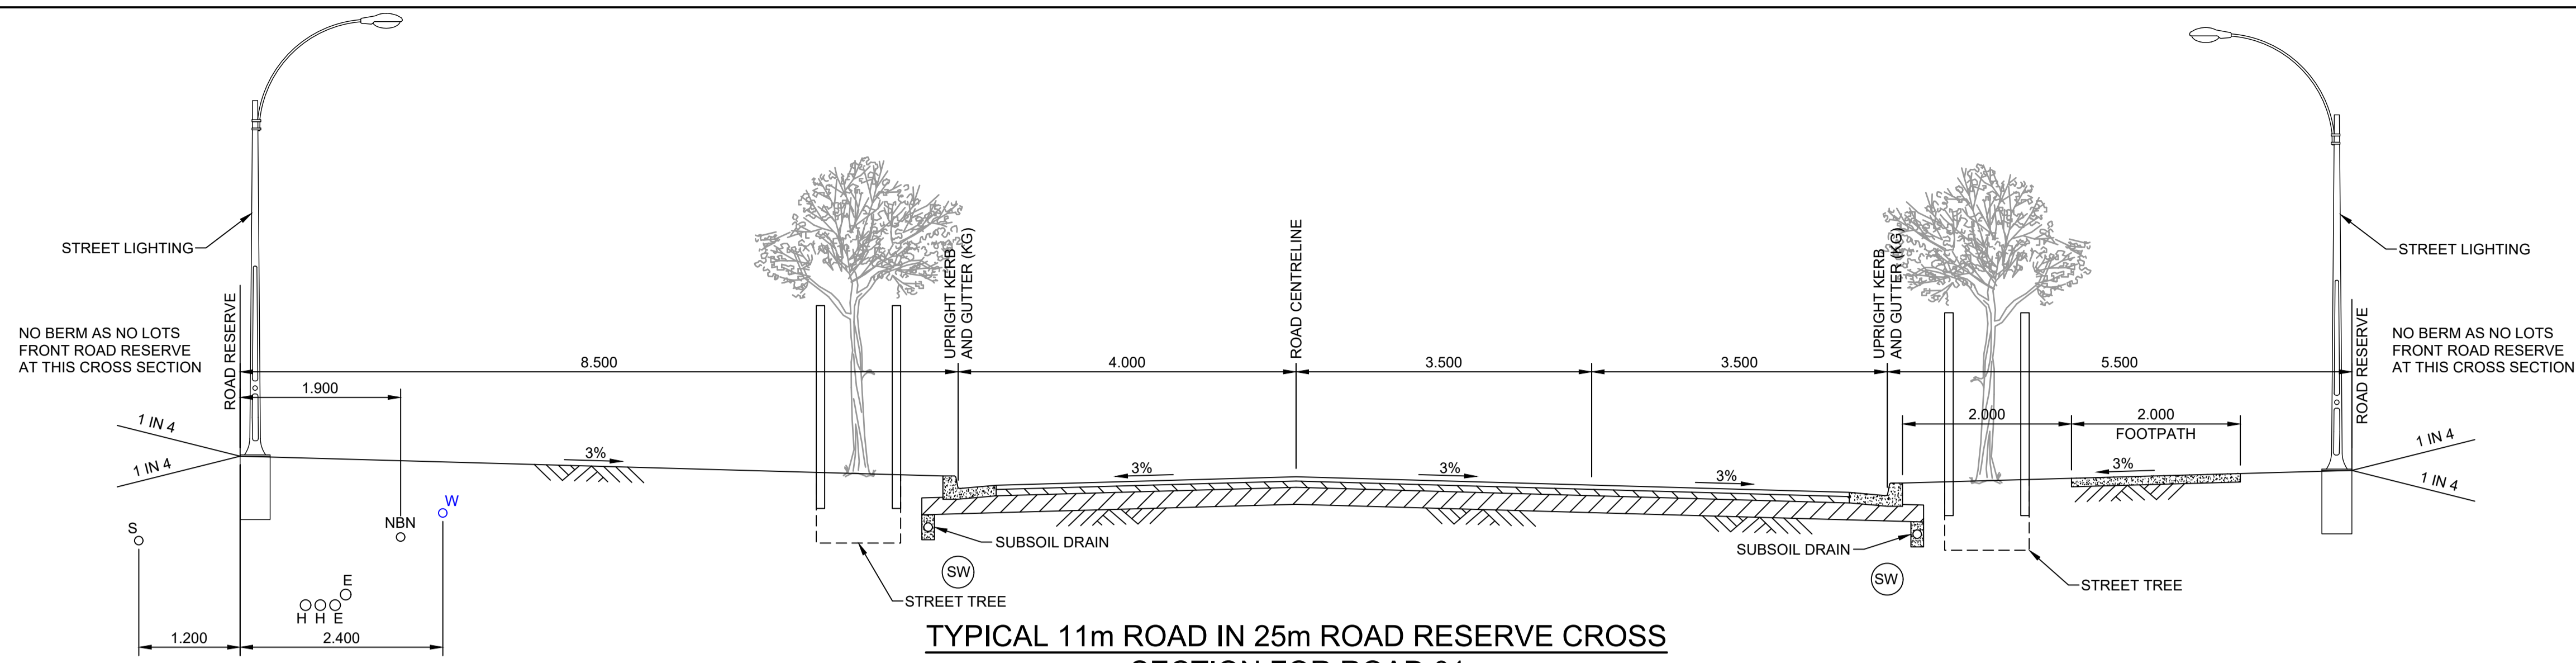
TYPICAL 11m ROAD IN 25m ROAD RESERVE CROSS SECTION FOR ROAD 01
SCALE 1:50

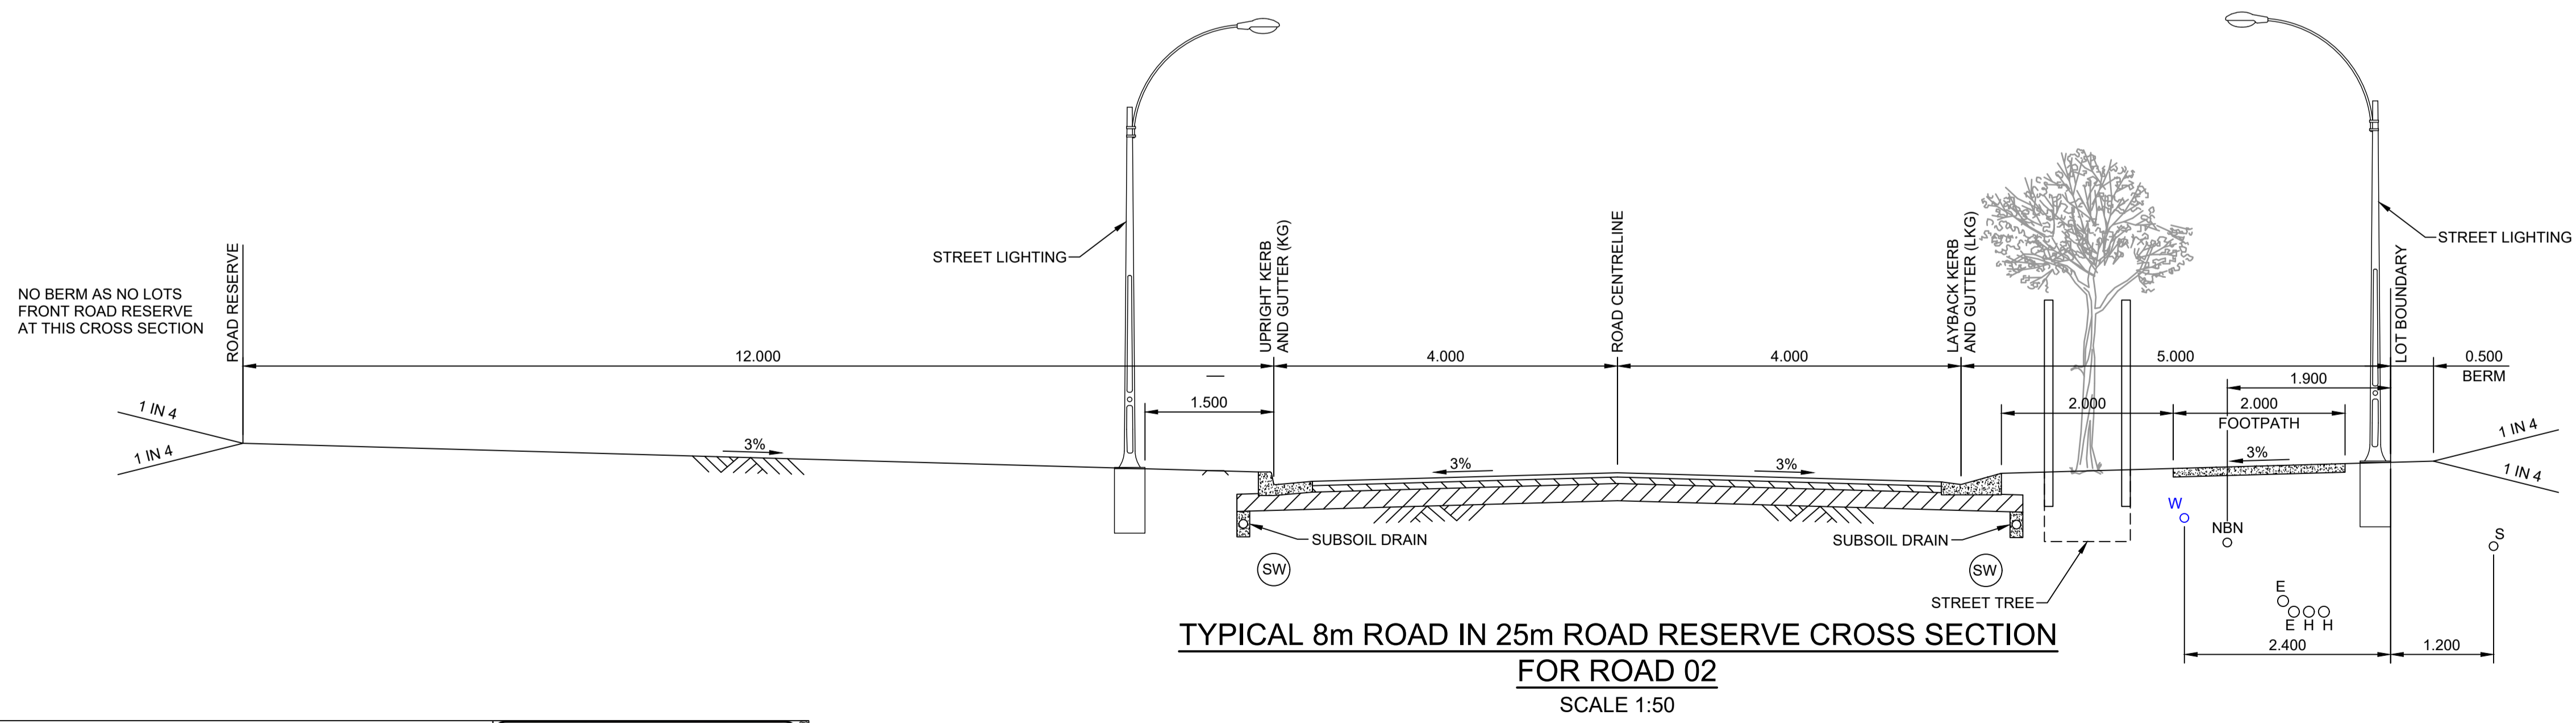
TYPICAL 8m ROAD IN 25m ROAD RESERVE CROSS SECTION FOR ROAD 02
SCALE 1:50

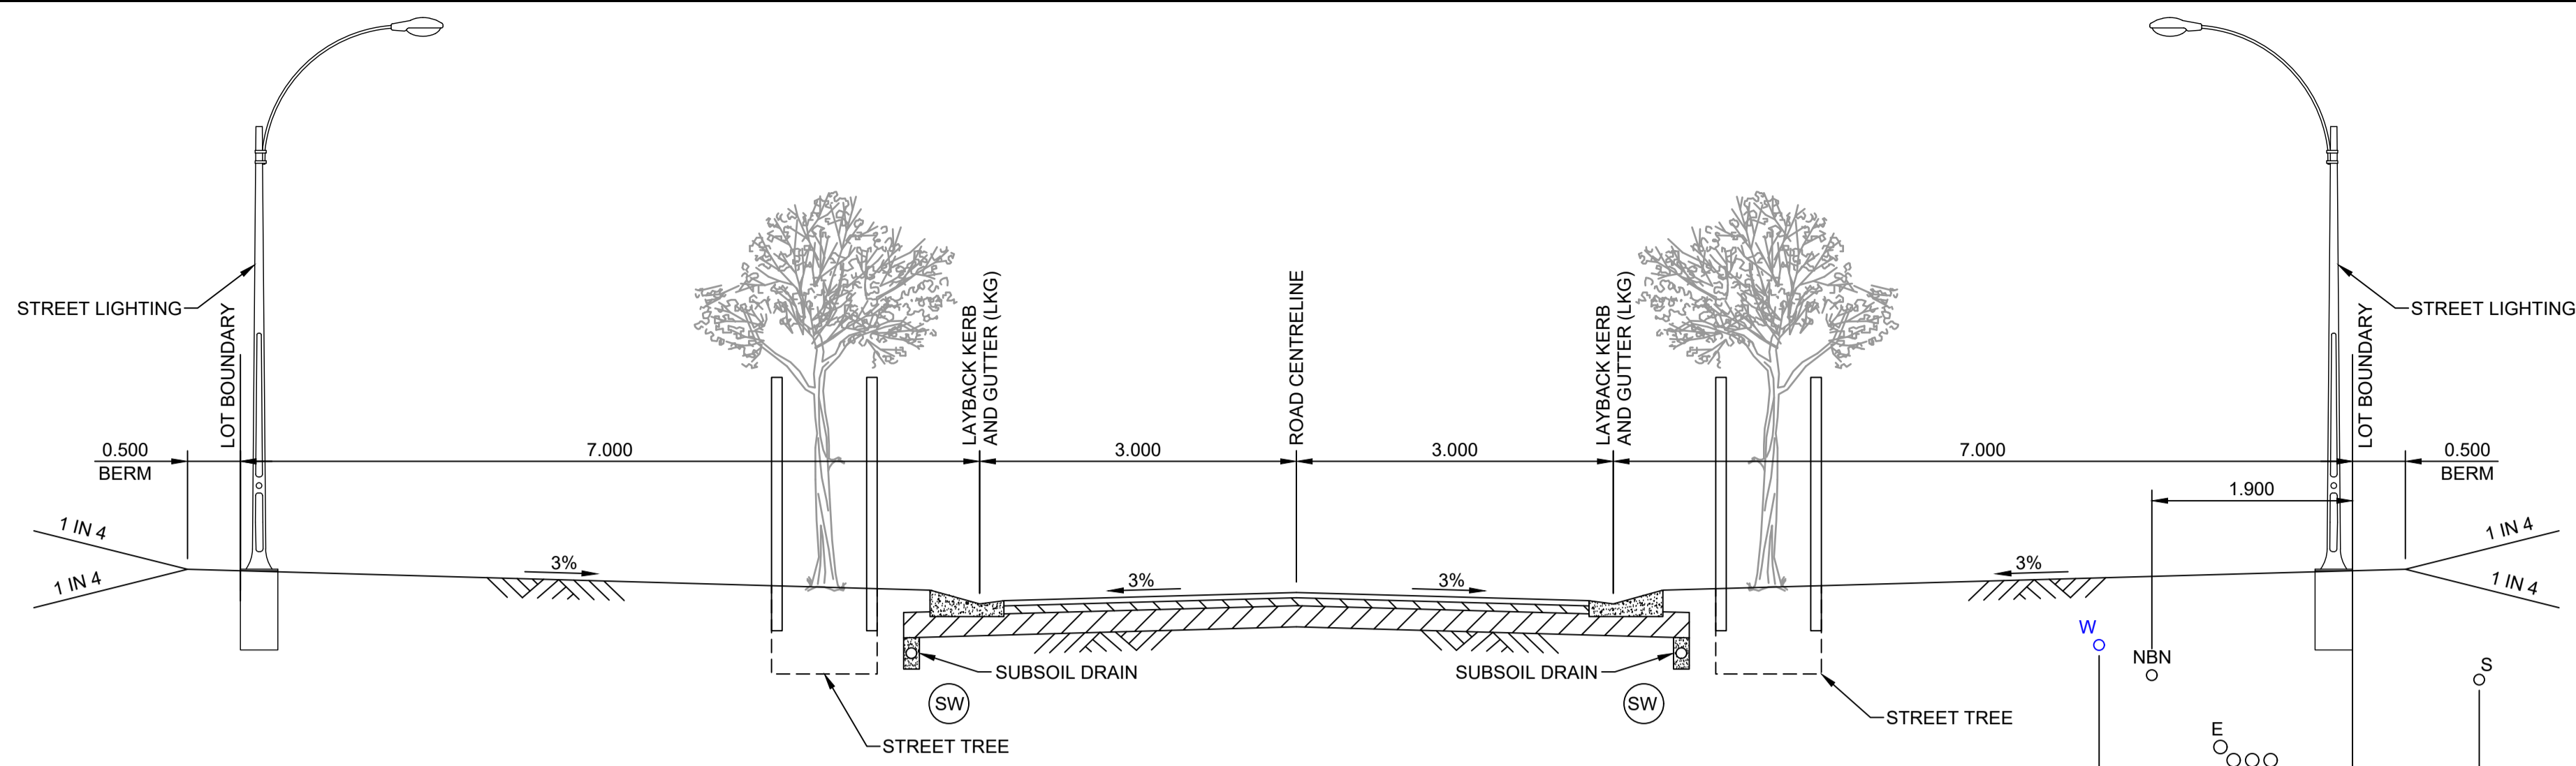
TYPICAL 6m ROAD IN 20m ROAD RESERVE CROSS SECTION FOR ROAD 05
SCALE 1:50

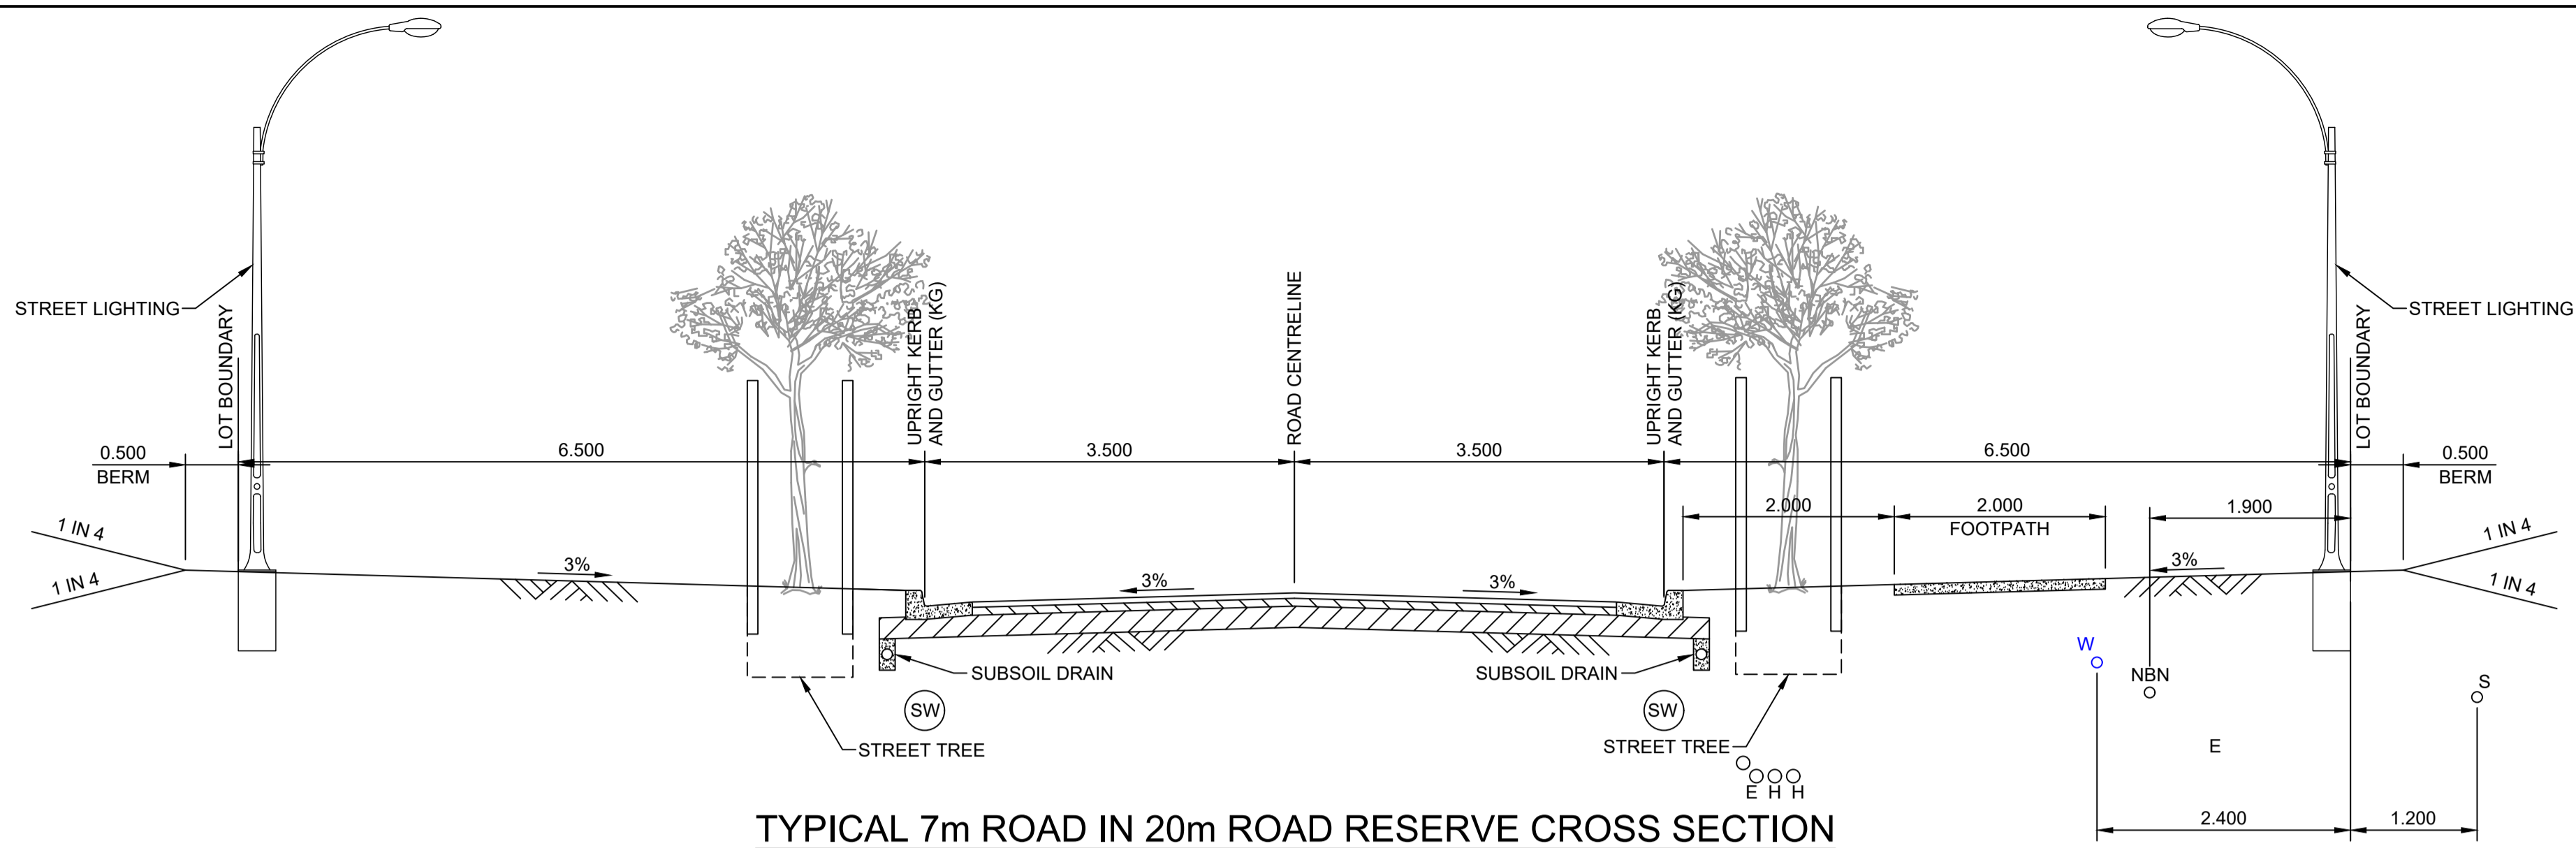
TYPICAL 7m ROAD IN 20m ROAD RESERVE CROSS SECTION
FOR ROAD 08
SCALE 1:50

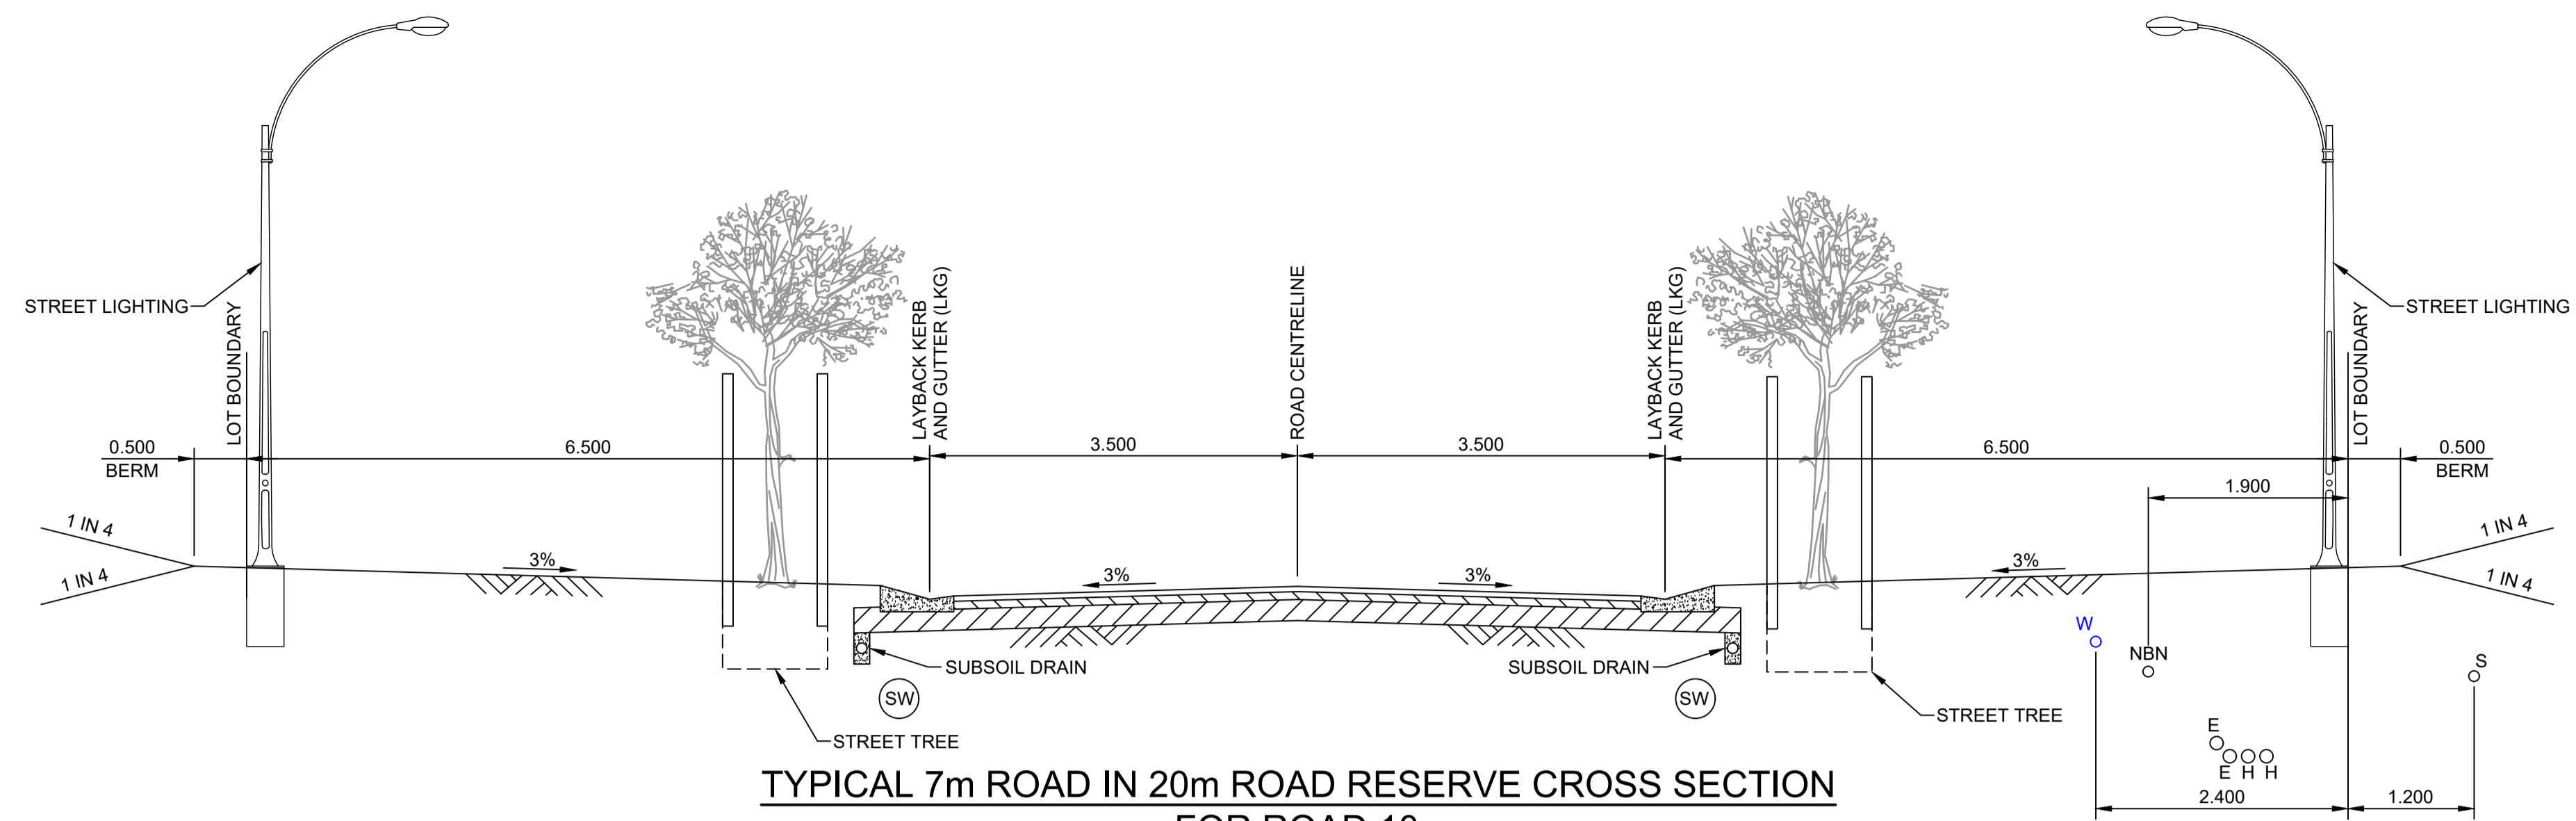
**TYPICAL 7m ROAD IN 20m ROAD RESERVE CROSS SECTION
FOR ROAD 10**
SCALE 1:50
